Hurricane Irma: Consequences of Intense Rainfall and Storm Surge from a Tropical Storm in North and Central Florida

ABSTRACT: Hurricane Irma affected the Florida peninsula from September 9-11, 2017, with high winds, rainfall, and storm surge. Although the storm made landfall on the west coast of Florida, impacts of the rainfall and storm surge affected central and northeast Florida. A GEER team mobilized on September 23, 2017, spent three days documenting sinkhole damage in central Florida, coastal scour and erosion along the northeast coast of Florida, and infrastructure damage in northeast Florida. Numerous sites with geotechnical damage were documented but this case history focuses specifically on sinkhole damage in The Villages, erosion and scour at Vilano Beach, failure of a concrete cover earth dam at Hampton Lake, and bridge embankment damage on US-17 over the Trout River. The most notable challenges to reconnaissance were the widespread and varied nature of the damages from Hurricane Irma and the rapid repair of damaged infrastructure that required the team to work closely with local, state, and federal officials to obtain documentation of the damage prior to repair.

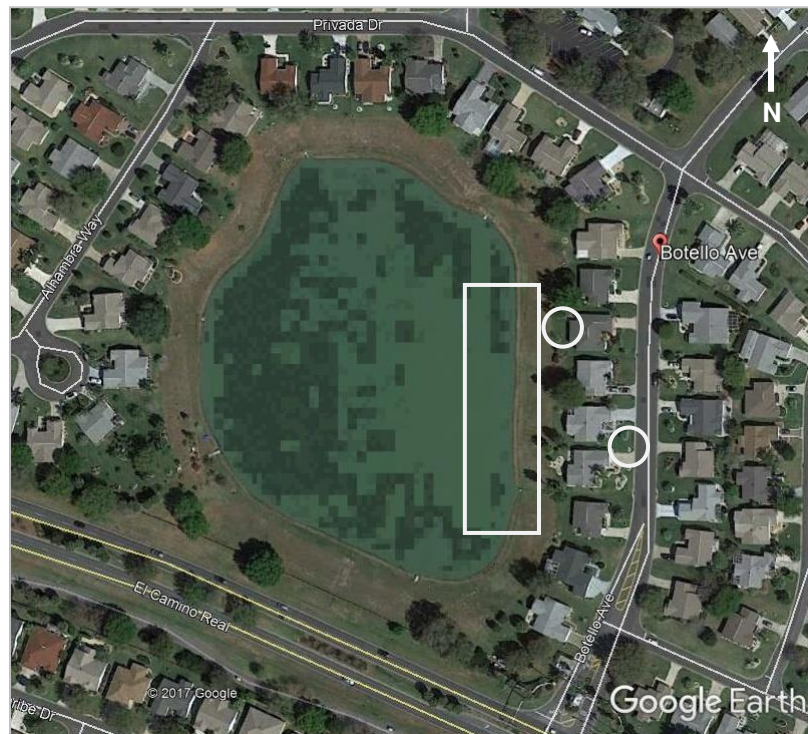
Several sinkholes were identified at a stormwater retention pond (Figure 4) in The Villages Alhambra, a body of water that is approximately 2 hectares (4.9 acres) in size, has six inlets, and is bounded by Privada Drive to the north and Botello Avenue to the east. The sinkholes associated with Hurricane Irma formed along the bottom, on the bank slope, and at the crest of the eastern side of the pond. Two additional sinkholes also affected residences.

Figure 4. Location of sinkholes formed in the retention pond in The Villages Alhambra, FL, at 28°57'10.68"N latitude and 81°59'33.65"W longitude (Google Earth, 2017).
