Reconnaissance of the New Orleans Hurricane and Storm Damage Risk Reduction System after Hurricane Gustav

Reconnaissance of the New Orleans Hurricane and Storm Damage Risk Reduction System after Hurricane Gustav.

International Journal of Geoengineering Case Histories, Volume 5, Issue 4, pp. 129-154, doi: 10.4417/IJGCH-05-04-

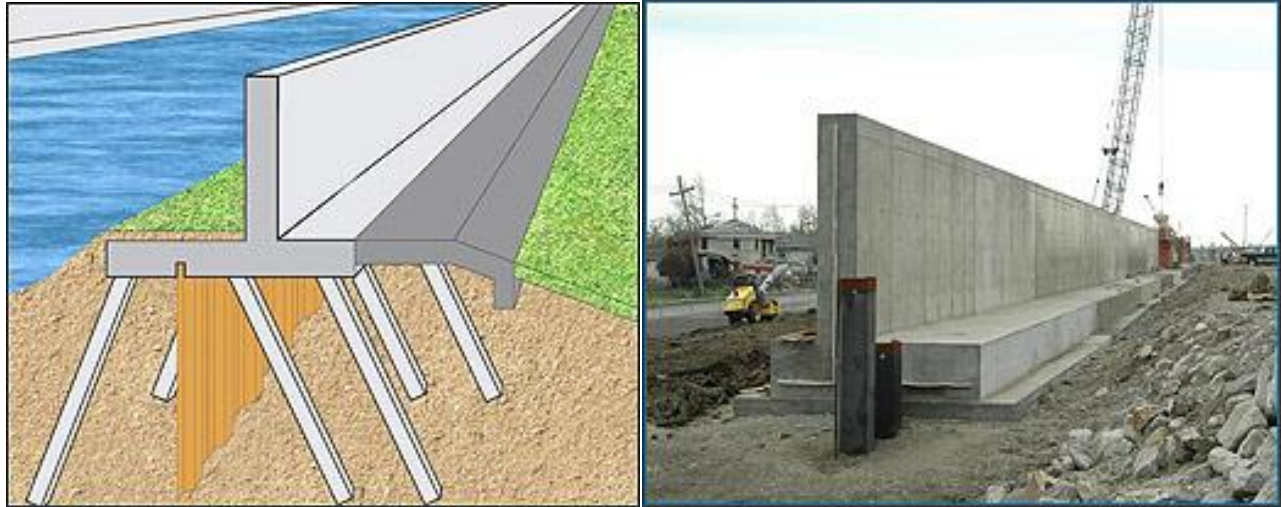
Figures 4 and 5. T-wall schematic and photograph of T-wall under construction.
(http://www.mvn.usace.army.mil/hps2/hps_outfall_canals.asp)

This entire stretch of I-wall, even the section between the two breaches that survived Katrina, was replaced with a T-wall (Figures 3, 4, and 25). The I-wall section south of Claiborne Avenue that did not breach in Katrina was left in place but was reinforced with a larger earthen berm and a buttressing structural concrete splash apron to strengthen the section, reduce the wall height, and provide overtopping scour protection (Figure 26).

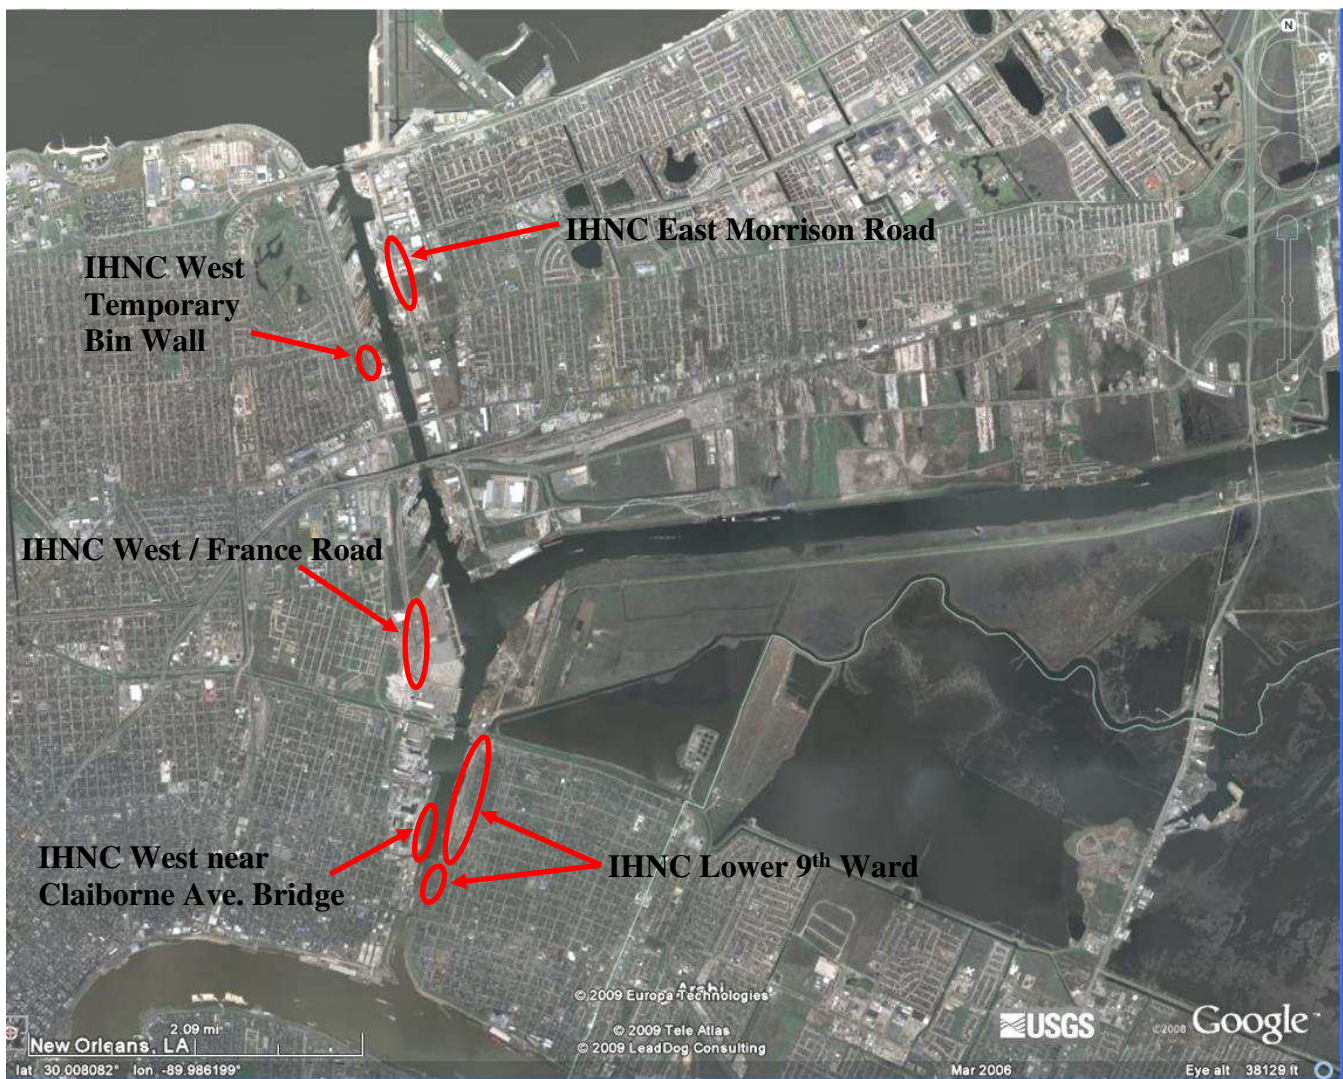
The storm surge from Hurricane Gustav in the metro New Orleans area was most dramatic along the IHNC, where several previous floodwall and levee failures resulted in catastrophic damage during Hurricane Katrina. Waves from Gustav overtopped the floodwalls at some locations along the western side of the IHNC. Figure 15 shows the locations of our reconnaissance along the IHNC.

Figure 15. Areas of reconnaissance along IHNC. (Google Earth Image)

On the western central section of the IHNC (see Figure 15), opposite the junction of the IHNC with the GIWW, the floodwall/levee system is located landward of industrial port facilities, up to about 460 m (1500 ft) from the IHNC. France Road and a railroad parallel much of this part of the HSDRRS. Overtopping surge and waves during Katrina resulted in three breaches in this area.

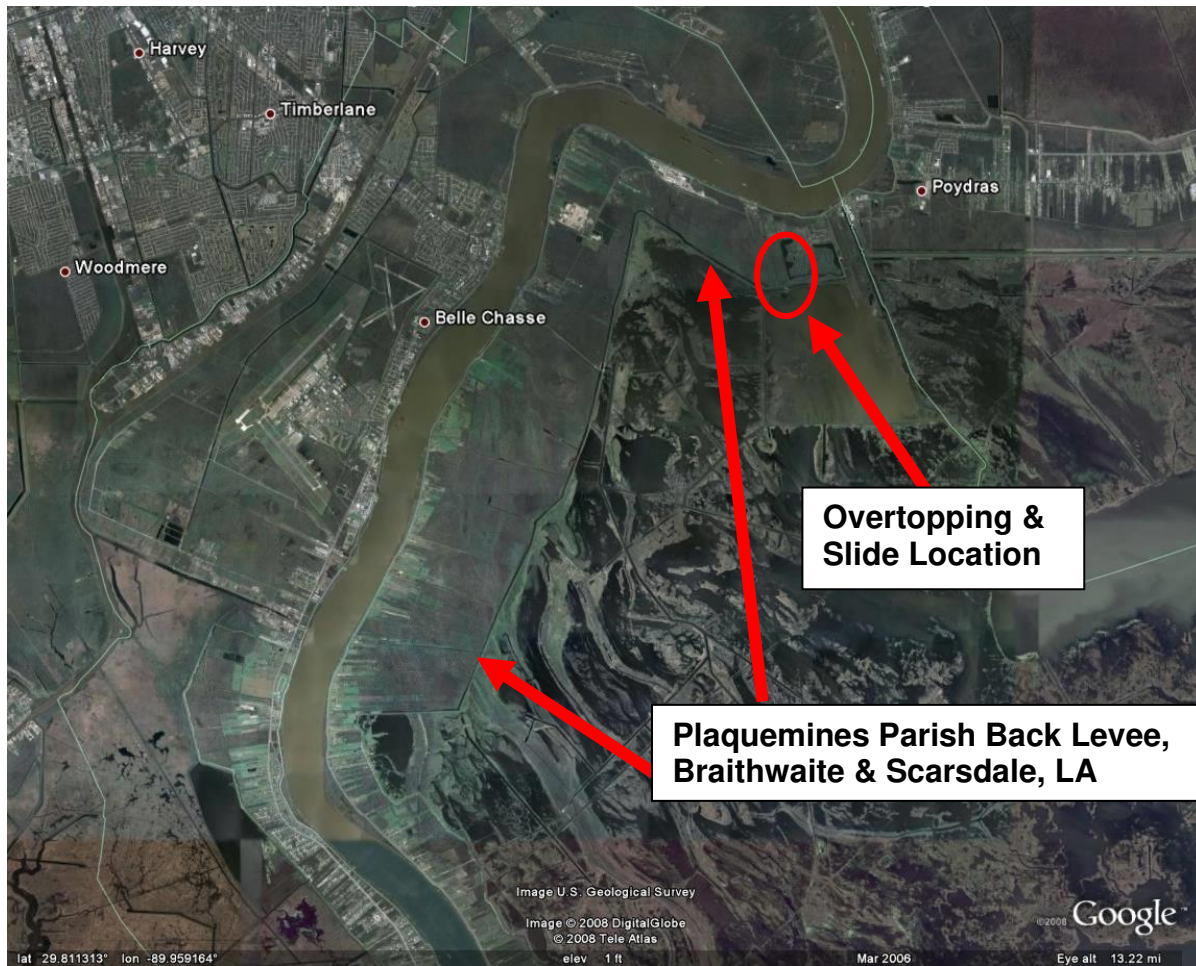
The team visited one length of non-federal back levee, which was constructed and maintained by Plaquemines Parish and which is not considered part of the New Orleans area HSDRRS. Our team observed about half of the northeastern-most back levee of the Parish, located as shown in Figure 34.

At the time of our visit, multiple sections of the levee crest were still covered with a slit-film woven geotextile, held in place with a continuous sand bag berm on the flood side and by intermittent sand bags on the protected side of the crest. Based on our observations and on interviews with a pump station operator, it appears that much of the back levee was overtopped and that a slope slide or slough had occurred on the protected side of the levee along one ~90-m- (~300-ft-) long levee section as shown in Figure 35. Figure 36 shows a part of the scarp for that slough. The team also observed that desiccation cracks were prevalent along parts of the levee. The desiccation cracks may have contributed to the slide by allowing overtopping water pressures into embankment zones critical to slope stability. The placement water content, compaction, and organic content of the back-levee soils were not known and may be factors in the susceptibility of the levee soils to desiccation cracks and erosion.

Along more southerly sections of the levee, the team observed signs of overtopping with less dramatic effects. Debris from overtopping and erosion gullies, often covered with sand bags, was prevalent along all sections of the levee.

Figure 34. Plaquemines Parish back levee near Braithwaite and Scarsdale, LA. (Google Earth / USGS Imagery)
