## Reconnaissance of the New Orleans Hurricane and Storm Damage Risk Reduction System after Hurricane Gustav

**ABSTRACT:** On October 2 and 3, 2008, a group of civil engineers sponsored by the National Science Foundation (NSF) and organized by the Geoengineering Extreme Events Reconnaissance (GEER) Association, visited the New Orleans area to assess levee performance during hurricane Gustav. This paper summarizes the team's observations and understanding of the state of the New Orleans Hurricane and Storm Damage Risk Reduction System (HSDRRS) in the fall of 2008 and the performance of elements of the HSDRRS during Hurricane Gustav. The fundamental conclusion was that the HSDRRS performed well under the surge and wave stresses generated by Gustav. The team's observations led to lessons about dangers to floodwalls from boats and barges, the importance of timely preparation for hurricanes, erosion resistance of clay levees, and the need for continued emphasis on evacuation for life protection.

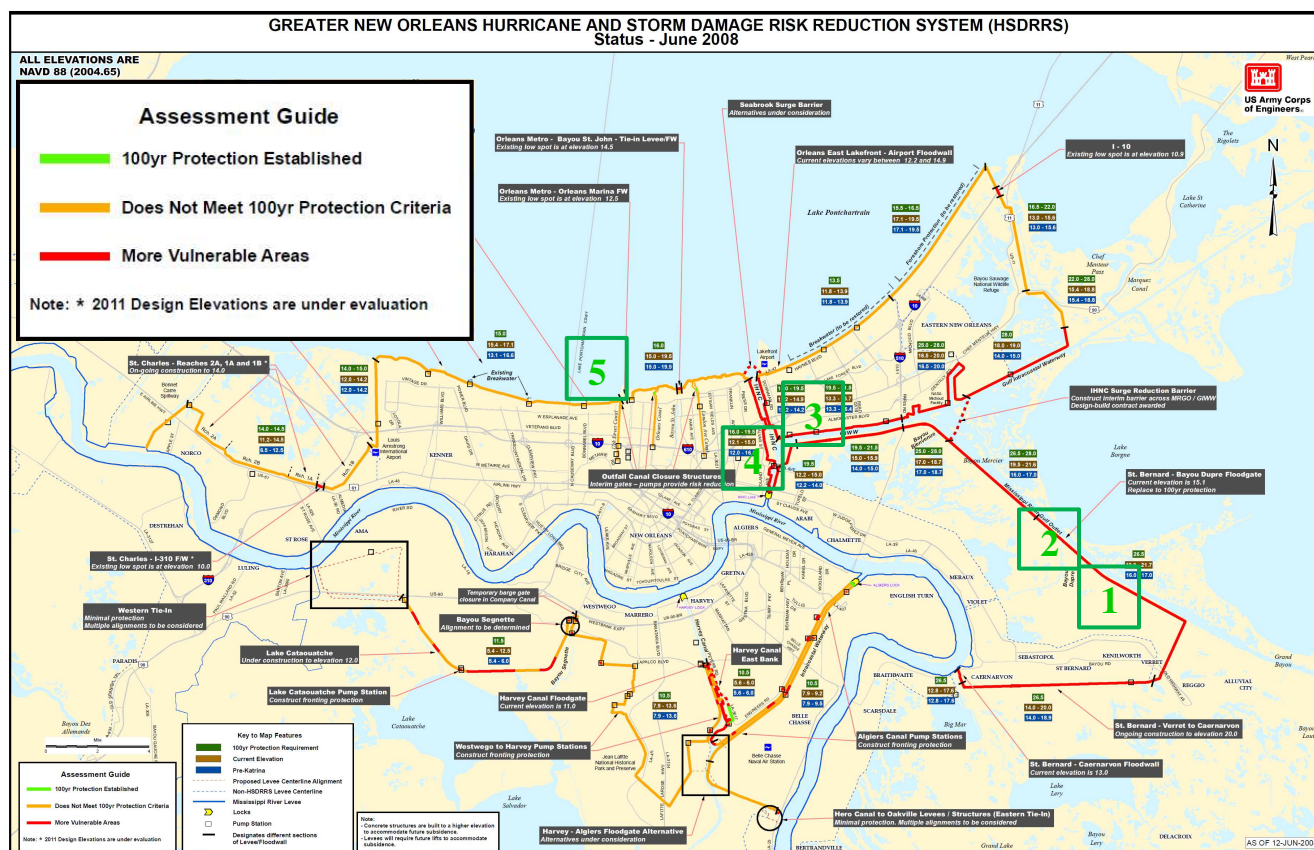
Figure 1 shows the layout and status of the HSDRRS as reported by the USACE in June 2008, about two months before the arrival of Gustav. Our group visited selected locations along the HSDRRS; specifically, where the team knew breaches occurred during Katrina or where our USACE guides identified areas of interest. Table 1 lists the pre-Katrina HPS and June

2008 HSDRRS structure elevations from Figure 1 for the various sites that the team visited or researched. The improvements to the HSDRRS as of August 2008 were, in many places, temporary, to provide a heightened interim level of protection until the planned improvements could be fully completed. The USACE reported completion of those improvements in May 2018.

Figure 1. HSDRRS Status Plan, June 2008.
