# Reconnaissance of the New Orleans Hurricane and Storm Damage Risk Reduction System after Hurricane Gustav

**ABSTRACT:** On October 2 and 3, 2008, a group of civil engineers sponsored by the National Science Foundation (NSF) and organized by the Geoengineering Extreme Events Reconnaissance (GEER) Association, visited the New Orleans area to assess levee performance during hurricane Gustav. This paper summarizes the team's observations and understanding of the state of the New Orleans Hurricane and Storm Damage Risk Reduction System (HSDRRS) in the fall of 2008 and the performance of elements of the HSDRRS during Hurricane Gustav. The fundamental conclusion was that the HSDRRS performed well under the surge and wave stresses generated by Gustav. The team's observations led to lessons about dangers to floodwalls from boats and barges, the importance of timely preparation for hurricanes, erosion resistance of clay levees, and the need for continued emphasis on evacuation for life protection.

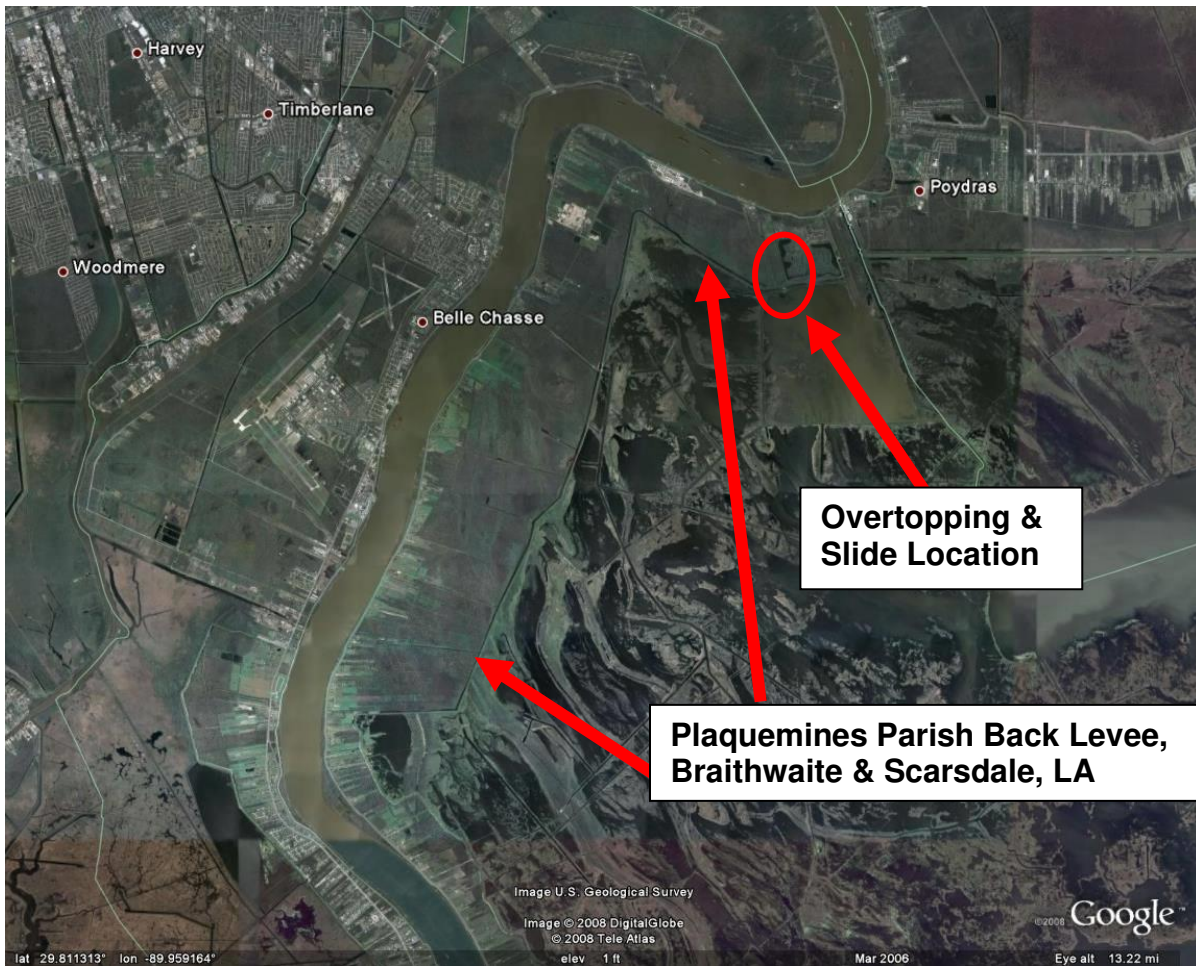
Figure 34. Plaquemines Parish back levee near Braithwaite and Scarsdale, LA. (Google Earth / USGS Imagery)

The team visited one length of non-federal back levee, which was constructed and maintained by Plaquemines Parish and which is not considered part of the New Orleans area HSDRRS. Our team observed about half of the northeastern-most back levee of the Parish, located as shown in Figure 34.

At the time of our visit, multiple sections of the levee crest were still covered with a slit-film woven geotextile, held in place with a continuous sand bag berm on the flood side and by intermittent sand bags on the protected side of the crest. Based on our observations and on interviews with a pump station operator, it appears that much of the back levee was overtopped and that a slope slide or slough had occurred on the protected side of the levee along one ~90-m- (~300-ft-) long levee section as shown in Figure 35. Figure 36 shows a part of the scarp for that slough. The team also observed that desiccation cracks were prevalent along parts of the levee. The desiccation cracks may have contributed to the slide by allowing overtopping water pressures into embankment zones critical to slope stability. The placement water content, compaction, and organic content of the back-levee soils were not known and may be factors in the susceptibility of the levee soils to desiccation cracks and erosion.

Along more southerly sections of the levee, the team observed signs of overtopping with less dramatic effects. Debris from overtopping and erosion gullies, often covered with sand bags, was prevalent along all sections of the levee.
