Reconnaissance of the New Orleans Hurricane and Storm Damage Risk Reduction System after Hurricane Gustav

ABSTRACT: On October 2 and 3, 2008, a group of civil engineers sponsored by the National Science Foundation (NSF) and organized by the Geoengineering Extreme Events Reconnaissance (GEER) Association, visited the New Orleans area to assess levee performance during hurricane Gustav. This paper summarizes the team's observations and understanding of the state of the New Orleans Hurricane and Storm Damage Risk Reduction System (HSDRRS) in the fall of 2008 and the performance of elements of the HSDRRS during Hurricane Gustav. The fundamental conclusion was that the HSDRRS performed well under the surge and wave stresses generated by Gustav. The team's observations led to lessons about dangers to floodwalls from boats and barges, the importance of timely preparation for hurricanes, erosion resistance of clay levees, and the need for continued emphasis on evacuation for life protection.

Reference: Wooten L., Gilbert R. B., Marcuson, III W. F., Harder, Jr. L. F., and Nicholson P. G. (2020).

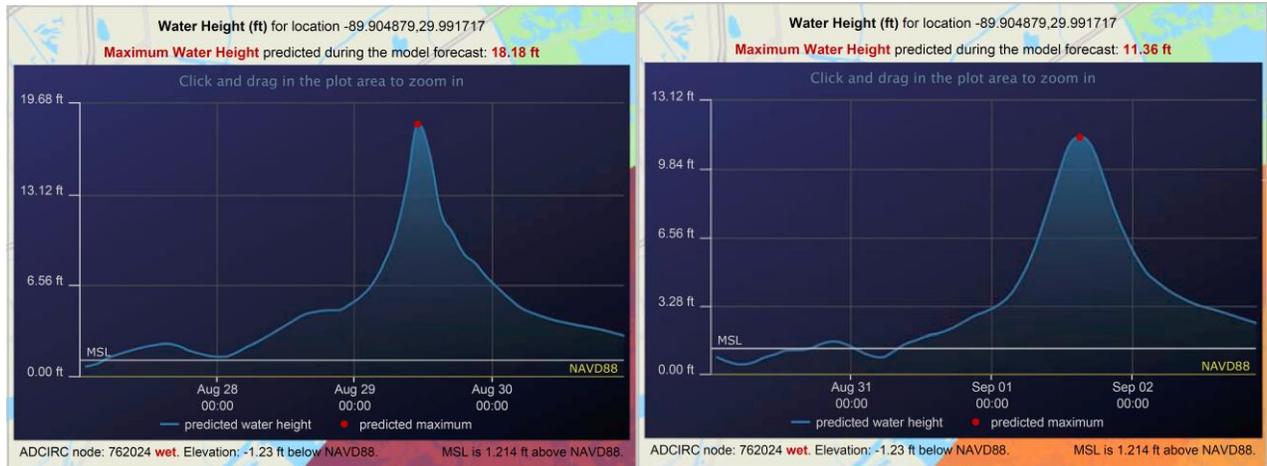
As visible in Figure 9, the storm surge from Hurricane Gustav reached a maximum level, almost 4.3 m (14 ft) (North American Vertical Datum of 1988, NAVD 88), southeast of New Orleans in the marsh bordering Black Bay . Along the New Orleans HSDRRS, the greatest storm surge levels were in the Inner Harbor Navigation Canal (IHNC), also referred to as the Industrial Canal. At the IHNC Lock, the peak water level reached 3.4 m (11 ft). In contrast, the peak storm surge levels in the IHNC during Hurricane Katrina were approximately 1 m (3 ft) higher (IPET 2008), given that the measured peak water level at the IHNC Lock during Katrina was 4.4 m (14.4 ft). Figure 10 shows hindcast hydrographs illustrating the difference in flood levels between Katrina and Gustav at the north end of the MRGO waterway levee.

Figure 10. Hindcast hydrographs for Katrina (left, 5.5 m [18.2 ft] peak) and Gustav (right, 3.5 m [11.4 ft] peak) storm surges along MRGO levee. Only Imperial units were retrieved. (<https://cera.coastalrisk.live/>)

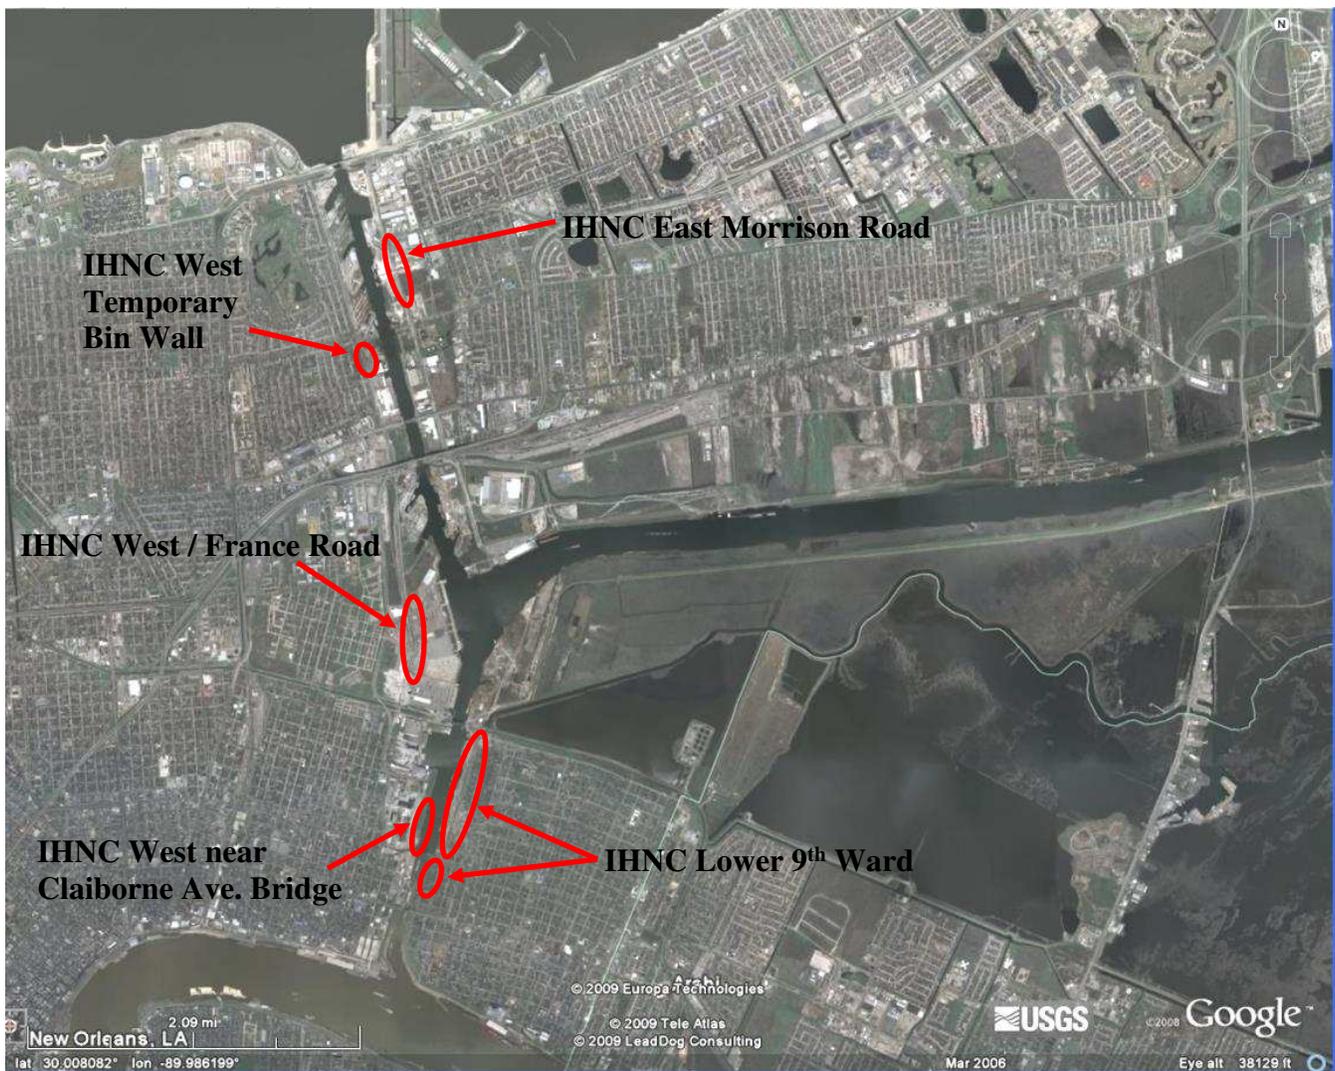
The storm surge from Hurricane Gustav in the metro New Orleans area was most dramatic along the IHNC, where several previous floodwall and levee failures resulted in catastrophic damage during Hurricane Katrina. Waves from Gustav overtopped the floodwalls at some locations along the western side of the IHNC. Figure 15 shows the locations of our reconnaissance along the IHNC.

Figure 15. Areas of reconnaissance along IHNC. (Google Earth Image)

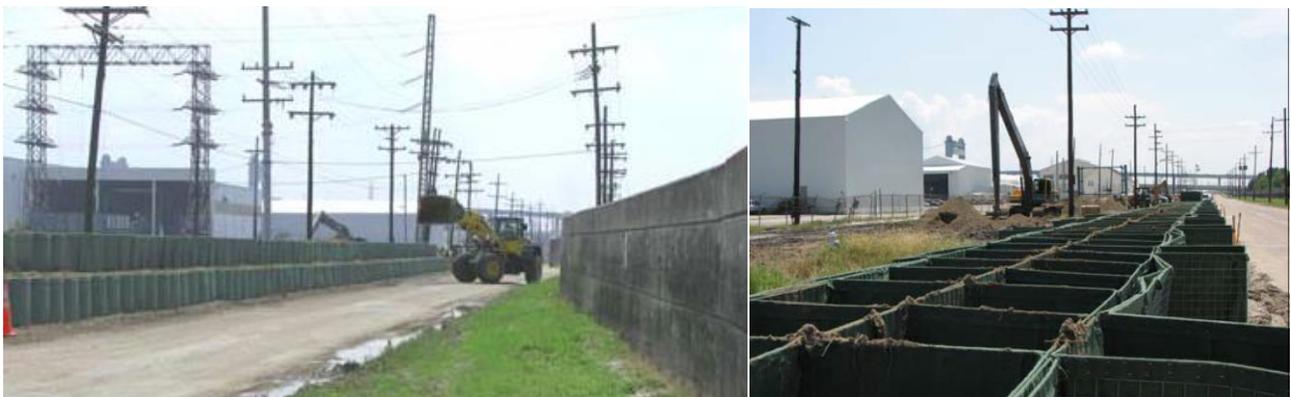
Immediately prior to Gustav, the USACE constructed a ~550-m- (~1800-ft-) long temporary bin wall using HESCO baskets to protect one length of the I-wall along the northwest side of the IHNC that did not meet required stability criteria. Figure 30 shows the temporary bin wall under construction by the USACE, and Figure 31 shows the bin wall immediately after Gustav.

Figure 30. Temporary bin wall under construction, IHNC West along France Road. (August 2008, 30.0157° N, 90.0324° W, http://www.mvn.usace.army.mil/HPS/Status%20Report%20Newsletters/Sept_9_2008.pdf)

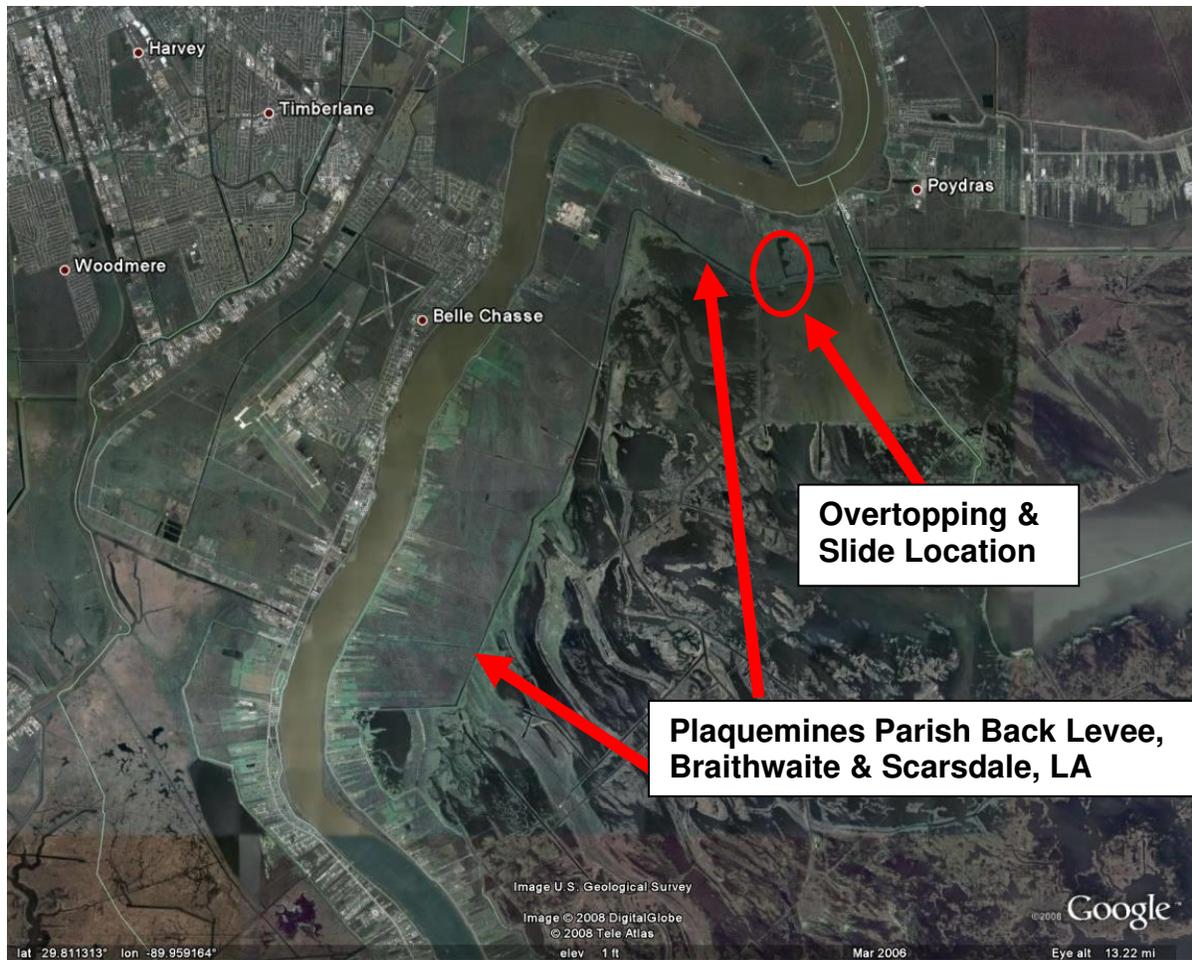
At the time of our visit, multiple sections of the levee crest were still covered with a slit-film woven geotextile, held in place with a continuous sand bag berm on the flood side and by intermittent sand bags on the protected side of the crest. Based on our observations and on interviews with a pump station operator, it appears that much of the back levee was overtopped and that a slope slide or slough had occurred on the protected side of the levee along one ~90-m- (~300-ft-) long levee section as shown in Figure 35. Figure 36 shows a part of the scarp for that slough. The team also observed that desiccation cracks were prevalent along parts of the levee. The desiccation cracks may have contributed to the slide by allowing overtopping water pressures into embankment zones critical to slope stability. The placement water content, compaction, and organic content of the back-levee soils were not known and may be factors in the susceptibility of the levee soils to desiccation cracks and erosion.

Along more southerly sections of the levee, the team observed signs of overtopping with less dramatic effects. Debris from overtopping and erosion gullies, often covered with sand bags, was prevalent along all sections of the levee.

Figure 34. Plaquemines Parish back levee near Braithwaite and Scarsdale, LA. (Google Earth / USGS Imagery)
