# Images Collected from the Internet Reveal the Failing Mechanism of the Tailing Dam Breach at Kolontar, Hungary

**ABSTRACT:** The failure of the red sludge tailing dam at Kolontar in 2010 was the most severe environmental disaster in the history of Hungary. The official investigations are confidential because the legal case has not been closed. The publicly accessible information from the breach of the dam are the photographs taken by the media and news agencies. Collecting these images and analyzing the recorded fractures and displacements of the dam reveal the failing mechanism. The breach of the dam resulted from failing to sliding, which had been developed in three stages. This conclusion is consistent with the observed movements of the dam deduced from a persistent scattered radar interferometry deformation analysis conducted between 2003 and 2010.

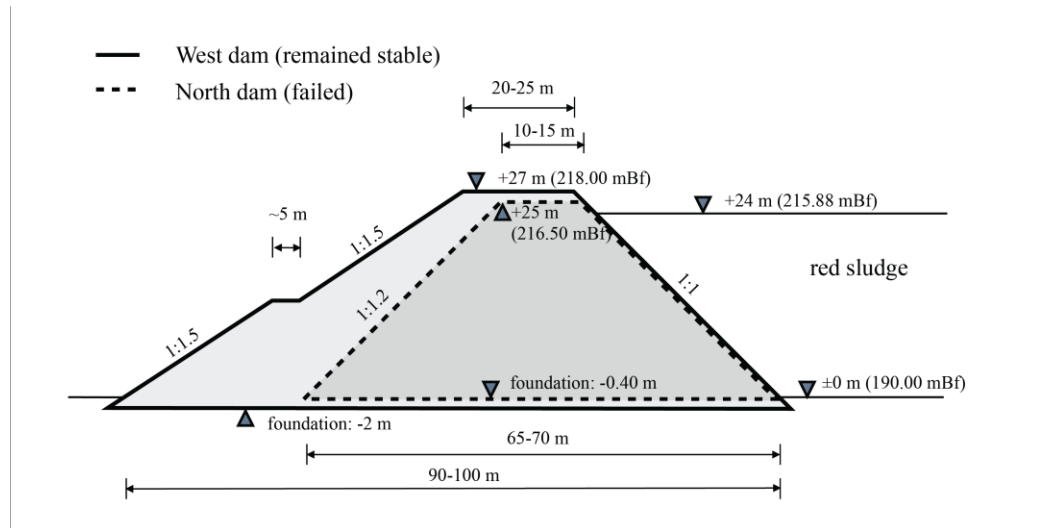
**Figure 3.** The cross sections of the North and West dams (Farkas et. al., 2013). The Northern dam primarily was designed to separate two reservoirs. The cross section of the dam therefore is significantly smaller in comparison to the West dam, which was designed to support the sludge pressure of the reservoir.
