## The July 10 2000 Payatas Landfill Slope Failure

**ABSTRACT:** *This paper presents an investigation of the slope failure in the Payatas landfill in Quezon City, Philippines. This failure, which killed at least 330 persons, occurred July 10<sup>th</sup> 2000 after two weeks of heavy rain from two typhoons. Slope stability analyses indicate that the raised leachate level, existence of landfill gas created by natural aerobic and anaerobic degradation, and a significantly over-steepened slope contributed to the slope failure. The Hydrologic Evaluation of Landfill Performance (HELP) model was used to predict the location of the leachate level in the waste at the time of the slope failure for analysis purposes. This paper presents a description of the geological and environmental conditions, identification of the critical failure surface, and slope stability analyses to better understand the failure and present recommendations for other landfills in tropical areas. In addition, this case history is used to evaluate uncertainty in parameters used in back-analysis of a landfill slope failure.*

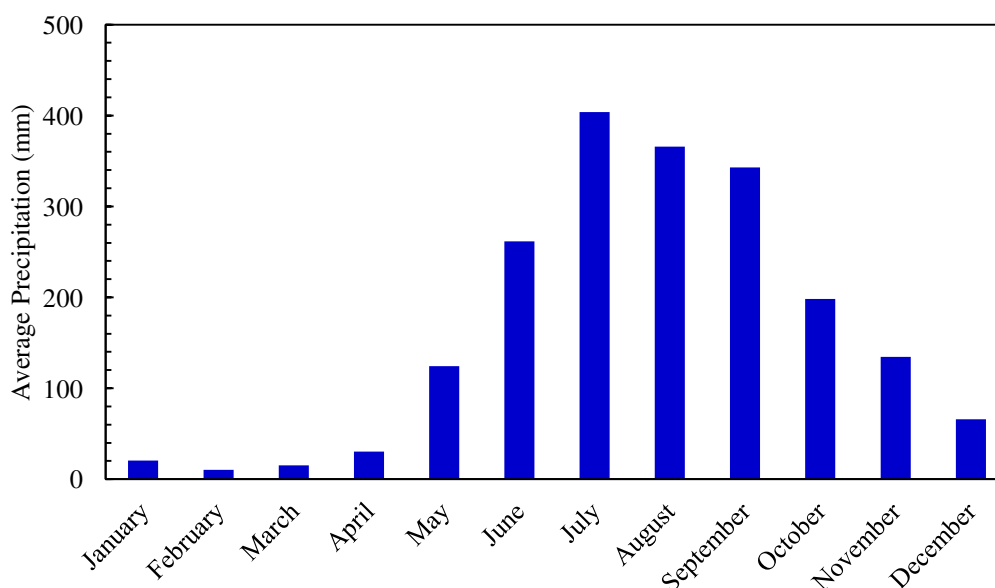
*Figure 13. Average monthly precipitation for Manila, Philippines from Quezon City weather station (data from [www.weather.com](http://www.weather.com)).*

The precipitation database in the HELP model does not provide historical precipitation data for Quezon City, so recorded rainfall data from 1 May through 31 July 2000, was obtained from the Quezon City weather station and imported into HELP. This provides a reasonable simulation of the two months of precipitation immediately preceding the slope failure. Replicating approximate initial moisture conditions before May 1<sup>st</sup> 2000 involved executing the HELP model for several years prior to the failure. As a result, weather and climate conditions similar to Quezon City were required because this data is not available from the Quezon City weather station. Quezon City, located at 14° latitude, is closer to the equator than the United States and hence, has different climate conditions. Quezon City weather is dominated by high humidity, precipitation, and warm conditions year round. Table 7 presents a summary of the key weather conditions for Quezon City. The HELP program can also generate daily precipitation data using a synthetic weather generator. By entering the normal mean monthly precipitation values of Manila, Philippines shown in Figure 13, HELP generated synthetic precipitation records for 10 years preceding the failure. This synthetic record was used until May 1<sup>st</sup> of the 10<sup>th</sup> year, so that the water content and saturation levels reached a reasonable steady state value before applying the recorded data from the Quezon City weather station. From May 1<sup>st</sup> to July 31<sup>st</sup>, recorded precipitation values from the Quezon City station (Canty and Associates LLC, 2004) were input to HELP.

The results of the HELP model predict a leachate level of 12.9 m, including the depressed area, on the brown native plastic clayey silt subgrade on the day of the slope failure. This value is within the range of leachate level (11.5 m and 13.5 m) back-calculated using the circular and planar failure surfaces shown in Figure 11(a) and 11(b), respectively. HELP model
