A High Rock Cut Stabilization in Muscat City, Oman

Reference: Hayat, T.M., Bhatti, T.J. and Goldsmith, R. (2017). *A High Rock Cut Stabilization in Muscat City, Oman*.

International Journal of Geoengineering Case histories, <http://casehistories.geoengineer.org>, Vol.4, Issue 2, p.96-112.

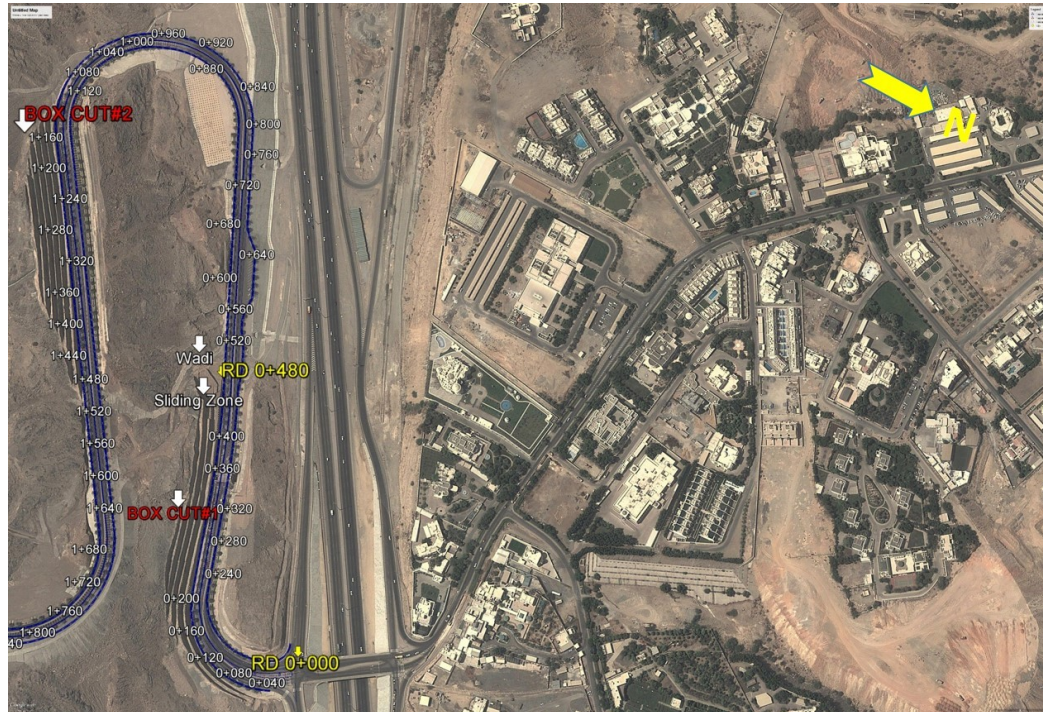
Figure 1. Layout of the Ring Road and its various features of interest to the study identified on Google Earth © Image.

To provide a shorter connection between the existing Muscat Expressway and a new development in Muscat Municipality, a 6.8 km long ring road traversing through rugged mountainous terrain has been constructed. In order to maintain a convenient grade in the initial 1.5 km, two major box cuts (at RD 0+000 to 0+500 m and 1+120 to 1+480 m) having high and steep cut slopes on either sides were required (Figure 1).

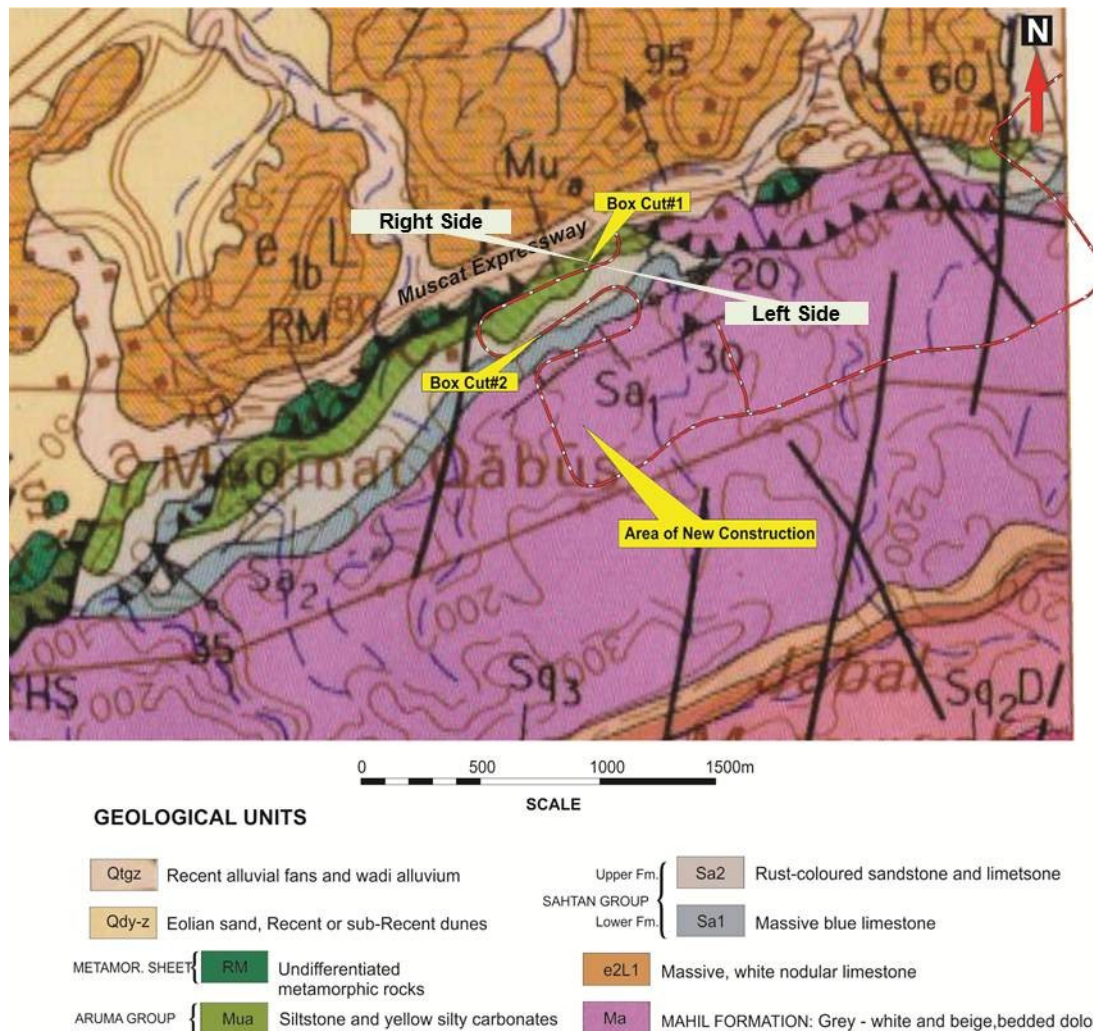
Figure 3. Geological map of the project area.

An extract of the Sib area geological sheet is shown in Figure 3. It illustrates the geology of Box Cut #1, which consists of ground making a contact between Aruma Group, and Sa2; the Upper Formation of the Sahtan Group. Box Cut #2 follows the contact between Units Sa2 and Sa1.

It is interpreted that the Lower Formation of the Sahtan Group is exposed in Box Cut #1 and the Upper Formation is exposed partly in box Cut #2. There was a discrepancy between the map and what was observed on the ground, i.e. when the built up landmarks were aligned, the geology did not match exactly and vice versa. This could be due to a shift in datum between the 1986 map and the project grid. What was observed and mapped on the ground was used in design.

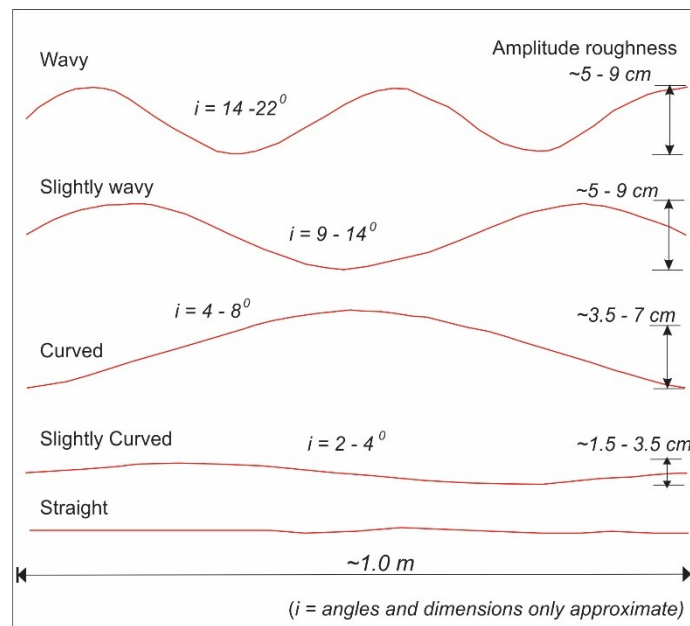
Figure 6. Large scale roughness profiles.

Hack et. al. (2003) reported that the large scale waviness contributed in increasing the friction angle of a discontinuity. Figure 6 shows the approximate addition to the friction angle that should be incorporated in the design for waviness of various amplitudes in the discontinuities over 1 meter length (Hack et. al. 2003). Miller (1988) reported that the waviness angle could be calculated from the observed variation in the dip of any discontinuity in the field.

Mapping of the geological structures in both Box Cuts revealed a high degree of variability in waviness. In Box Cut #1 measurements of a single bed over 5.0 m trace length gave a range of dips of 31° to 43°, with a mean of 35°. The dip direction ranged from 315 to 335°. Observations were also made on a smaller scale where there were variations with a general waviness (ϕ_w) that was on the order of $\pm 5^\circ$ over a few meters.
