# Assessment of Stability Conditions of Ancient Underground Quarries using On-Site Monitoring and Numerical Modeling

**ABSTRACT:** This work, carried out by members of the University of Parma's Department of Civil and Environmental Engineering and Architecture, analyzes the stability of the ancient underground quarries at Viggù (Varese, Italy). The objective of the study was to verify the actual structural predisposition to instability phenomena in the ancient ornamental stone quarries for a historical and cultural valorization as well as the recovery of the Danzi and Beltrami quarries. Although completely abandoned, these sites could be used as a tourist attraction and/or as a teaching environment. They are a wonderful example of industrial architecture, presenting audacious compositions of filled-in trenches and room and pillar techniques (Hedley and Grant, 1972). With such objectives in mind, a monitoring system that aims to control the most significant joints and discontinuities of the site has been realized. A numerical model of the entire rock mass has been developed in order to analyze the stability of the underground openings. A route for visitors has also been identified.

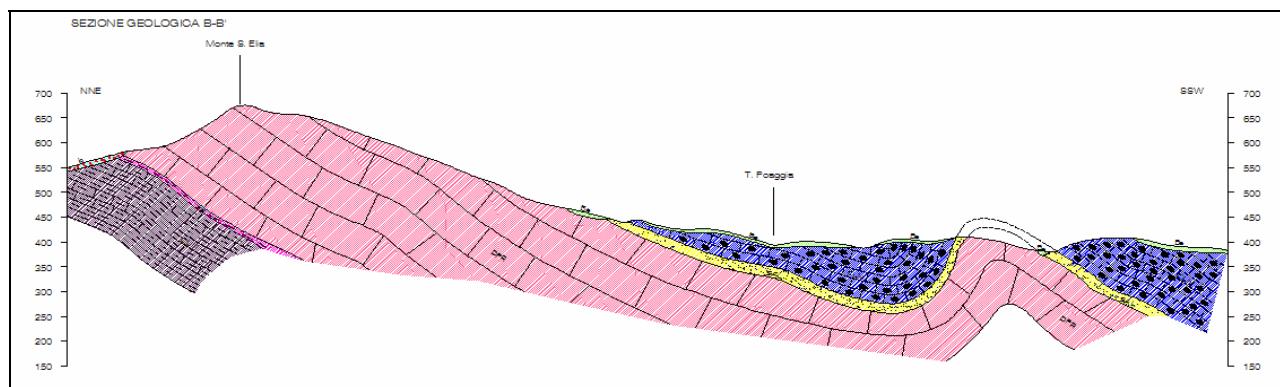
Figure 2. Geological section of area subjected to quarry activities (from Scesi, 2000).

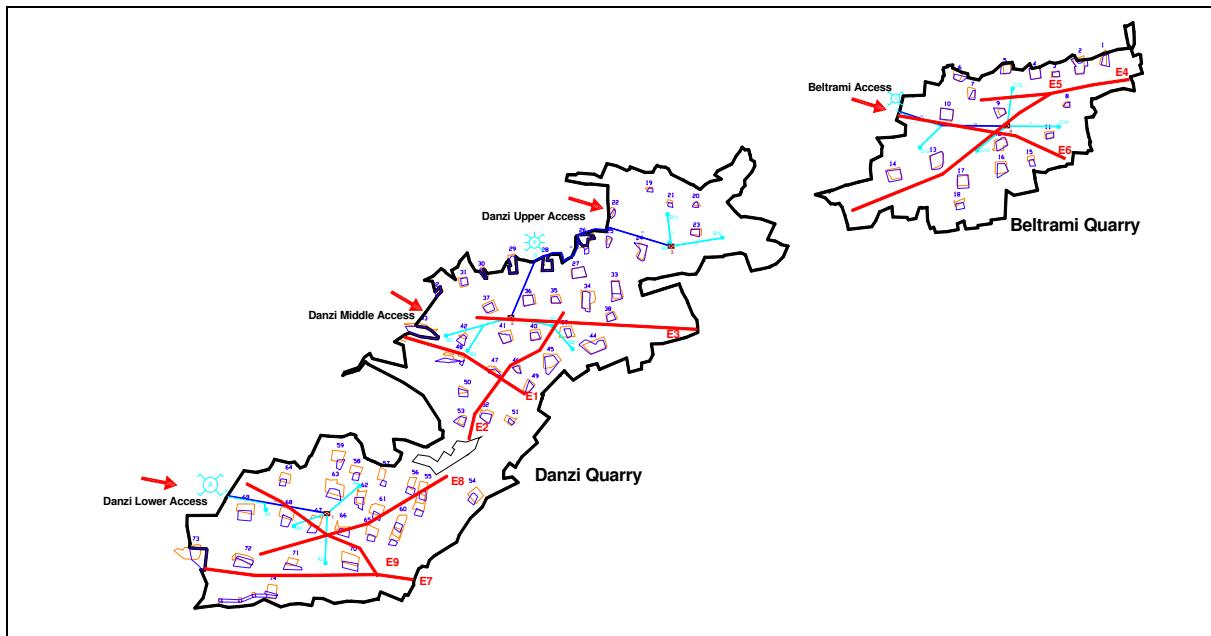
*Figure 5. Map of quarries with their names, accesses and respective position. Base (green) and roof (blue) of pillars are numbered and outlined.*

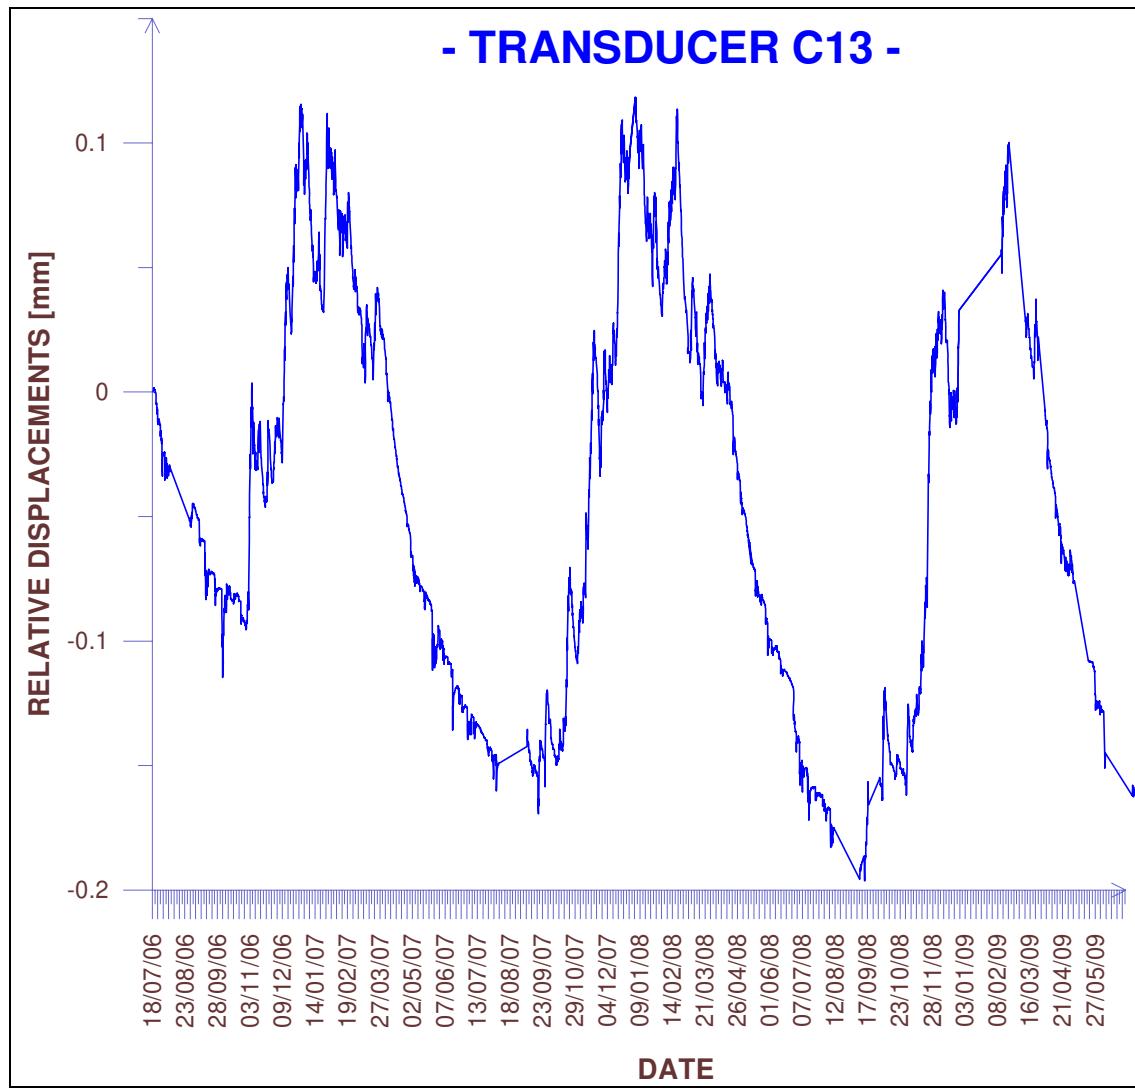
Figure 8. Readings from C13 transducer in period July 2006–May 2009.

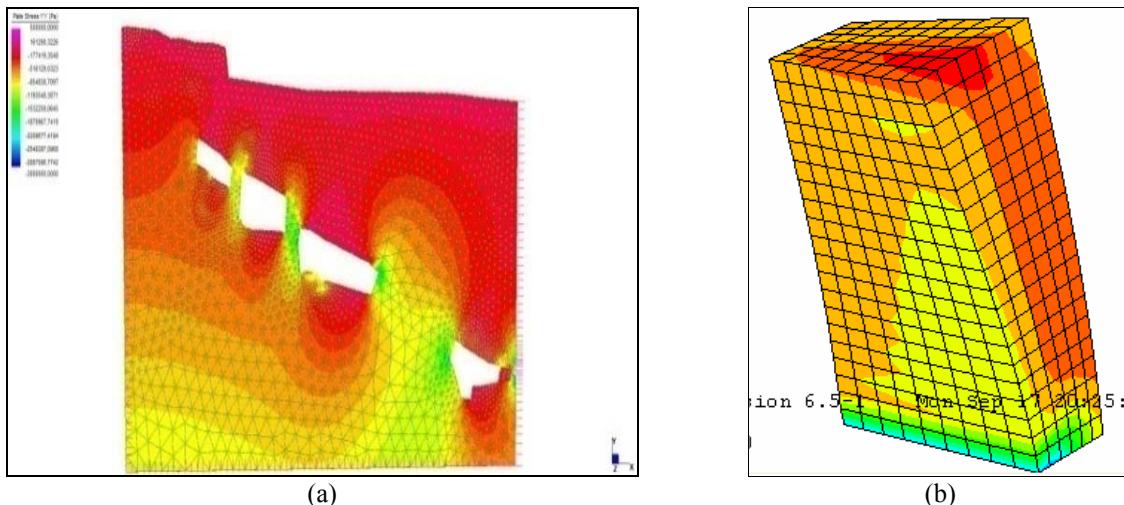
Figure 12. Vertical stresses: (a) 2D model of vertical section on pillar No. 23 (in center in (a)) modeled with Straus/ (G+D Computing, 1999) (see Figure 7 for pillar location on a map); (b) 3D model of pillar using ABAQUS code.

The FEM analysis on pillar 23 (see Figure 7) returned a value of approximately 2.22 MPa for vertical stress in the area where the flat jack test was performed, which fits well with the experimental results that indicate a vertical stress of 2.14 MPa. The same conceptual procedure has been used for all of the pillars and walls that were tested with the flat jack. The mechanical features of the rock mass after the calibration procedure are reported in Table 9.

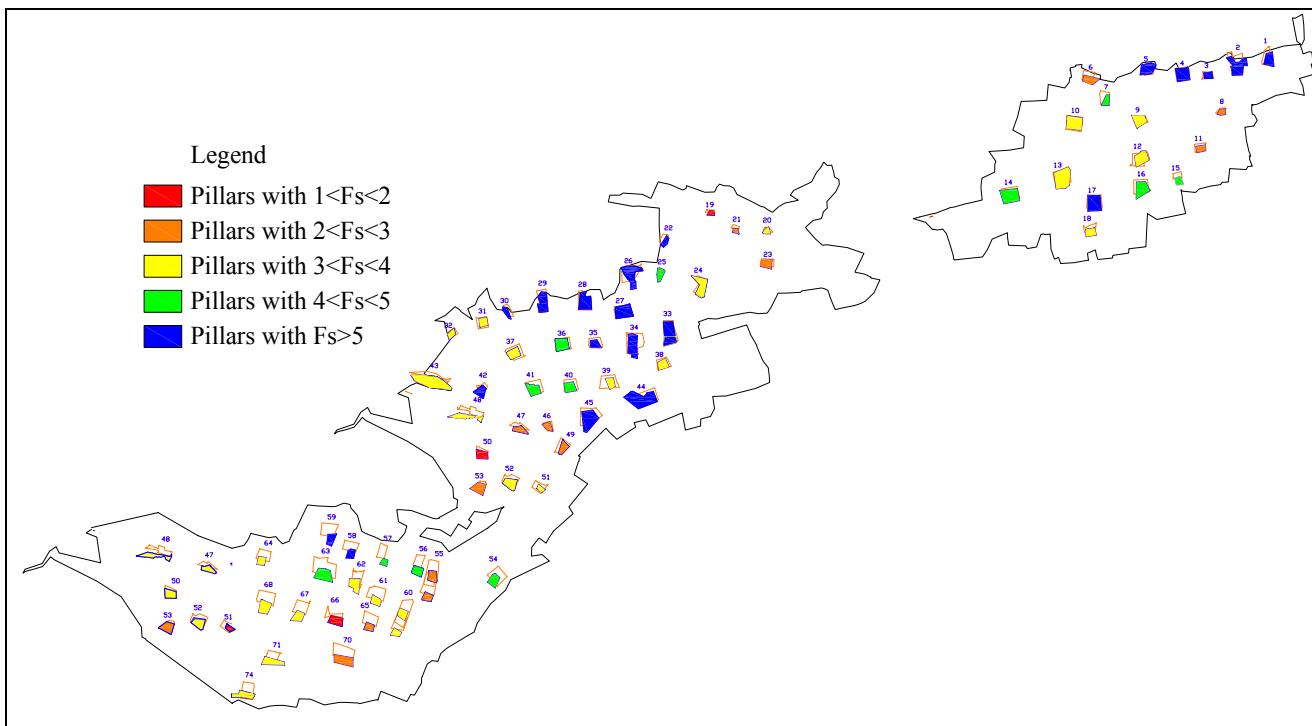
*Figure 13. Quarry map reporting SF range for each pillar.*

Figure 13 shows the SF computation for each pillar in the entire quarry. This graphical representation has been used to identify an optimal route for visitors in light of the stability of the various pillars.

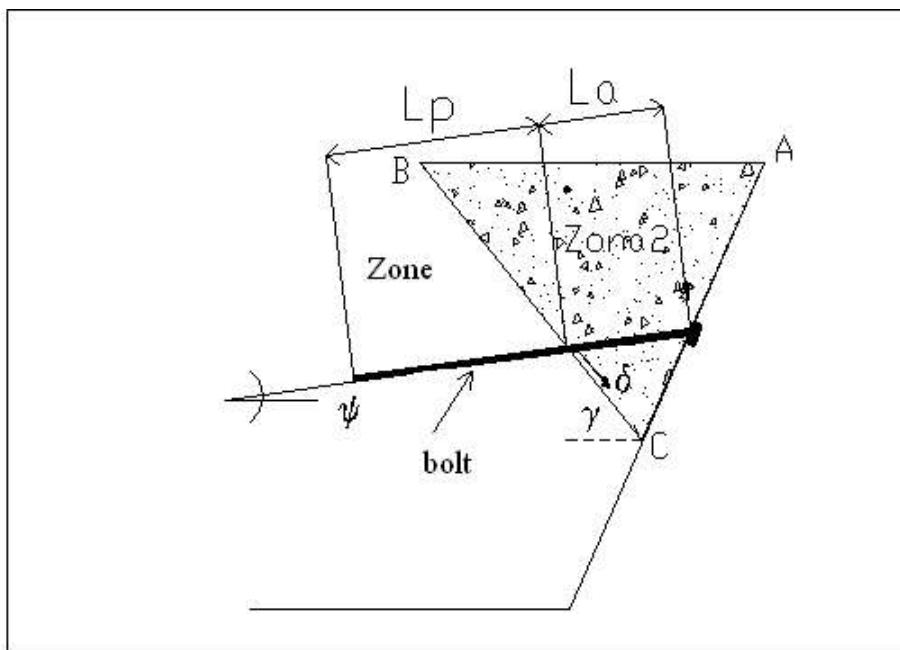
Figure 14. Scheme of interaction between rock mass and bolt;  $La$ : length of bolt in unstable zone (zone 1);  $Lp$ : length of bolt in stable zone (zone 2);  $\delta$ : block displacement along sliding;  $\psi$ : dip of bolt from horizontal plane;  $\gamma$ : angle between sliding direction and horizontal plane.

Reinforcement design was carried out according to the block reinforcement procedure (BRP) (Oreste and Cravero, 2008). This method was developed for passive bolting dimensioning for rock block reinforcement. The method can be applied to blocks of small to medium dimensions that are possibly detaching from vertical walls or from roofs. The computation method considers the response of the bolt through the unstable block. The unknowns of the method are: axial forces and shear and flexural forces along the bolt caused by small displacements due to the unstable block. According to this procedure, the correct bolt can be obtained after a series of tests using a trial and error method which compares different bolting schemes. The factors of safety obtained in the different scenarios are compared until the required safety conditions are reached. Finally, the required stabilization force is determined.

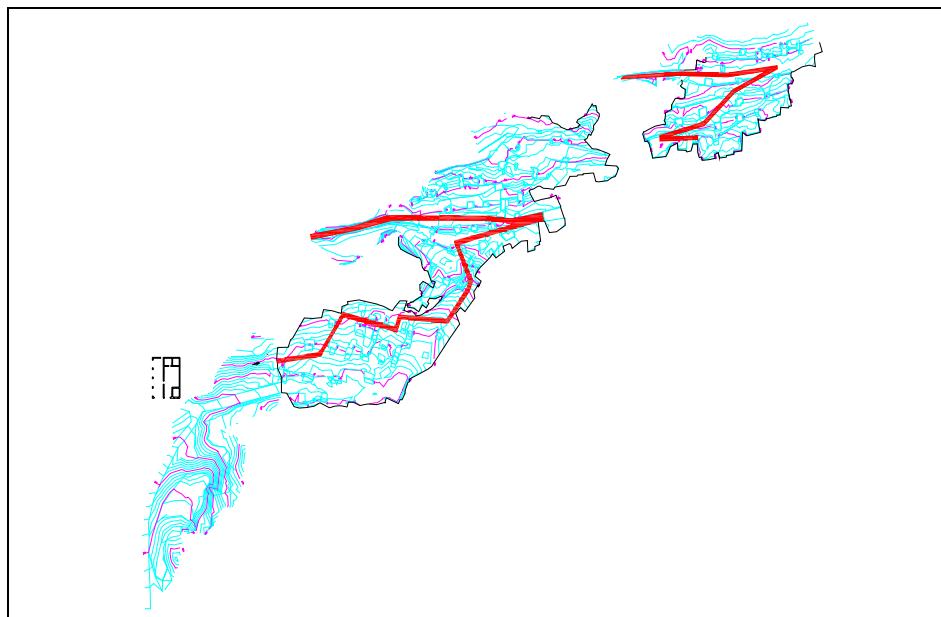
*Figure 15. Map showing route for visitors (red) inside underground quarries.*

The path starts from the most recently excavated chamber, where the material was excavated using the diamond wire technique and some majestic pillars were left in place to guarantee the overall stability of the quarry. These pillars became one of the particular features of these quarries. The first chamber is also characterized by the presence of old mining tools, diamond wire cutting machines and a number of buildings that were used as warehouses and workshops by the miners.
