# MSE Wall Behavior during Large Truck Impact at High Speed against Barrier on Top of Wall

**ABSTRACT:** Some 45 years ago, the total number of annual deaths on U.S. roadways was slightly over 50,000. In 2020, this number was reduced to less than 39,000 despite the fact that the number of kilometers traveled almost doubled. One of the major contributing factors to this life-saving improvement is the development of better roadside safety barriers. This paper describes one of the largest instrumented crash tests with a 352 kN truck hitting a 1.07 m high reinforced concrete barrier at 79.5 kph and a 15-degree angle. The barrier transferred the load to the Mechanically Stabilized Earth (MSE) wall through the sliding and rotation of the barrier-moment slab placed on top of the wall's edge. The instrumentation indicated that some of the MSE wall strips in the vicinity of the crash area were brought to the pull-out failure load during the impact. However, since the impact duration was very short, the displacement of the front of the wall and the barrier were tolerable and the wall needed only cosmetic repair. The maximum horizontal dynamic force on the barrier at impact was 712 kN and th

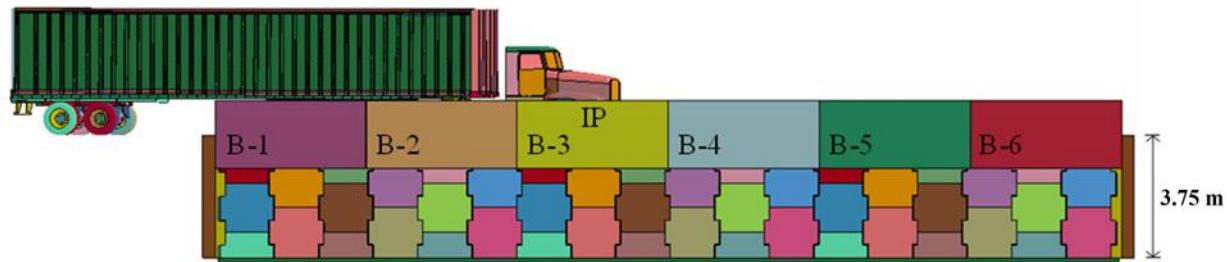
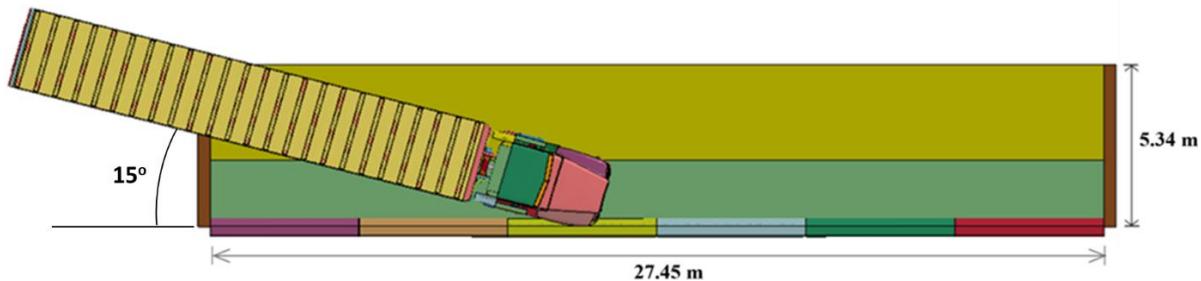
(a) Cross section of barrier-moment slab-MSE wall assembly with truck.

(b) Front view of the barrier-moment slab-MSE wall assembly with truck.

(c) Plan view of the barrier-moment slab-MSE wall assembly with truck.

**Figure 1.** Finite element mesh for simulation of barrier-moment slab-MSE wall assembly with truck: (a) cross section of barrier-moment slab-MSE wall assembly with truck, (b) front view of the barrier-moment slab-MSE wall assembly with truck, and (c) plan view of the barrier-moment slab-MSE wall assembly with truck.

The software used for the simulations was LS-DYNA (Hallquist, 2007). The Finite Element Method (FEM) models included the tractor-trailer truck, the L shape barrier and moment slab, and the MSE wall with soil and reinforcement strips (Figure 1).

The dimensions of the model (Figure 1) were 27.45 m in length, 3.75 m in height, and 5.34 m in width. The barrier height from the pavement surface to the top of the barrier was 1.07 m and the width of the moment slab was varied but finally chosen as 2.13 m, measured from the back of the MSE wall panel to the end of the moment slab. The bottom of the moment slab was 1.02 m deep below the pavement surface, and the length of the reinforcement strips was 3.05 m. Referring to Figure 1, the boundary conditions were as follows: all boundaries were free of any constraints except for the vertical boundary at the back of the wall, at the bottom of the wall and on the side-ends of the wall.

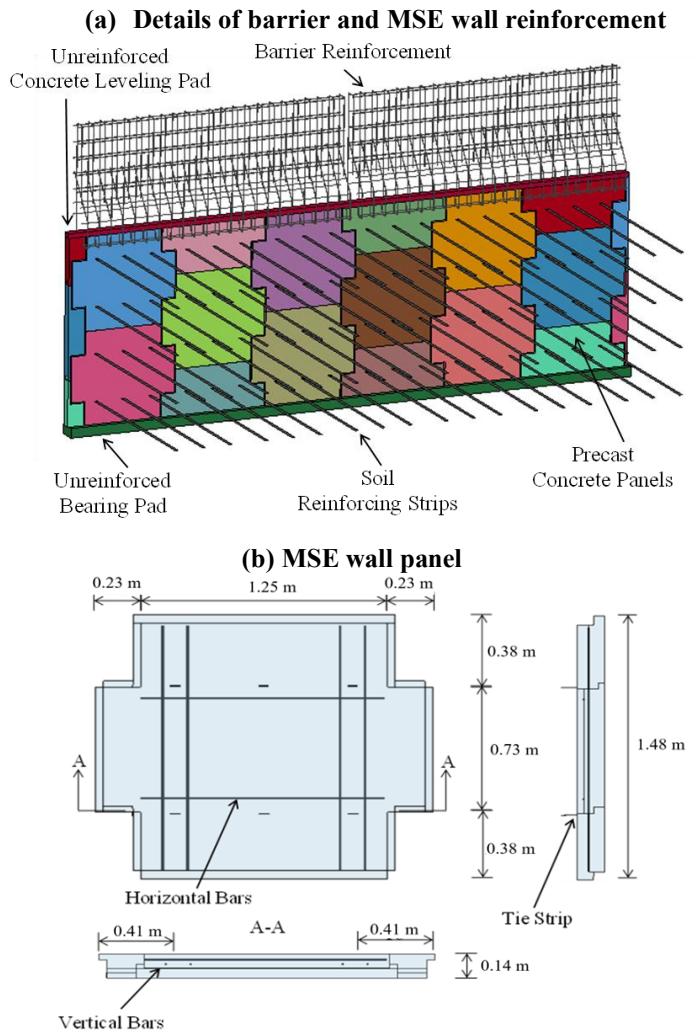
**Figure 2.** Barrier-moment slab and MSE wall model: (a) details of barrier and MSE wall reinforcement, and (b) MSE wall panel.

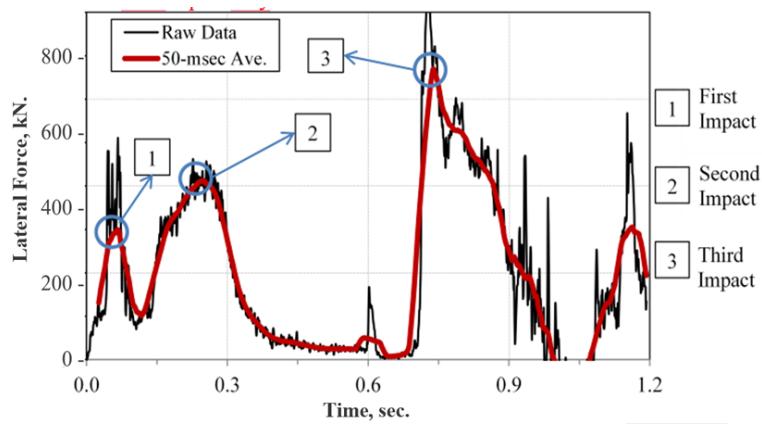
**Figure 3.** Horizontal impact force as a function of time in FEM simulation.

The impact horizontal force on the barrier as a function of time is shown in Figure 3. Two lines can be seen: one shows rapid variations in the load which is the actual measured response, and the other shows a smoother variation. The smoother line corresponds to the 50-millisecond average of the signal, which is common practice in roadside safety data analysis. The 50-ms signal identifies three distinct impacts associated with the front axle of the tractor at a peak dynamic force of 332 kN, the rear axle of the tractor (458.8 kN), and the rear axle of the trailer also known as the back slap (744.9 kN). Figure 4 shows the displacement at the top and at the bottom of the barrier. The main part of the impact lasted one second.

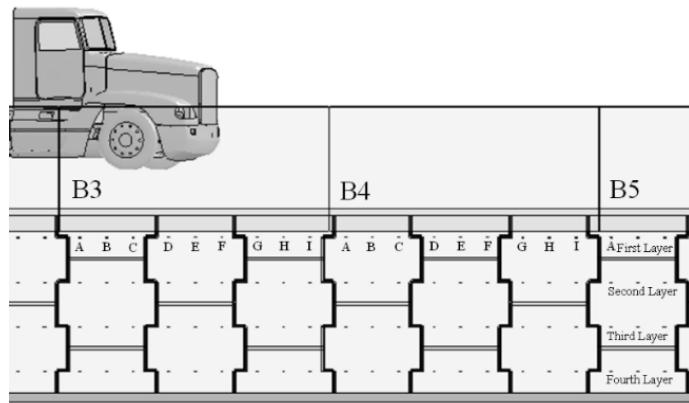
Figure 5. Reference designation for the strips in the wall.

The total load in the MSE wall strips is the addition of the static load due to the earth pressure in the wall and the dynamic load due to the TL5 impact. The designation of the strips in the wall is given in Figure 5. For example, B3\_B\_1<sup>st</sup> refers to barrier segment B3, strip B in the first layer of strips. The top or first layer of strips is the one that is most severely influenced by the dynamic impact. The total load in the most heavily loaded individual strip in the first layer of strips during the impact and the dynamic component are shown in Figure 6a. The peak total load is 26.03 kN with a peak dynamic component of 22.02 kN. In the second layer of strips (Figure 6b), the corresponding peak total load and peak dynamic load were 15.4 and 8.5 kN respectively. The calculated maximum pullout resistance of the strips according to AASHTO LRFD (2014) was 10.14 kN for strips in the first layer and 15.57 kN for strips in the second layer. Therefore, according to the numerical simulation, the reinforcing strips of the first layer reached pull-out failure during the impact. The pull-out displacement of the strips is shown in Figure 7 and indicates a maximum displacement of 10 mm. Laboratory tests conducted on strips in a pressurized sand box showed displacements to failure of about 5 mm. This is consistent with the numerical simulations indicating that the reinforcement strips were at failure during the impact. The dynamic and permanent displacement of the wall panels are shown in Figure 8; the permanent displacement of the panels is limited to 7 mm, indicating that the wall could likely be reused without repair.

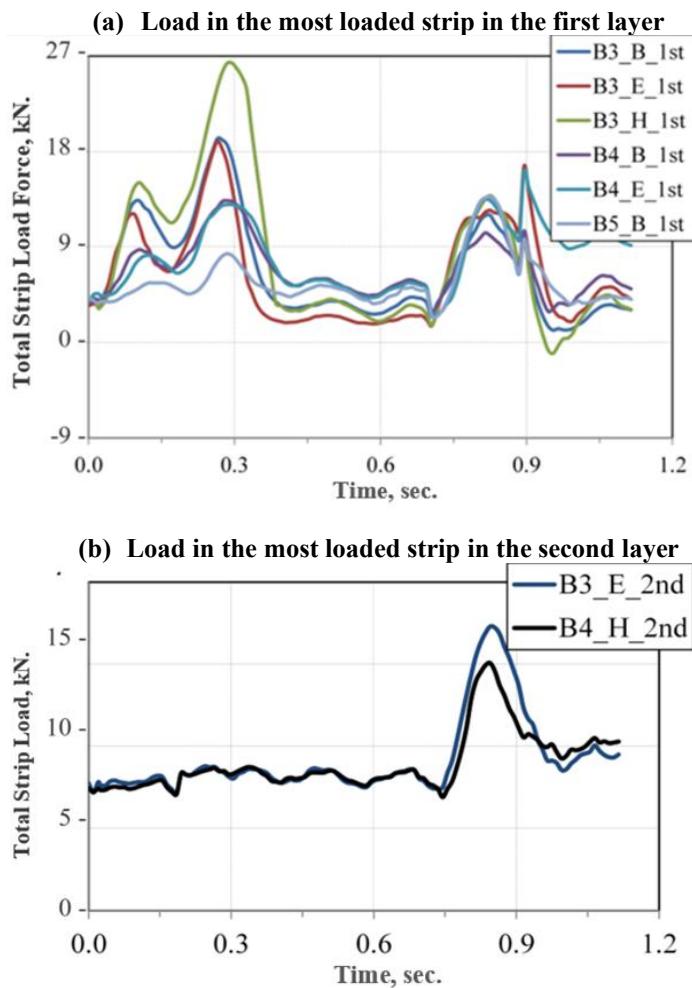
**Figure 6.** Total load in the most loaded strip for the first and second rows of strips in FEM simulation:  
(a) load in the most loaded strip in the first layer, and (b) load in the most loaded strip in the second layer.

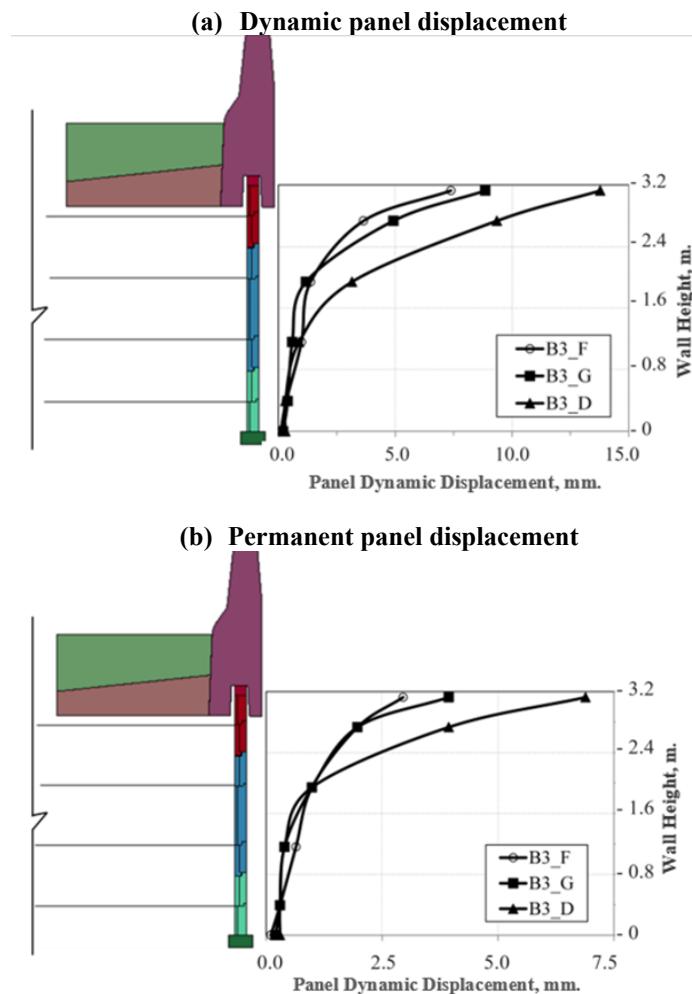
**Figure 8.** Displacement of the MSE wall panel in FEM simulation:  
(a) dynamic panel displacement, and (b) permanent panel displacement.

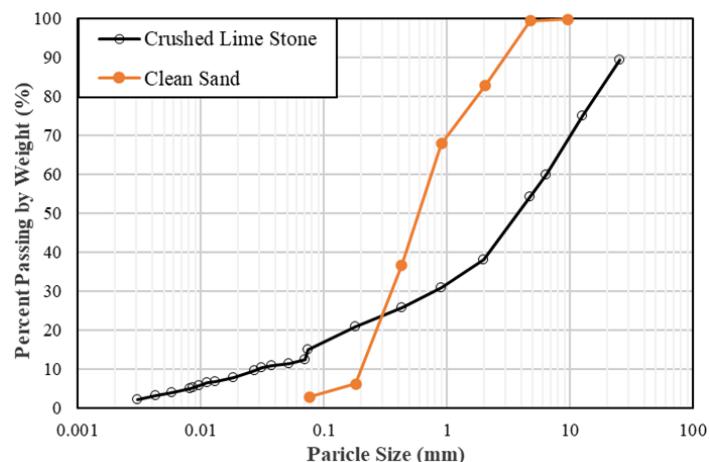
**Figure 10.** Particle size distribution curves for the clean sand and the crushed limestone rock.

The backfill consisted of two soils: the clean sand used to build the wall from the bottom of the excavation to the bottom of the moment slab (1.98 m), and the crushed limestone from the bottom of the moment slab to the pavement surface (1.02 m). The clean sand was a poorly graded sand (SP) with a  $D_{50}$  of 0.51 mm, a coefficient of uniformity of 3.85, a coefficient of curvature of 0.84, and 3.1% passing sieve No. 200 (Figure 10a). The modulus of the sand was 14.8 MPa as measured with the BCD (Briaud et al., 2006), and the direct shear test friction angle was 34 degrees. The crushed limestone rock (also called road base) was a silty gravel with a  $D_{50}$  of 4 mm, a coefficient of uniformity of 216.7, a coefficient of curvature of 3.28, and 15.0 % passing sieve No. 200 (Figure 10b). The modulus of the crushed limestone was 55.2 MPa as measured with the BCD, and a large triaxial cell test gave a friction angle of 45 degrees. The sand was compacted in 150 mm thick lifts to a dry density of 17.4 kN/m<sup>3</sup> (95% of maximum dry density) and 3.03% water content, while the crushed limestone was compacted in lifts of 250 mm to a dry density of 20.1 kN/m<sup>3</sup> (95% of maximum dry density) and 5.81% water content.

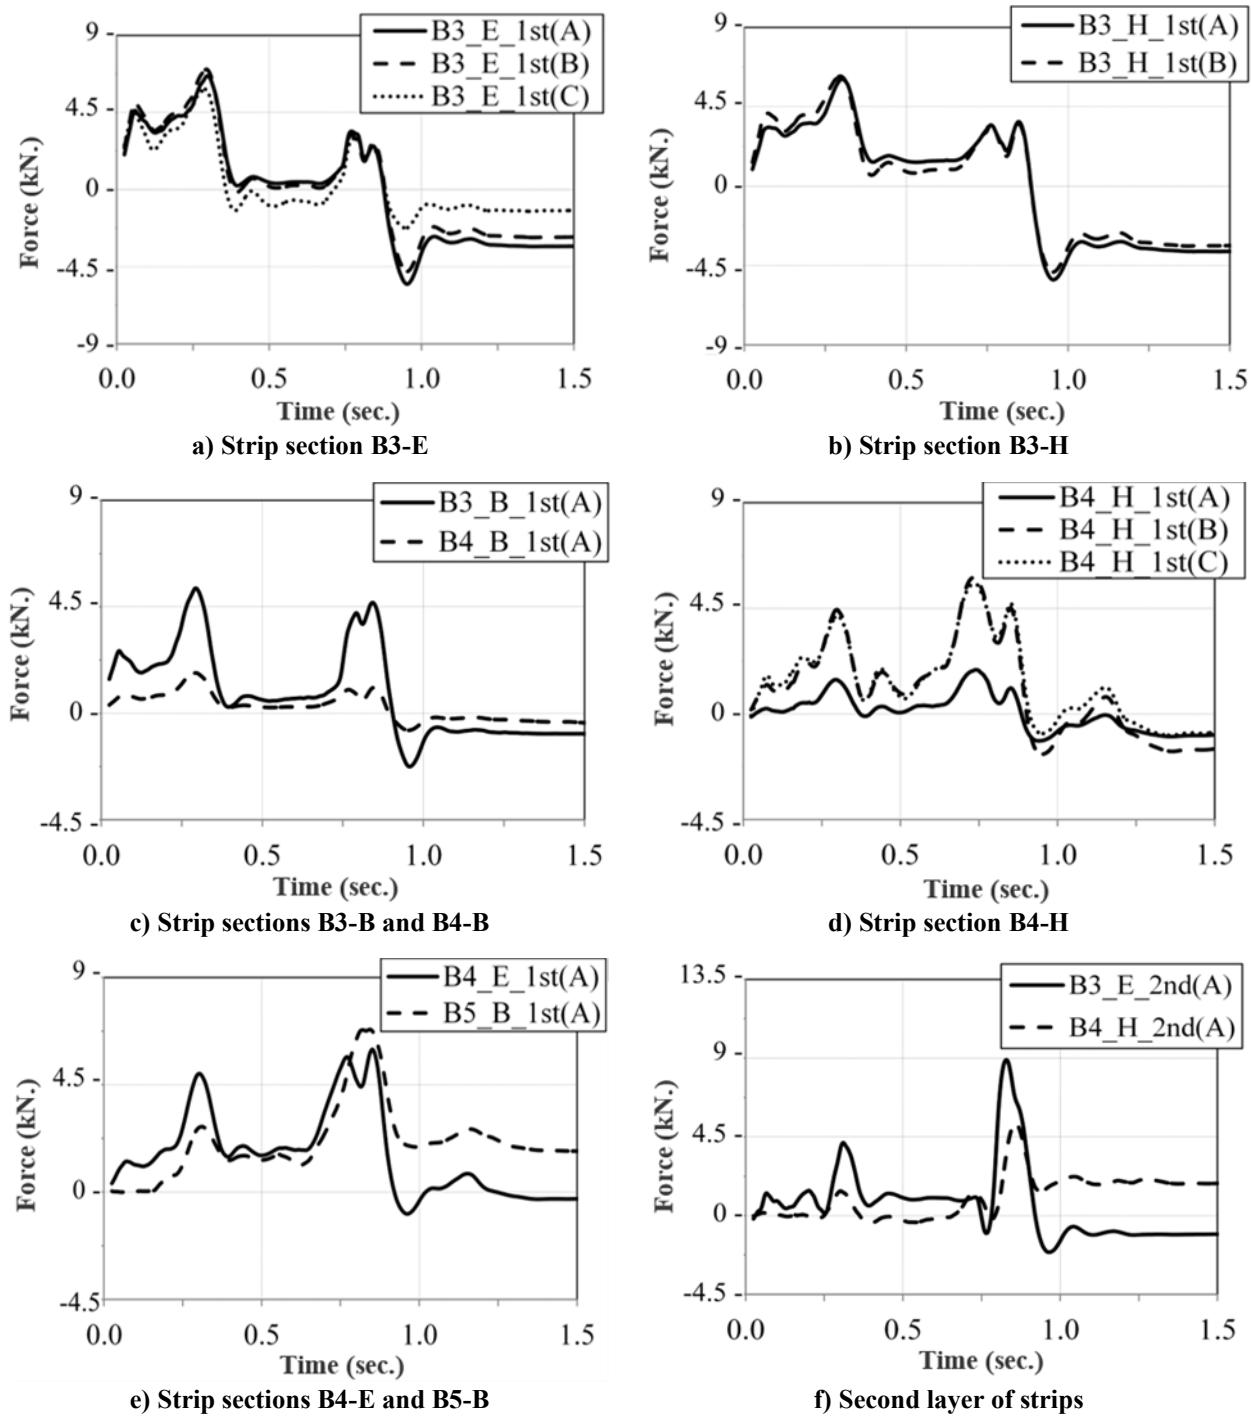
**Figure 13.** Dynamic load in the wall reinforcing strips during the impact (50 msec average): (a) strip section B3-E, (b) strip section B3-H, (c) strip sections B3-B and B4-B, (d) strip section B4-H, (e) strip sections B4-E and B5-B, and (f) second layer of strips.

The location of the MSE wall reinforcing strips that were instrumented is shown in Figure 11. The total load in a strip in this project is defined as the addition of the static load due to the internal stability of the wall under gravity active pressure and the dynamic load induced by the truck impact. The load in the strips was measured 0.178 m behind the strip connection to the panel, and the dynamic load vs. time is shown in Figure 13. The maximum dynamic component of the loads in the strips is listed in Table 1 and the total load in Table 2. The dynamic load in the strips was maximum near the strip-to-panel connection point. As can be seen, the measured static loads are close to those calculated by AASHTO. The sum of the dynamic load and the static load is defined as the total load in the first layer of strips; the total load reaches the calculated ultimate resistance of the strip closest to the impact.

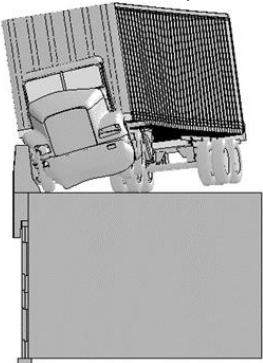
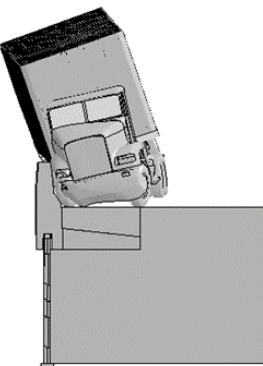
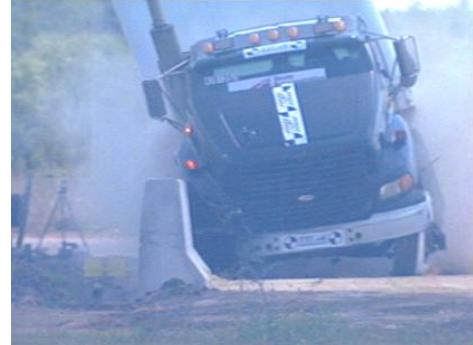
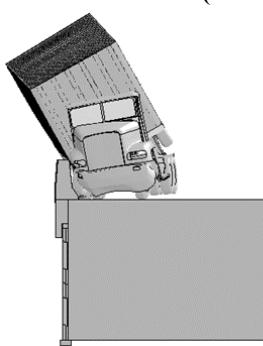
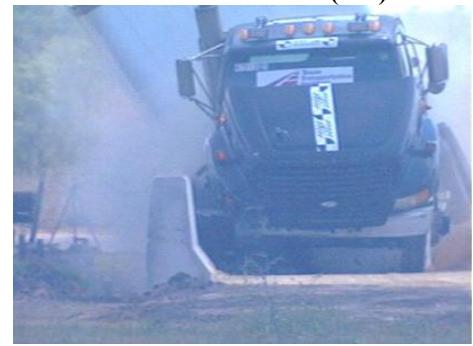
**Figure 14.** Comparison between simulation and test of sequential views of the impact.

Qualitatively, the sequential views of the impact from the simulation and the test compare well, as seen in Figure 14. Quantitatively, the acceleration results were closer for the rear axle of the trailer, which corresponds to the highest load in the impact than for the rear axle of the tractor. Indeed, for the trailer, the longitudinal and lateral accelerations were -2.7 g's and -11.6 g's for the model, and -3.4 g's and -10.8 g's for the test; for the tractor, they were -2.1 g's and -5.3 g's for the longitudinal

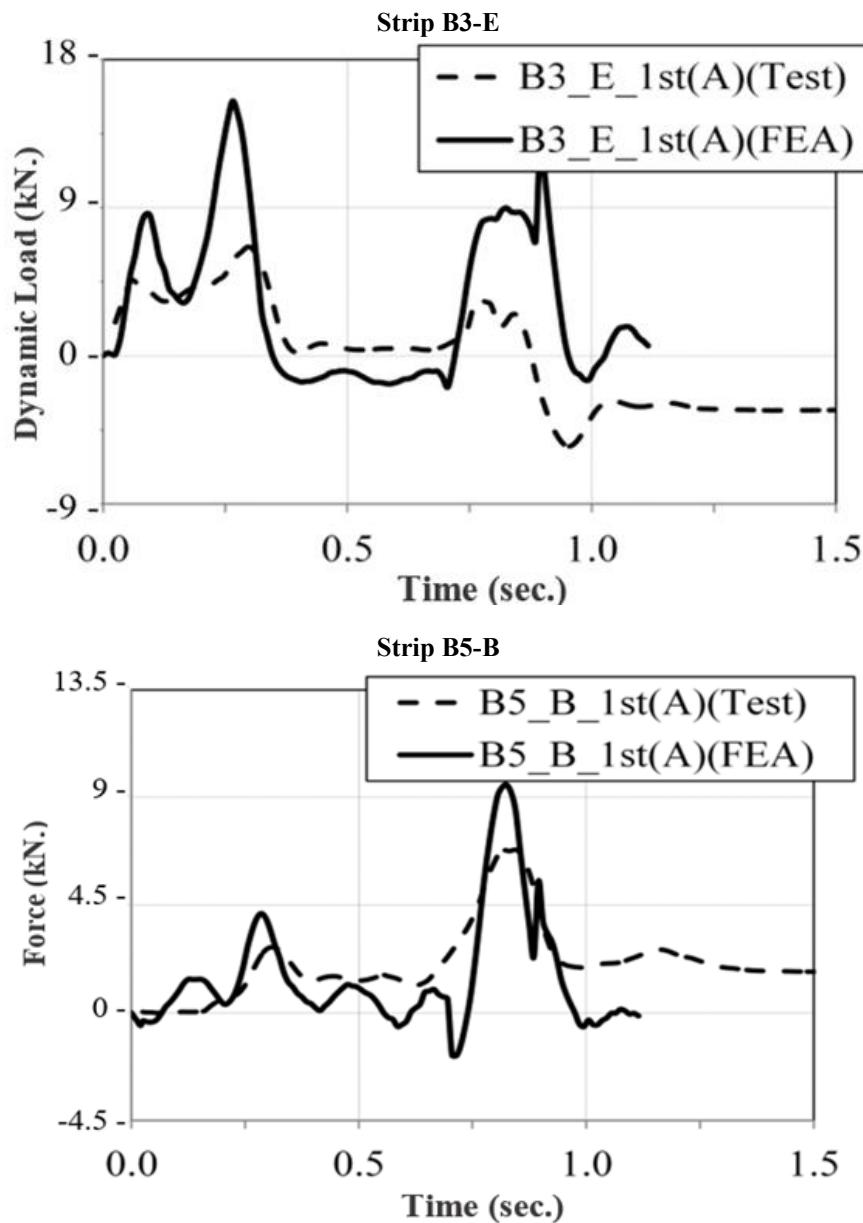
Figure 15. Comparison of the dynamic component of the strips' loads in the uppermost layer of soil reinforcement.

and lateral acceleration in the model, and -1.4 g's and -4.4 g's for the test. These acceleration values are 50 msec averages. The simulation predicted reasonably well the permanent displacement of the barrier, as shown in Table 3. The dynamic displacements of the wall panels during the test could not be measured due to problems in the instrumentation. The measured lateral permanent deflections of the wall panels after the test ranged from 0.25 mm to 13.72 mm. The dynamic and permanent deflection determined from the simulation ranged from 0.25 mm to 14.73 mm and from 0.25 mm to 7.11 mm, respectively. The simulation under-predicted the permanent displacement in some wall panels but predicted others reasonably well. In addition, the simulation predicted high bending stresses of the panels located underneath the impact point and, after the test, hairline cracks were observed at those locations. The simulation overpredicted the tension load in the top strips near the point of impact but did better at other locations (Figure 15), particularly in the second row of strips.

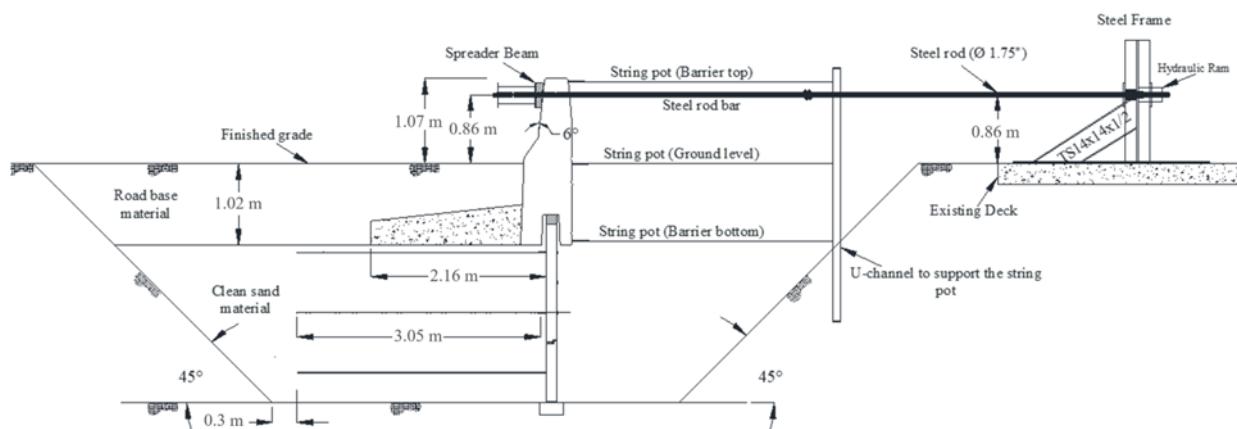
Figure 16. Set up for the horizontal static load test on the barrier.

After the full-scale impact test, a horizontal static load test was performed on the barrier moment slab system on top of the MSE wall (Figure 16). The objective was to assess the ultimate horizontal load of the system as an equivalent static load to the maximum horizontal dynamic load in the impact test. The section of barrier selected was one that had received minor loading from the impact of the truck (B5). The horizontal load was applied at a height of 0.864 m through a 3.05 m long spreader bar to engage a 9.15 m length of barrier and a 9.15 m length of moment slab in the load test. The load was applied in 22.25 kN increments lasting one minute each. The horizontal displacement of the top and the bottom of the barrier were recorded, as well as the horizontal displacement of the coping. The horizontal load-horizontal displacement curve for the load test is shown on Figure 17(a) along with the numerical simulation results. Figure 17(b) shows the displacements at different heights of the barrier. During the static load test, the load in the strip right below the loading point (B5\_B\_1<sup>st</sup>(A)) was recorded (Figure 18). The figure indicates that the load started to increase rapidly in the strip when the static load on the barrier exceeded 356 kN, which is assumed to be the point at which sliding of the barrier was prominently engaged. Because the barrier moment slab redirected the truck properly and without major repair needed, the static load considered to be equivalent to the maximum dynamic load on the barrier was the maximum load applied to the barrier in the horizontal static load test before the nonlinear behavior started, or 356 kN.

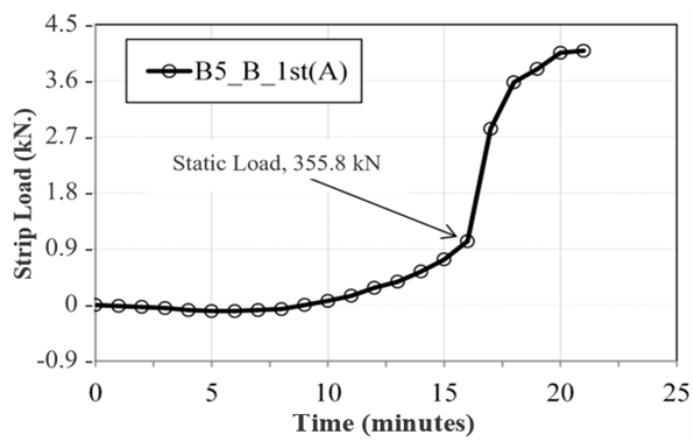
Static Load Rate in the Barrier, 22.24 kN/min

**Figure 18.** Load in top strip below barrier loading point.

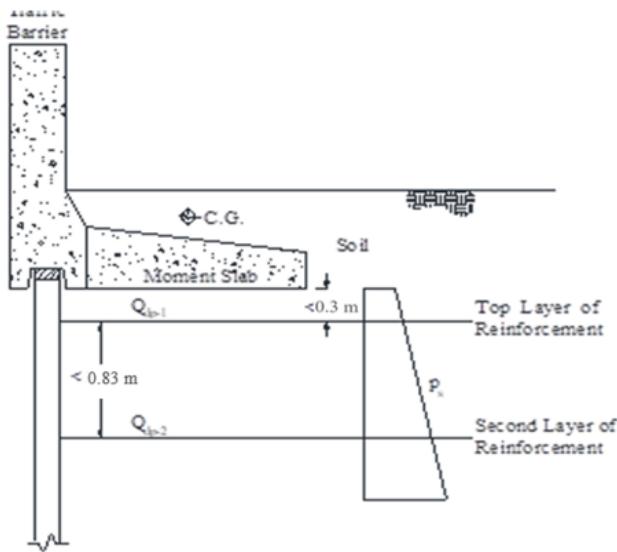
**Figure 20.** Line load diagram for static and dynamic components to design MSE wall strips for TL5 impact loading.

**Table 5.** Suggested TL5 design line loads for pull out of MSE wall reinforcing strips.

Line load (kN/m)	
First layer, $Q_{dp-1}$	Second layer, $Q_{dp-2}$
16.9	14.6
