# A geocomposite barrier for hydrocarbon containment in the Arctic

Bathurst, R. J., Rowe, R. K., Zeeb, B., Reimer, K. (2006), *A geocomposite barrier for hydrocarbon containment in the Arctic*, International Journal of Geoengineering Case histories, <http://casehistories.geoengineer.org> , Vol.1, Issue 1, p.18-34.

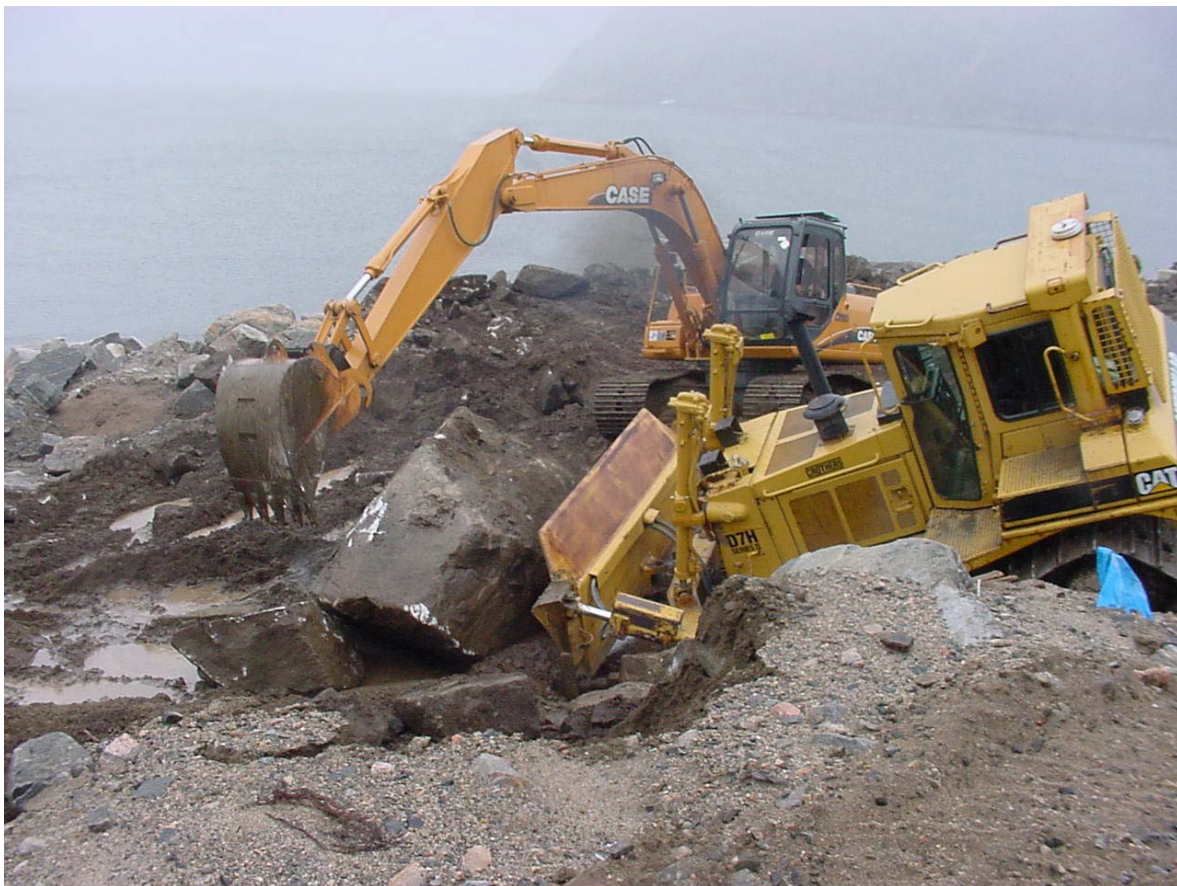
*Figure 4. Photograph illustrating large boulders encountered at east end of trench excavation.*

The barrier system was designed to be placed on the down-slope side of the excavated trench. The decision for a sloped installation was largely dictated by factors such as available manpower and ease of construction. It was recognized that this approach would require more geosynthetic barrier material and excavation than an alternative vertical wall system. However, a vertical trench was not possible because of the presence of large boulders and the possibility of intercepting the groundwater table that could lead to trench wall instability. Photographs of trench excavation illustrating ground conditions at the site are shown in Figures 4 and 5. The groundwater table was not observed during excavation of the trench nor was there visual evidence of free product LNAPL. The ponded water on the permafrost layer in Figure 5 was the result of rainfall runoff.

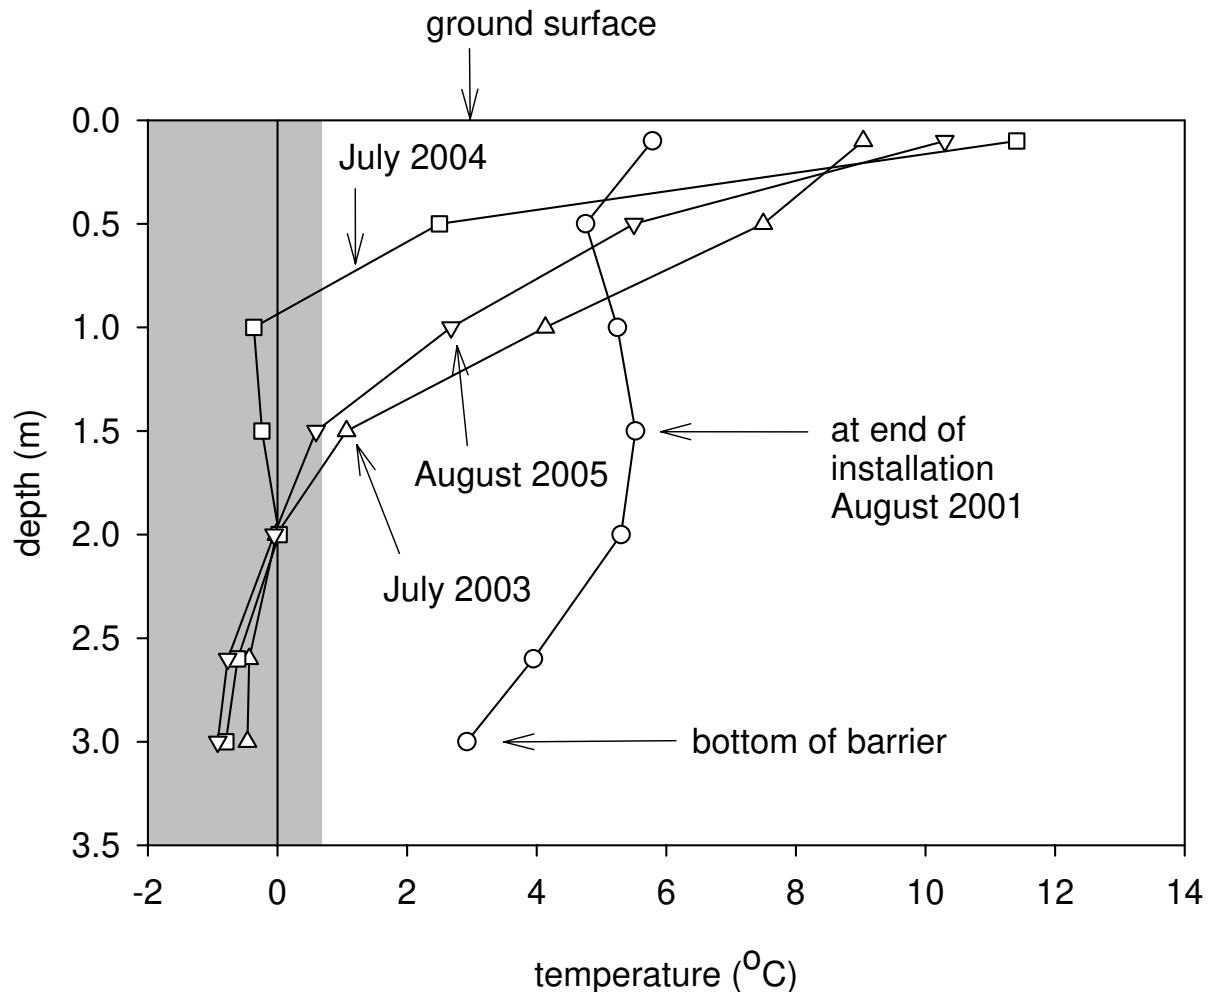
Figure 13. Temperature profiles at location of barrier system corresponding to times of maximum recorded surface temperature.
