Expedient Mitigation of Collapsible Loess in Northern Afghanistan

Christopher T. Senseney, Assistant Professor, U.S. Air Force Academy, Colorado, 80840-6232, USA; email: christopher.senseney@usafa.edu

Reference: Senseney, C. (2013). *Expedient Mitigation of Collapsible Loess in Northern Afghanistan*

International Journal of Geoengineering Case histories,

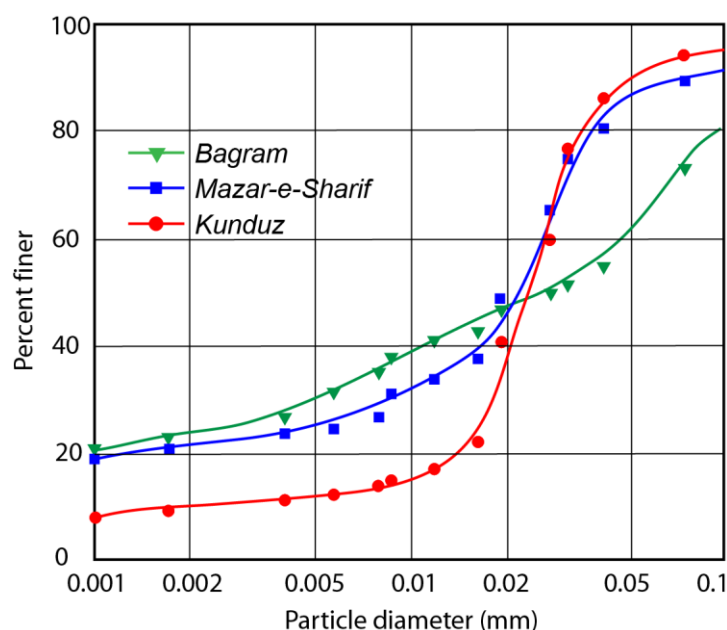
Figure 4. Particle size distributions of Kunduz, Mazar-e-Sharif and Bagram soil.

Soils from Afghanistan military bases in Kunduz, Mazar-e-Sharif and Bagram were evaluated for collapse using Gibbs and Bara's criteria and Handy's criteria. Sand cone tests were conducted and disturbed soil samples were collected at a depth of 0.5 m (20 in). Three sand cone tests and three samples were obtained from Kunduz and two sand cone tests and two samples each were obtained from Mazar-e-Sharif and Bagram. An average of the soil properties are given in Table 1 and an average of the particle size distributions in Fig. 4, where fine content less than 0.075 mm was determined using a hydrometer apparatus (ASTM 2007). The Kunduz and Mazar-e-Sharif soil exhibit a uniform distribution with particles concentrated in the range 0.01 to 0.06 mm, indicating the soils are loessial and will not compact well. On the contrary, the Bagram soil exhibits a more well-graded distribution, indicating the soil is not loessial and has higher potential for compaction. According to Gibbs and Bara's criteria, the Kunduz and Mazar-e-Sharif soil is collapsible, while the Bagram soil would fall just inside the non-collapsible region (see Fig. 3). According to Handy's criteria, the Kunduz soil has high probability of collapse, the Mazar-e-Sharif soil will probably collapse, and the Bagram soil has less than 50% probability. These results match what military forces have observed. As many as 48 sites in and around the Kunduz Airfield show signs of collapsed soil (SIGAR 2010) and an earthen drainage ditch near the Mazar-e-Sharif Airfield experienced slope failure from collapsible soil. No evidence of collapse has been observed at Bagram. Lutenegeger and Saber's collapse test or other collapse tests were not used in this study because the equipment to obtain undisturbed samples and equipment to conduct necessary laboratory tests are not available in Afghanistan.

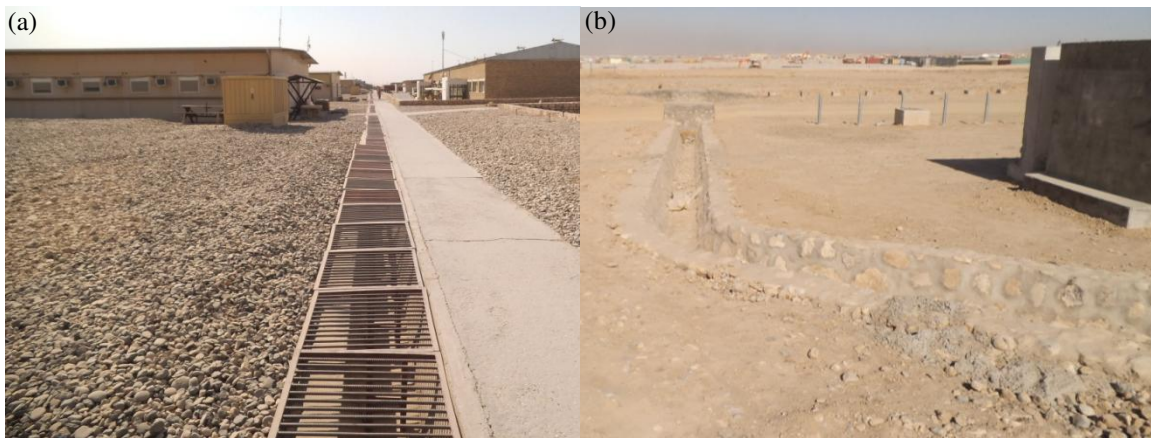
Figure 5.a. Cast in place concrete trench drain and gravel cover over the ground surface, b. grouted stone channel constructed with locally available cobble stones.

A suitable drainage design at expedient military bases is open channel drains and a gravel cover over the ground surface. Cast in place concrete trench drains (as shown in Fig. 5a) should be trapezoidal or rectangular with depths generally ranging from 0.15-1.0 m (0.5-3.3 ft), depending on local hydrological conditions. The drain bottom and side walls must be reinforced to withstand earth pressure and anticipated loads. Grouted stone channels (see Fig. 5b) are also acceptable. Such channels are common in Afghanistan given the abundance of naturally occurring cobble stone deposits in river beds. Downspouts from buildings should feed into the drains. UngROUTED riprap-lined channels or earthen drainage ditches (see Fig. 2d) are not recommended because water infiltration may cause collapse and/or slope failure.
