Reclamation and Safety of High Cantilever Strong Box Pipe Pile Seawall in Marine Clay

Reference: Soh, K.K., Wai, T.T., Yeo, L., and Lim, P.K. (2016). *Reclamation and Safety of High Cantilever Strong Box Pipe Pile Seawall in Marine Clay*. International Journal of Geoengineering Case histories, <http://casehistories.geoengineer.org>, Vol.3, Issue 3, p.176-189. doi: 10.4417/IJGCH-03-03-04

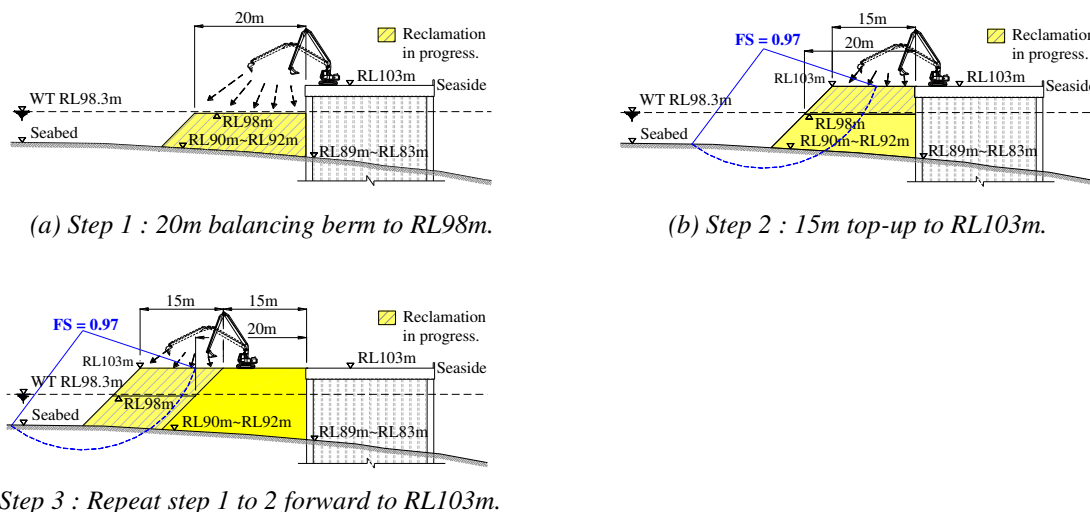
Figure 9. Limited balancing berm for stage 1 reclamation - Method A1

Reclamation steps of limited balancing berm method A1 is shown in Figure 9. The reclamation filling of Grade A material by the limited balancing berm was likely to cause minimal localized squeezing of the soft clay below the seabed. The squeezing effect was probably limited at 1 m to 2 m below the seabed as the factor of safety was slightly less than 1. The lowest factor of safety was at step 2 and step 3 and was localized after completion of 20 m berm to RL103 m.

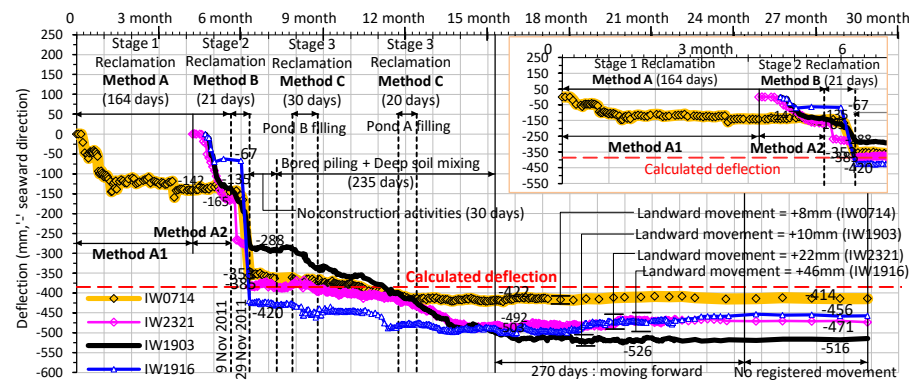
Figure 14. Comparison of deflection of capping beam of section 2 and 3 of seawall.

(a) Deflection of capping beam of seawall for section 2.

(b) Deflection of capping beam of seawall for section 3.

(c) Inclinometers at various sections of seawall.

Figure 14 shows the comparison of deflections of the sections 2 and 3 of the seawall. Section 2 is from box no. 1/41 to box no. 6/46, and represented by inclinometers IW0103, IW4412 and IW0503, whereas section 3 is from box no. 7/47 to box no. 28 and deflection is from inclinometers IW0714, IW1903, IW1916 and IW2321. The influence of the various methods of reclamation is examined. Method A1, A2, and C reclamations were supervised and recorded on site. There was no record of supervision for method B reclamation.

After the reclamation filling by method A1 and A2, the full active pressure wedge was on section 2 and an almost full 44 m active pressure wedge on section 3. At this stage the passive resistance of soft clay was fully mobilized. Deflection of both sections was lesser than the 60% of the calculated value. Method B was in the proximity of section 3 and caused a plunge in 3 inclinometers IW0714, IW1916 and IW2321, with a maximum value of -353 mm or 0.80% of H as shown in Figure 14b. The plunge was caused by the concentration of the generated lateral force of the slurry clay flow beyond the 44 m active wedge, using the constructed seawall as a reaction. Inclinometer IW1916 suggested that this slurry clay force might be higher than the 44 m active wedge force. This was a transient force which dissipated after the creation of the massive slurry clay ponds B and A.

The average deflection of the stringent balancing berm method A2 was -122 mm at section 3 (Rotating height = 40 m to 44 m) and this was lower than the limited balancing berm method A1 with an average deflection of -156 mm at section 2 (Rotating height = 25 m to 40 m). This lower deflection at section 3 showed that the stringent balancing berm method A2 had the minimum seawall deflection, as shown in Table 4.
