Reclamation and Safety of High Cantilever Strong Box Pipe Pile Seawall in Marine Clay

ABSTRACT: A high cantilever seawall was constructed in soft clay of 15 m to 32 m thickness and the enclosed water between the shoreline and the seawall was reclaimed. The area was 7 hectare and the reclamation height ranged from 10 m to 20 m. The reclamation methods were controlled and not intended to cause additional incremental deflection to the already high design deflection of -385 mm or 0.89% of H ($H = 44$ m is defined as rotating and not cantilever height). However the different methods of reclamation had a significant influence on the slurry clay flows and thus caused additional incremental deflection. The slurry clay flows pushed the deflection of seawall to an additional maximum magnitude of -353 mm or 0.80% of H. The maximum seawall deflection of -526 mm or 1.20% of H was based on inclinometer IW1903 readings. At such high seawall movement, the inclinometer deflection profiles indicate safety in the design and the long term deflection is stable. This reclamation experience indicates that it is difficult to control slurry clay flows in future high reclamation filling of 10 m to 20 m hei

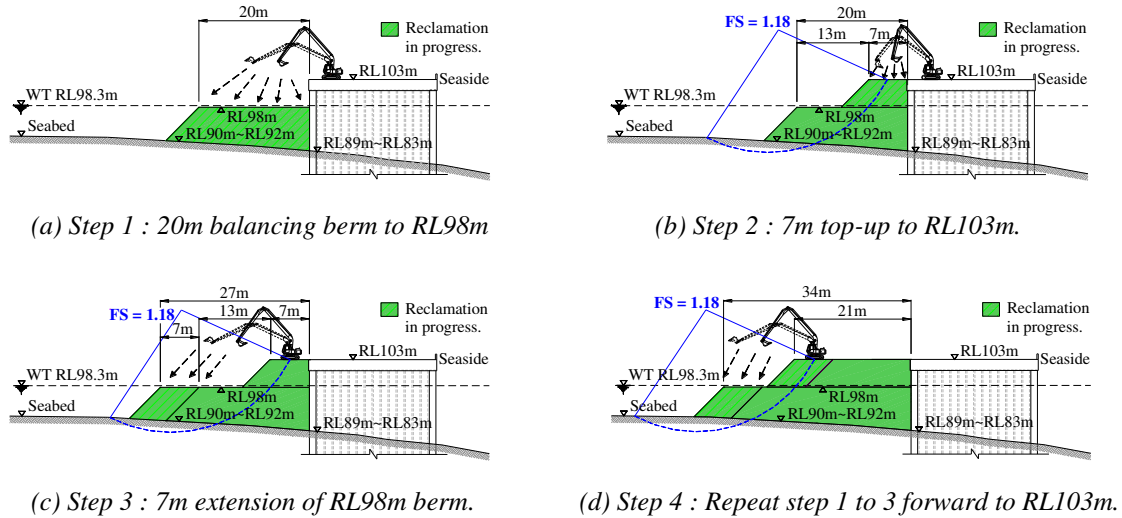
Figure 10. Stringent balancing berm for stage 1 reclamation - Method A2 ■.

Reclamation by the stringent balancing berm method A2 as shown in Figure 10 was a slower filling of Grade A material. The lowest factor of safety for the stringent balancing berm method A2 at step 2, step 3 and step 4 was 1.18. This method was unlikely to cause any clay squeezing below the seabed.

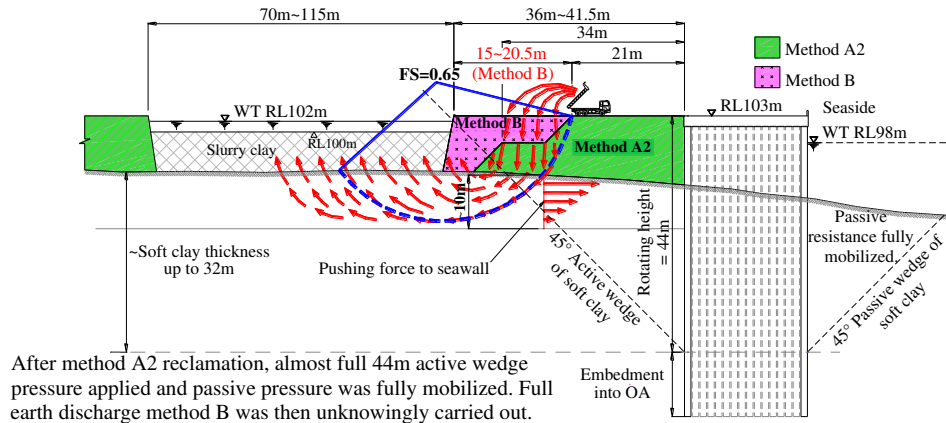
Figure 11. Full earth discharge method B for stage 2 reclamation at section 3.

Reclamation steps of full earth discharge method B are shown in Figure 11, after stringent balancing berm method A2. Direct full discharge of Grade B material straight from the lorry was likely to cause significant slurry clay flows during stage 2 reclamation. The extent and depth of the slurry clay flows could be deep, intensive and extensive, if the direct discharge was concentrated on a particular spot. The factor of safety was extremely low for the accumulated lorry load by direct full earth discharge. This method of reclamation was extremely fast. Vast quantity of Grade B material was poured directly into the enclosed water within a very short period as shown in Figure 7, and this caused the massive slurry clay flows at ponds B and A. This method of reclamation was not recorded in the site. The method was interpreted during the period when the inclinometers recorded sudden plunge in the deflection of seawall and the sighting of heaving of clay slurry at pond B on 25 Nov 2011. Chu et al. (2009) reported the slurry clay upheaval in a stringently controlled filling procedure for a slurry pond in Singapore.

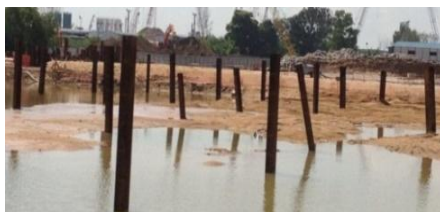
Pond A
Controlled filling layout with kingposts in progression of 0.5 m thick sand layer at every 10 m x 10 m grid.

Figure 12. Photograph showing controlled filling method C for stage 3 reclamation.

Reclamation by controlled filling method C for filling into ponds B, A and C is shown in Figure 12. This controlled filling of 0.5 m thickness with Grade A material was enforced for the clay slurry ponds A, B and C. For pond A, a grid pattern of 10 m x 10 m was set up for the filling that was carried out in progression. At each step of progression, the fill thickness was

not exceeding 0.5 m. Even with such stringent control filling, some of the kingposts were noted to tilt. The method of reclamation was extremely slow and may cause clay squeezing of thickness less than 0.5 m. Similar layering reclamation filling in 0.5 m thickness was carried out for ponds B and C.

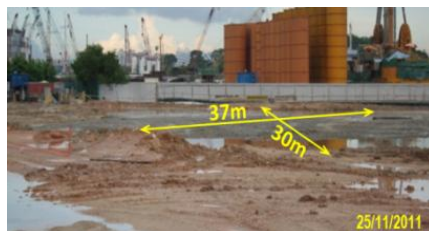
(c) Photograph of pond C. (37 m x 30 m x 7.5 m) with slurry clay heaved from RL94.5 m to RL102 m.

The clay slurry ponds B and C were observed on 25 Nov 2011 as shown in Figure 13, when the clay slurry was pushed sideways and upward to the pond water level RL102.0 m. Pond A was still submerged in water and the clay slurry thickness was determined by chain sounding.

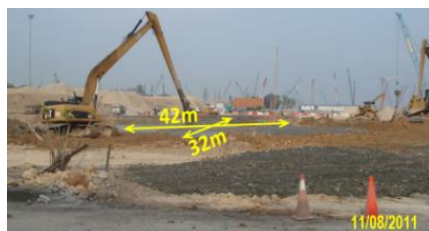
(d) Photograph of pond D (42 m x 32 m x 5.5 m) with slurry clay heaved from RL96.5 m to RL102 m.

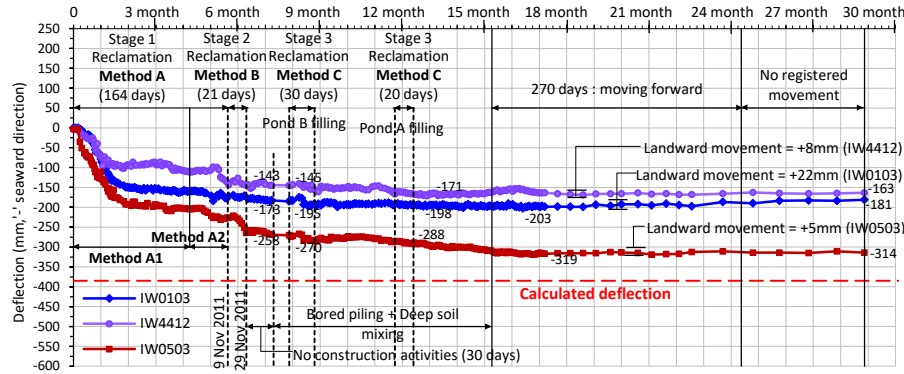
(a) Deflection of capping beam of seawall for section 2.

Figure 14. Comparison of deflection of capping beam of section 2 and 3 of seawall.

Figure 14 shows the comparison of deflections of the sections 2 and 3 of the seawall. Section 2 is from box no. 1/41 to box no. 6/46, and represented by inclinometers IW0103, IW4412 and IW0503, whereas section 3 is from box no. 7/47 to box no. 28 and deflection is from inclinometers IW0714, IW1903, IW1916 and IW2321. The influence of the various methods of reclamation is examined. Method A1, A2, and C reclamations were supervised and recorded on site. There was no record of supervision for method B reclamation.

After the reclamation filling by method A1 and A2, the full active pressure wedge was on section 2 and an almost full 44 m active pressure wedge on section 3. At this stage the passive resistance of soft clay was fully mobilized. Deflection of both sections was lesser than the 60% of the calculated value. Method B was in the proximity of section 3 and caused a plunge in 3 inclinometers IW0714, IW1916 and IW2321, with a maximum value of -353 mm or 0.80% of H as shown in Figure 14b. The plunge was caused by the concentration of the generated lateral force of the slurry clay flow beyond the 44 m active wedge, using the constructed seawall as a reaction. Inclinometer IW1916 suggested that this slurry clay force might be higher than the 44 m active wedge force. This was a transient force which dissipated after the creation of the massive slurry clay ponds B and A.

The average deflection of the stringent balancing berm method A2 was -122 mm at section 3 (Rotating height = 40 m to 44 m) and this was lower than the limited balancing berm method A1 with an average deflection of -156 mm at section 2 (Rotating height = 25 m to 40 m). This lower deflection at section 3 showed that the stringent balancing berm method A2 had the minimum seawall deflection, as shown in Table 4.

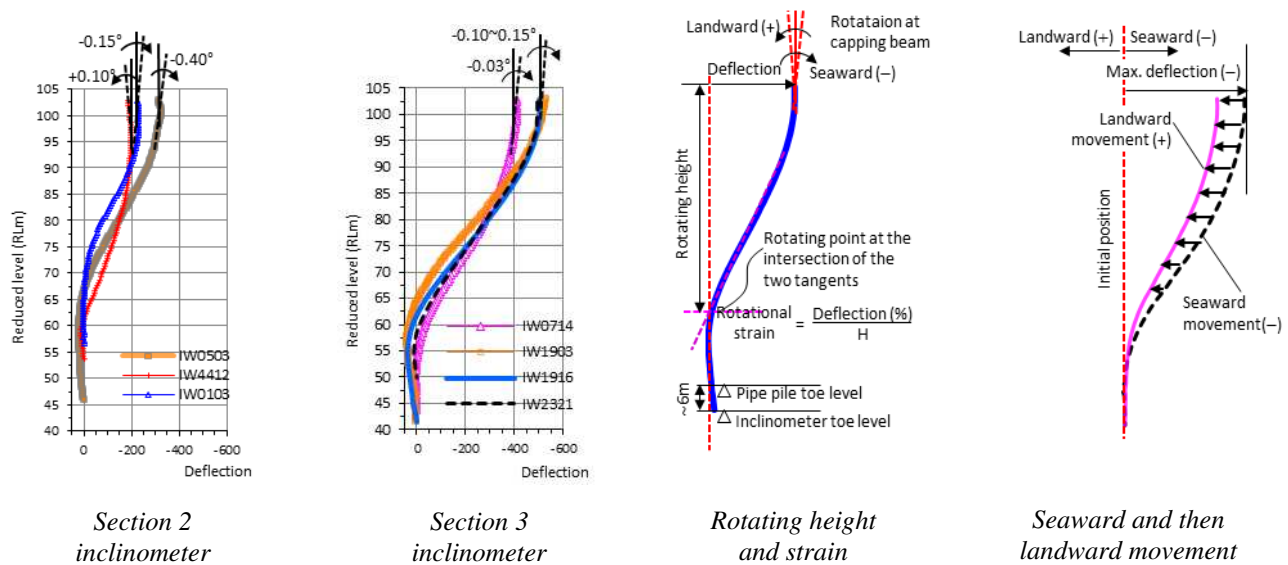
Figure 17. Inclinometer profiles at maximum deflection, seaward and subsequent landward movement.

Based on the inclinometer installed inside the hollow pipe piles, the deflection of the seawall for section 2 and 3 are shown in Figure 17. As the cantilever structure rotates just above the embedment into OA, the rotating point is the intersection of the tangent line into OA and above OA. The rotating height is from the rotating point to top of capping beam. The deflection profile of the inclinometers are shown in Table 6. The long-term stability of the seawall is demonstrated by the inclinometer deflection profiles.

Depth of embedment into OA by inclinometer readings is higher than design construction of pipe pile embedment. This higher passive resistance of the OA indicates no loss of design passive resistance despite the high seawall movement of 1.20% of H. The bottom of the strong box is rigidly held together. The profile of the inclinometer deflection indicated robustness of the integrated strong box. The robustness was derived from (a) the optimization of the vertical bending capacity of the pipe piles, (b) capping the top of the pipe piles as a box, (c) utilizing the P-P interlock to produce the box action within the rotating height. The deflection profile of the inclinometer was at the elastic state.

The deflection seaward (-ve) was the accumulation of lateral forces from reclamation within the 44 m active wedge, other construction activities within the 44 m active wedge and the creation of the slurry clay pond B and A beyond the 44 m active wedge. The maximum seaward (-ve) of -353 mm or 0.80% of H was caused by the slurry clay pond B and A. After the lateral push of these forces stabilized, the seawall then moved in the reverse direction towards the landside (+ve) as shown in Figure 17. The landward movement was monitored for a period of 13 months and the maximum magnitude is +46 mm as shown in Table 6. The landward movement suggested that the seaward (-ve) deflection of 1.20% of H is still within the elastic state of the geo-structural turning back moment capacity of the strong box. The landward movement was caused by the vertical consolidation of the 44 m active wedge.
