Reclamation and Safety of High Cantilever Strong Box Pipe Pile Seawall in Marine Clay

Reference: Soh, K.K., Wai, T.T., Yeo, L., and Lim, P.K. (2016). *Reclamation and Safety of High Cantilever Strong Box Pipe Pile Seawall in Marine Clay*. International Journal of Geoengineering Case histories, <http://casehistories.geoengineer.org>, Vol.3, Issue 3, p.176-189. doi: 10.4417/IJGCH-03-03-04

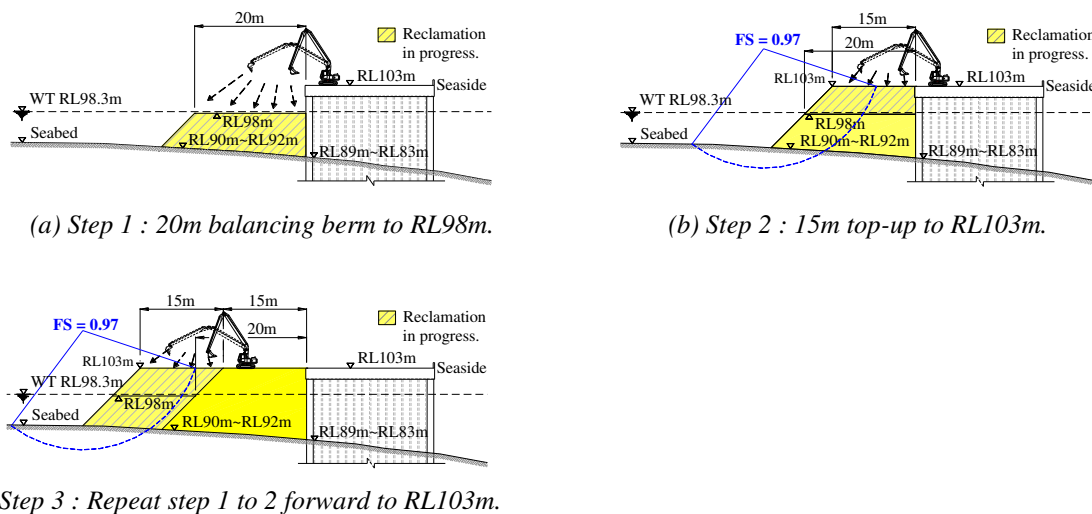
Figure 9. Limited balancing berm for stage 1 reclamation - Method A1

Reclamation steps of limited balancing berm method A1 is shown in Figure 9. The reclamation filling of Grade A material by the limited balancing berm was likely to cause minimal localized squeezing of the soft clay below the seabed. The squeezing effect was probably limited at 1 m to 2 m below the seabed as the factor of safety was slightly less than 1. The lowest factor of safety was at step 2 and step 3 and was localized after completion of 20 m berm to RL103 m.
