Reclamation and Safety of High Cantilever Strong Box Pipe Pile Seawall in Marine Clay

ABSTRACT: A high cantilever seawall was constructed in soft clay of 15 m to 32 m thickness and the enclosed water between the shoreline and the seawall was reclaimed. The area was 7 hectare and the reclamation height ranged from 10 m to 20 m. The reclamation methods were controlled and not intended to cause additional incremental deflection to the already high design deflection of -385 mm or 0.89% of H ($H = 44$ m is defined as rotating and not cantilever height). However the different methods of reclamation had a significant influence on the slurry clay flows and thus caused additional incremental deflection. The slurry clay flows pushed the deflection of seawall to an additional maximum magnitude of -353 mm or 0.80% of H. The maximum seawall deflection of -526 mm or 1.20% of H was based on inclinometer IW1903 readings. At such high seawall movement, the inclinometer deflection profiles indicate safety in the design and the long term deflection is stable. This reclamation experience indicates that it is difficult to control slurry clay flows in future high reclamation filling of 10 m to 20 m hei

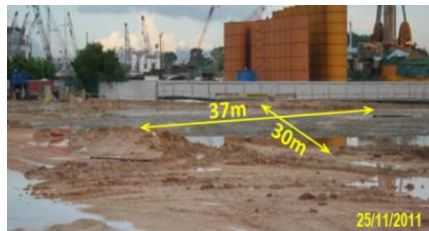
(c) Photograph of pond C. (37 m x 30 m x 7.5 m) with slurry clay heaved from RL94.5 m to RL102 m.

The clay slurry ponds B and C were observed on 25 Nov 2011 as shown in Figure 13, when the clay slurry was pushed sideways and upward to the pond water level RL102.0 m. Pond A was still submerged in water and the clay slurry thickness was determined by chain sounding.

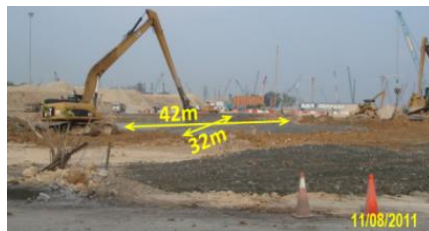
(d) Photograph of pond D (42 m x 32 m x 5.5 m) with slurry clay heaved from RL96.5 m to RL102 m.
