Geotechnical and Structural Challenges over an Active Landslide

ABSTRACT: The construction of the steel arched Tsakona Bridge, designed to overpass an active landslide, required several temporary projects. Auxiliary steel towers were used for the erection and welding of the arch segments. Most of them had to be founded in the body of the sliding mass. An automated instrumentation and monitoring system was installed on site providing early warning to the engineers in charge in case large displacements were measured. The real-time recording data provided valuable information about the landslide movements. These monitoring results defined the geotechnical and structural design criteria for the deep foundation of the temporary towers. Several 2D and 3D geotechnical and structural models were created to evaluate the sliding effect on the foundation components, finalize their dimensioning and calculate the required reinforcement. The procedure followed for the design of the temporary deep foundation is described based on the criteria devised using the monitoring system, emphasizing on the continuous feedback between the geotechnical and structural design teams. Several key structural de

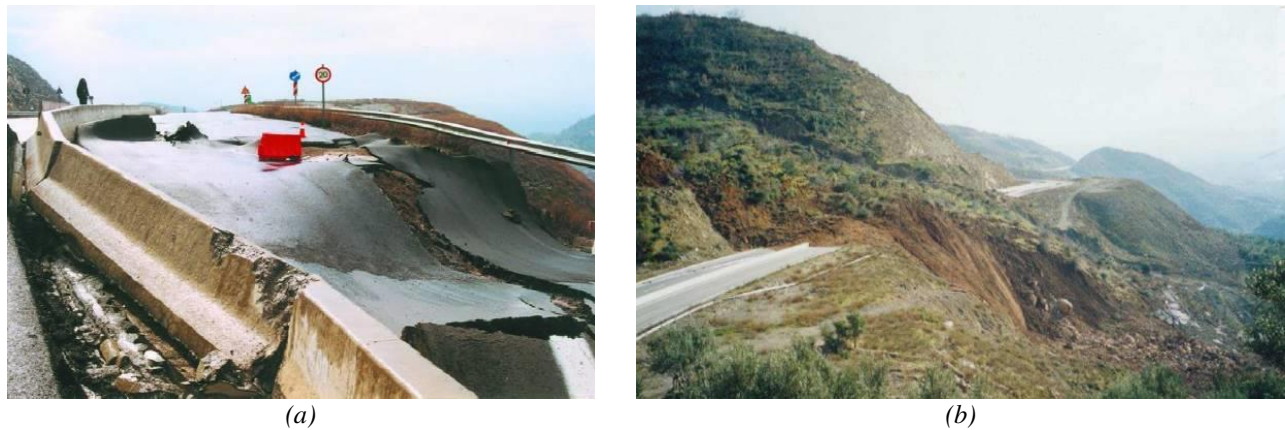
Figure 1. The Tsakona landslide (February 2003) (EMEK S.A (2015)) (a) large settlements on the road pavement (b) massive soil movement (Fikiris et al. (2001)).

The highway to the city of Kalamata in southern Peloponnese crossed through an old landslide, which was reactivated in January 2003 after a period of heavy rainfalls, leading to a major catastrophic slide. The triggered landslide is one of the largest that have occurred in Greece, the consequences of which are shown in Figure 1. Horizontal and vertical displacements of the sliding mass up to 100 m and 40 m, respectively, were measured, causing a soil mass movement of about 6,000,000 m³ of flysch colluvia and manmade deposits, extended in a large area of 400 m upslope and 700 m downslope of the highway (Belokas 2013, Belokas and Dounias 2016). Among several options studied for the rehabilitation of the National Highway, bridging over the landslide was selected as the most cost-efficient and technically feasible solution (Fikiris et al. 2011). The steel arched Tsakona Bridge, sketched in Figure 2, was decided to be constructed over the sliding mass, which moved downslope at an average rate of about 1.5-2.0 mm/month. This rate was increasing significantly during the periods of intense rainfalls, exceeding for short periods of time the value of 30 mm/month (projected rate of movement).

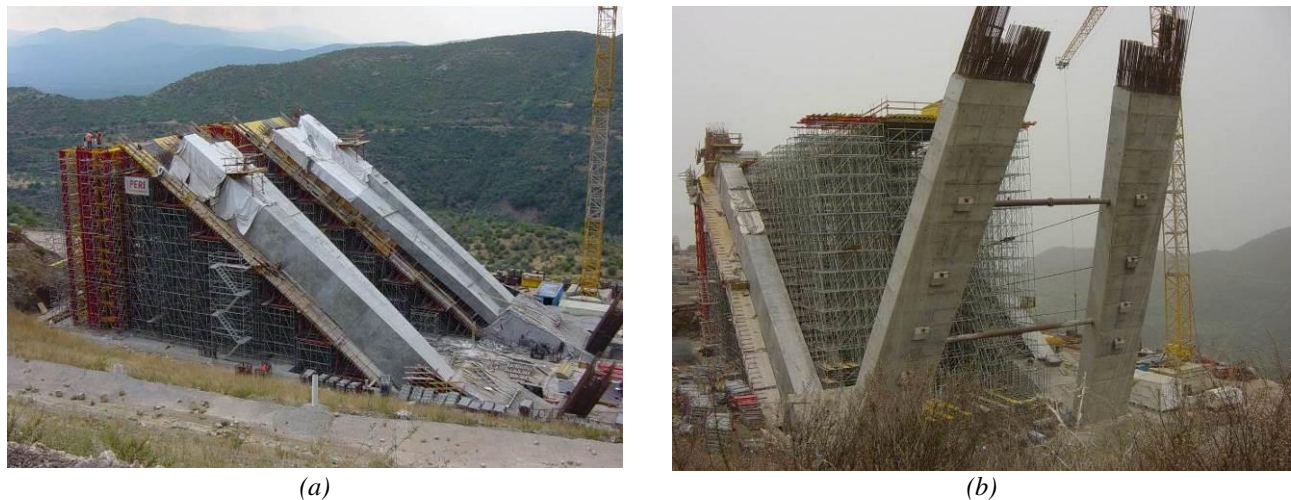
Figure 9. Construction of the (a) curved struts and (b) straight struts of the bridge pier.

The main body of the V-shaped pier consisted of two pairs of supporting struts. The southern struts were curved, following the parabolic geometry of the arch. The northern ones were designed as straight elements on the same inclined plane, converging towards each other. For the construction of the curved struts, scaffolding towers were used, anchored on slabs on the ground. For the straight struts a self-climbing formwork system was mobilized. Temporary horizontal bracings along the transverse direction kept the straight struts in place. At the same time, temporary tendons were utilized to suspend these struts from the completed curved ones, providing the necessary stability to the unfinished V-shaped pier (Figure 9). Before the construction of the curved struts, the two MT towers were installed to support their top ends. They were designed to provide bearing capacity of 12000 kN and 16500 kN each, under static and seismic load combination, respectively. Their foundation consisted of pile-groups penetrating the stable bedrock, connected with pile caps. Ground anchors were also foreseen, as mitigation measure to be activated in case large movements were observed during construction (Figure 10). A special arrangement was provided on the top of the MT towers to compensate any contingency movement within the loose soil above the bedrock as well as the elastic deformations of the auxiliary towers and the deformation due to temperature fluctuations. This arrangement included two (2) elastomeric bearings and four (4) lifting jacks for each tower. Continuous accurate surveying of the level of the bearings and vertical adjustments through the jacks were ensuring the fixed vertical position of the support during construction, until the complete functionality of the arch was achieved.

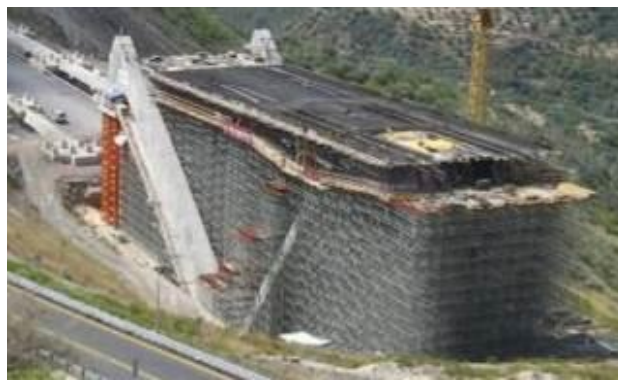
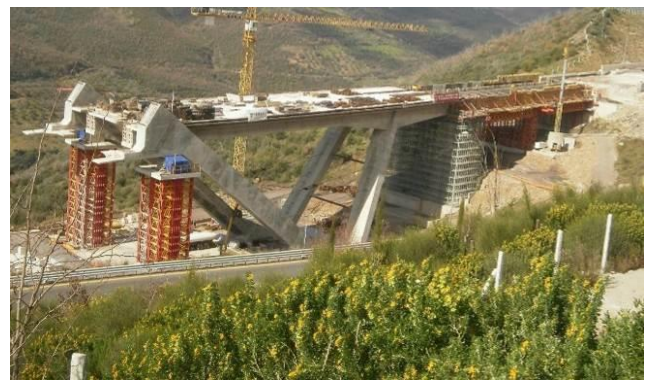
Figure 11. Construction of (a) the 55 m and (b) the 75 m access parts of the bridge prestressed concrete deck.

The 130 m prestressed concrete part of the bridge consisted of two parts, one 55 m long closing the V shape of the bridge pier and the other 75 m long between the straight struts of the pier and the northern abutment, as shown in Figure 11. The first part was poured on scaffolding anchored on the struts of the pier and ground slabs, while for the second one heavy duty bridge-type scaffolding was used, founded with piles on adverse surface morphology conditions, but on a stable ground (Figure 11). The construction of the bridge was completed with the steel arch part. The arch system with a span of 260 m and a rise of 45 m, consisted of two vertical steel arches, one for each branch of the Highway, connected with K-type bracings, all pre-fabricated. Segments of 12 m long were assembled and welded on the ground slabs or the bridge corridors, creating larger pieces of 36 m, which were in turn lifted to position with the heavy lifting system mounted on the temporary steel towers and welded at height. Shelter booths were seated at the top of the towers providing protection from the wind and the rain for the welding procedure of the arch segments (Figure 12a). The bridge was completed with the erection of the composite deck (Figure 12b), which was fully suspended from the arches with the use of hangers (Stathopoulos et al. 2014a, 2014b).

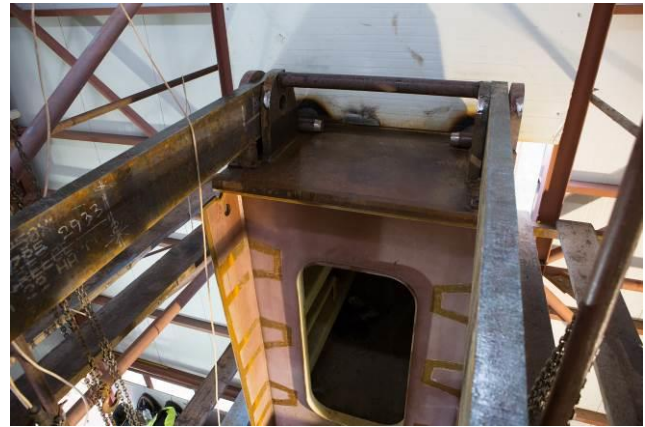
Figure 13. Connection arrangement for fixing the crown gap between the arch parts to weld the key segment (a) drawing (b) implementation.

The length of the crown gap changed during a 24 hours cycle up to 4 cm, because of the high temperature differences, rendering difficult the welding of the key segment. The gap was fixed to a firm distance to allow the welding of the last “tailor made” piece of the arch, using steel plates and pins. Four connections were designed (Figure 13) to sustain a total tensile and compressive force between the constructed parts of the arch equal to 10000 kN, caused by a mean temperature difference of $\pm 15^{\circ}\text{C}$.

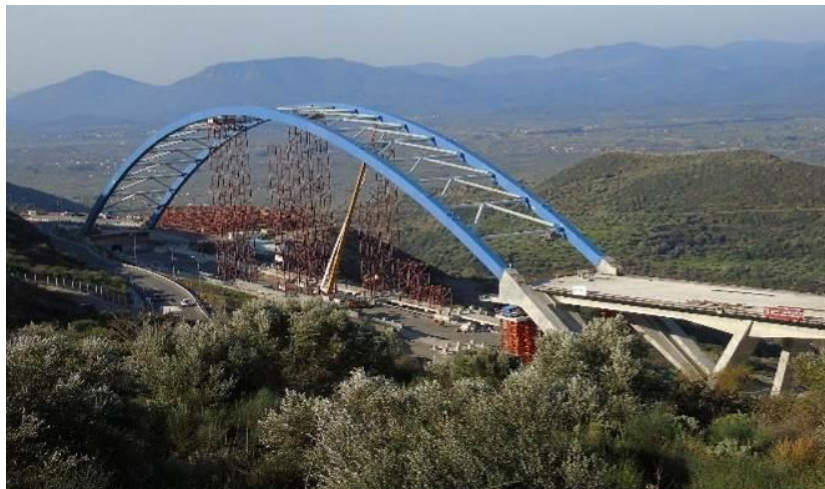
Figure 14. Removal of the temporary towers.

Other crucial issues were related with gradual removal of the arch supporting towers (Figure 14), as well as the total release of the bridge and the removal of the last supporting structure, the MT towers.

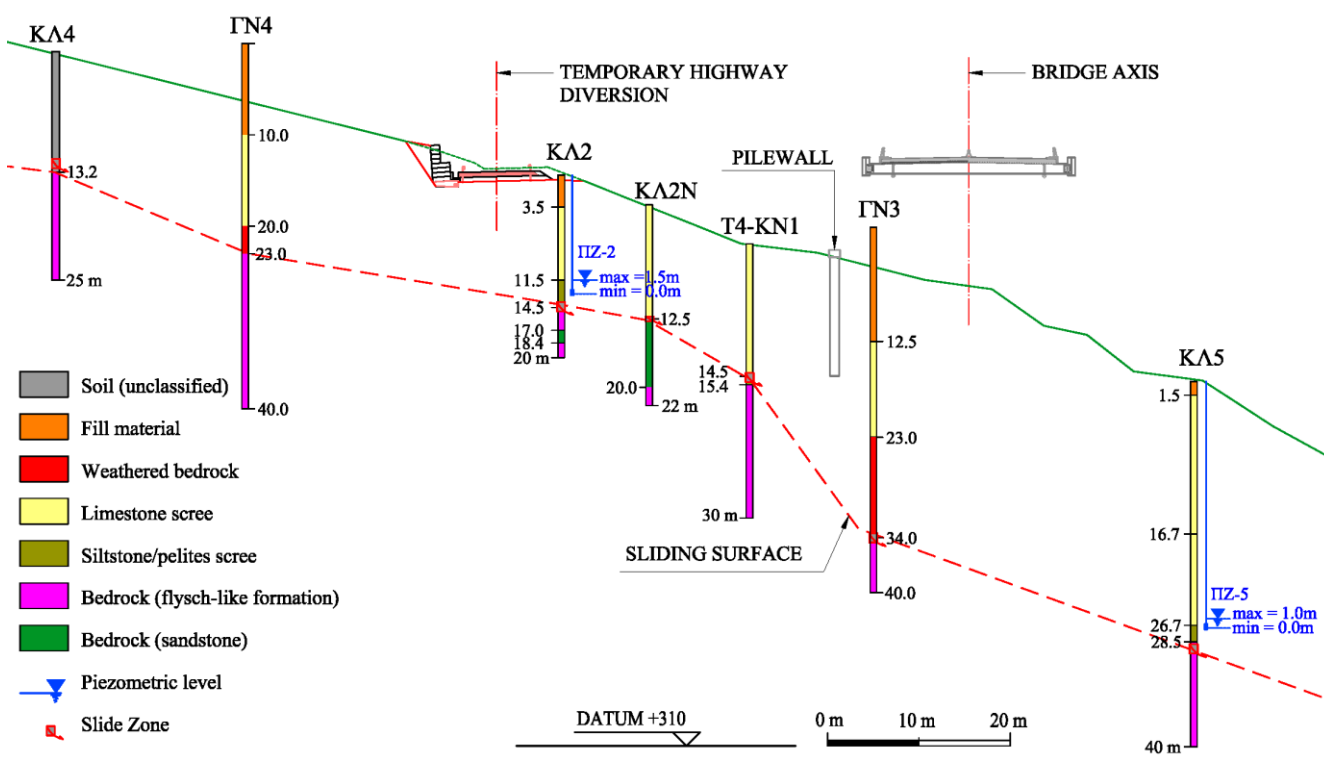
Figure 16. Section in between Piers Ii2 and Ii3 showing the position of the geotechnical instruments with respect to the bedrock surface.

shown in Figures 6 through 8 and 16. The scope of this procedure aimed at defining the geotechnical parameters that would feed the final structural design of each pier. These parameters were the coefficients of the earth pressure produced by landslide slippage and the constants of the equivalent elastic supports that would be applied as springs at the bottom of each pile of the structural models, simulating the soil-structure interaction. The constant of equivalent vertical spring of each pile of the piers was expressed as $K=P/v_z$, where $P=1000$ kN was a single load applied on the top of the corresponding pile and v_z was the calculating settlement. For the piles of the left branch a mean value derived from the analyses of all piers and a spring constant of 140,000 kN/m was adopted, while for the right branch the calculated values varied within a range of 120,000 kN/m – 1,000,000 kN/m. These results were in accordance with the ones derived from loading tests of non-functional piles. Regarding the earth pressure evolved at the upslope piles of the right branch piers $\Pi 2\Delta$ - $\Pi 4\Delta$, presenting the maximum free height and being founded in the sliding body, the horizontal and vertical stresses were calculated under static loads, resulting in equivalent pressure coefficient equal to $K_0=0.50$. The same value was obtained for the imposed movement, since the floating piles moved along with the sliding mass, as also demonstrated by the 3D geotechnical analyses and confirmed by the monitoring data.

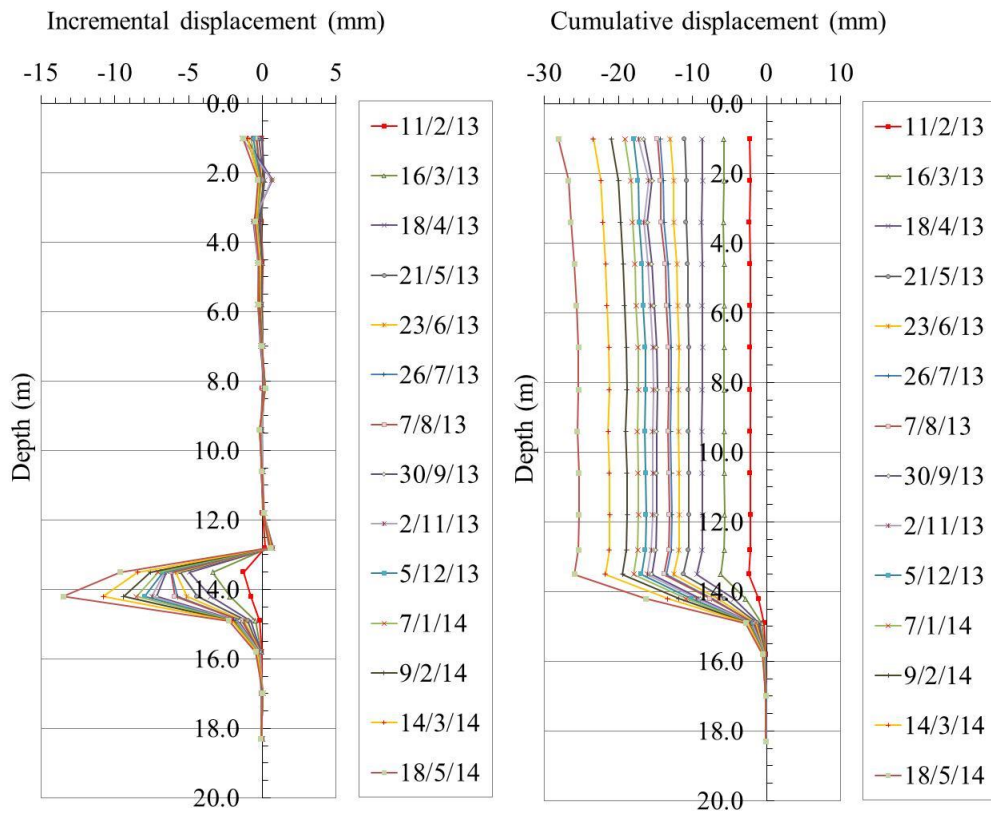
Figure 18. Typical diagrams of automated inclinometer K12 (measuring along the whole depth).

project. This application automatically processed the recorded data to information of engineering interest (displacements, piezometric level and rain level) updating representative tables and graphs for each instrument, continuously providing the evolution of the phenomena for further assessment and evaluation. The results of this procedure were uploaded to a shared cloud server every 4 hours, being accessible to the responsible design and construction teams, who could appraise the potential risk of the landslide any time at any point of the site. Apart from the continuous evaluation and analysis of the recording data, the data logger was setup to send SMS messages to the engineers in charge, in case large movements were recorded exceeding specific alert movement thresholds, initiating thus a series of increasing awareness and contingency actions. Several cases of excessive sliding movements as well as seismic events were noted during the construction period of the bridge and special instructions were issued to the construction team, especially during the winter season after incidents of intense rainfalls. The flow chart of the monitoring procedure is given in Figure 17. Two typical diagrams of the measured incremental and the calculated cumulative displacements in an automated inclinometer are given in Figure 18.

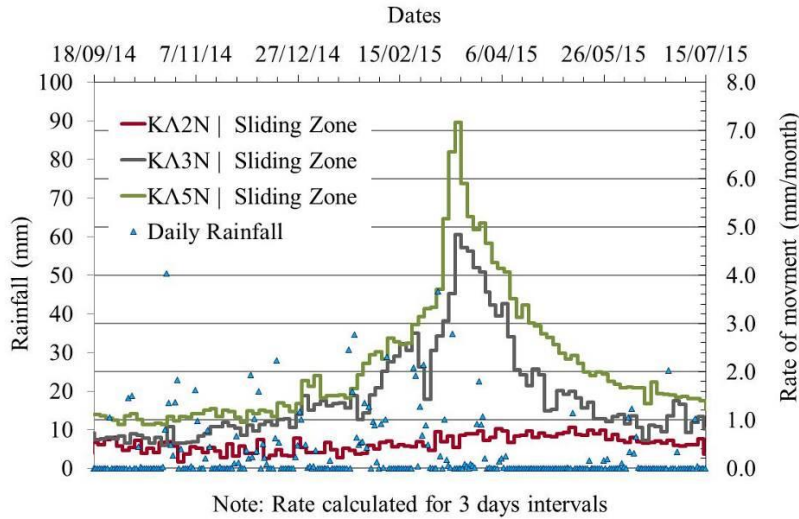
Figure 20. Diagram of slide movement rate with respect to rainfall.

- The rate of the sliding movement varied seasonally depending on rainfall, as shown in Figure 20. The rate picks are concentrated in the months of February and March, reflecting major rainfall incidents as well as the accumulation of rainfall along the whole rainy season (November-March). The influence of heavy rainfalls in the piezometric levels can be seen in Figure 21.

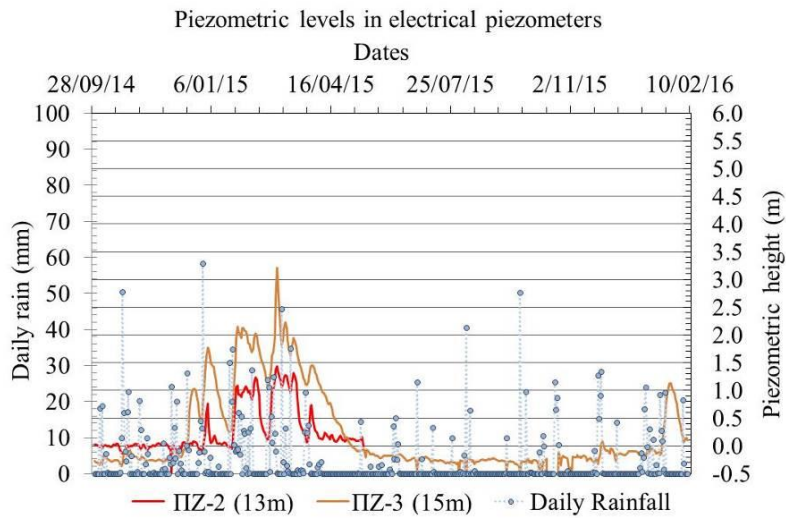
Figure 21. Diagram showing correspondence of piezometric levels to rainfall.
