Geotechnical and Structural Challenges over an Active Landslide

ABSTRACT: The construction of the steel arched Tsakona Bridge, designed to overpass an active landslide, required several temporary projects. Auxiliary steel towers were used for the erection and welding of the arch segments. Most of them had to be founded in the body of the sliding mass. An automated instrumentation and monitoring system was installed on site providing early warning to the engineers in charge in case large displacements were measured. The real-time recording data provided valuable information about the landslide movements. These monitoring results defined the geotechnical and structural design criteria for the deep foundation of the temporary towers. Several 2D and 3D geotechnical and structural models were created to evaluate the sliding effect on the foundation components, finalize their dimensioning and calculate the required reinforcement. The procedure followed for the design of the temporary deep foundation is described based on the criteria devised using the monitoring system, emphasizing on the continuous feedback between the geotechnical and structural design teams. Several key structural de

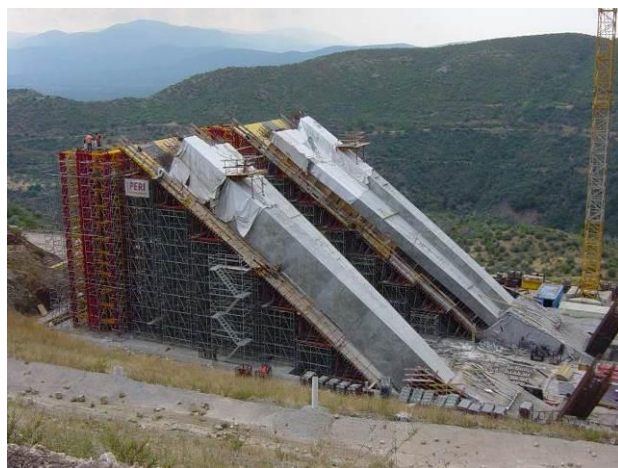
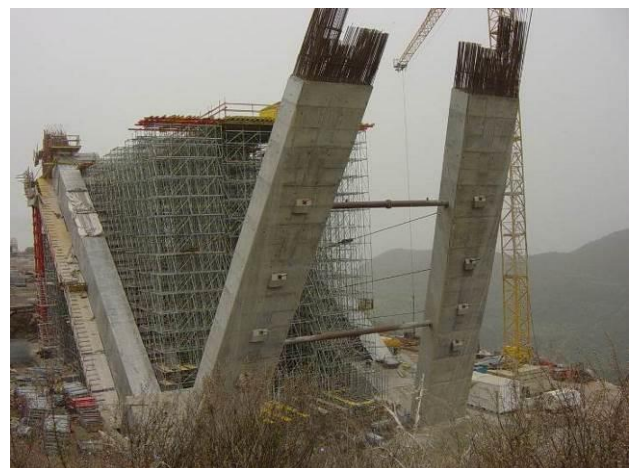
Figure 9. Construction of the (a) curved struts and (b) straight struts of the bridge pier.

The main body of the V-shaped pier consisted of two pairs of supporting struts. The southern struts were curved, following the parabolic geometry of the arch. The northern ones were designed as straight elements on the same inclined plane, converging towards each other. For the construction of the curved struts, scaffolding towers were used, anchored on slabs on the ground. For the straight struts a self-climbing formwork system was mobilized. Temporary horizontal bracings along the transverse direction kept the straight struts in place. At the same time, temporary tendons were utilized to suspend these struts from the completed curved ones, providing the necessary stability to the unfinished V-shaped pier (Figure 9). Before the construction of the curved struts, the two MT towers were installed to support their top ends. They were designed to provide bearing capacity of 12000 kN and 16500 kN each, under static and seismic load combination, respectively. Their foundation consisted of pile-groups penetrating the stable bedrock, connected with pile caps. Ground anchors were also foreseen, as mitigation measure to be activated in case large movements were observed during construction (Figure 10). A special arrangement was provided on the top of the MT towers to compensate any contingency movement within the loose soil above the bedrock as well as the elastic deformations of the auxiliary towers and the deformation due to temperature fluctuations. This arrangement included two (2) elastomeric bearings and four (4) lifting jacks for each tower. Continuous accurate surveying of the level of the bearings and vertical adjustments through the jacks were ensuring the fixed vertical position of the support during construction, until the complete functionality of the arch was achieved.
