# Geotechnical and Structural Challenges over an Active Landslide

Reference: Seferoglou, K., Vassilopoulou, I. and Chrysohoidis, F. (2018). *Geotechnical and Structural Challenges Over an Active Landslide*. International Journal of Geoengineering Case Histories, Vol.4, Issue 3, p.162-184.

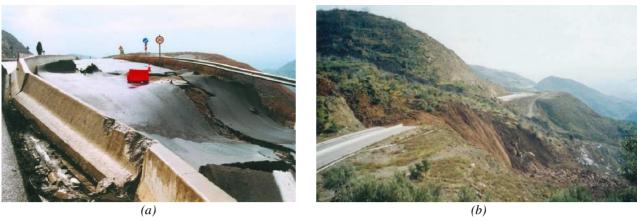
Figure 1. The Tsakona landslide (February 2003) (EMEK S.A (2015)) (a) large settlements on the road pavement (b) massive soil movement (Fikiris et al. (2001)).

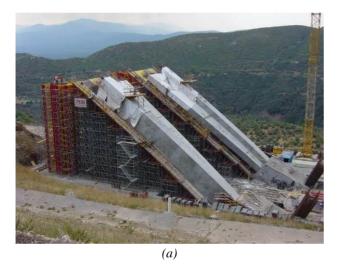
Figure 9. Construction of the (a) curved struts and (b) straight struts of the bridge pier.

The main body of the V-shaped pier consisted of two pairs of supporting struts. The southern struts were curved, following the parabolic geometry of the arch. The northern ones were designed as straight elements on the same inclined plane, converging towards each other. For the construction of the curved struts, scaffolding towers were used, anchored on slabs on the ground. For the straight struts a self-climbing formwork system was mobilized. Temporary horizontal bracings along the transverse direction kept the straight struts in place. At the same time, temporary tendons were utilized to suspend these struts from the completed curved ones, providing the necessary stability to the unfinished V-shaped pier (Figure 9). Before the construction of the curved struts, the two MT towers were installed to support their top ends. They were designed to provide bearing capacity of 12000 kN and 16500 kN each, under static and seismic load combination, respectively. Their foundation consisted of pile-groups penetrating the stable bedrock, connected with pile caps. Ground anchors were also foreseen, as mitigation measure to be activated in case large movements were observed during construction (Figure 10). A special arrangement was provided on the top of the MT towers to compensate any contingency movement within the loose soil above the bedrock as well as the elastic deformations of the auxiliary towers and the deformation due to temperature fluctuations. This arrangement included two (2) elastomeric bearings and four (4) lifting jacks for each tower. Continuous accurate surveying of the level of the bearings and vertical adjustments through the jacks were ensuring the fixed vertical position of the support during construction, until the complete functionality of the arch was achieved.

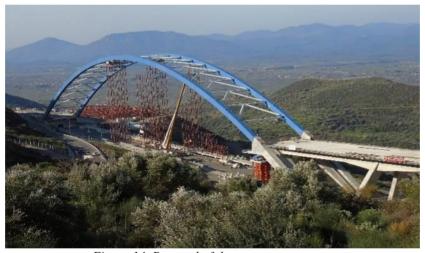
Figure 14. Removal of the temporary towers.

Other crucial issues were related with gradual removal of the arch supporting towers (Figure 14), as well as the total release of the bridge and the removal of the last supporting structure, the MT towers.

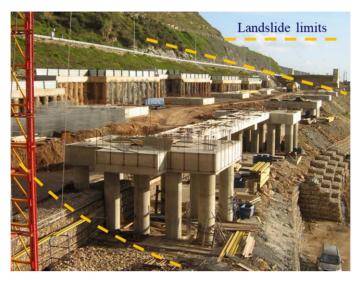
Figure 23. Assembling line of the right branch.

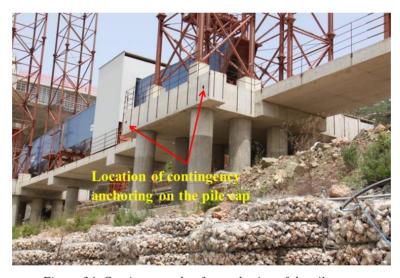
Figure 34. Contingency plan for anchoring of the pile caps.
