Geotechnical and Structural Challenges over an Active Landslide

ABSTRACT: The construction of the steel arched Tsakona Bridge, designed to overpass an active landslide, required several temporary projects. Auxiliary steel towers were used for the erection and welding of the arch segments. Most of them had to be founded in the body of the sliding mass. An automated instrumentation and monitoring system was installed on site providing early warning to the engineers in charge in case large displacements were measured. The real-time recording data provided valuable information about the landslide movements. These monitoring results defined the geotechnical and structural design criteria for the deep foundation of the temporary towers. Several 2D and 3D geotechnical and structural models were created to evaluate the sliding effect on the foundation components, finalize their dimensioning and calculate the required reinforcement. The procedure followed for the design of the temporary deep foundation is described based on the criteria devised using the monitoring system, emphasizing on the continuous feedback between the geotechnical and structural design teams. Several key structural de

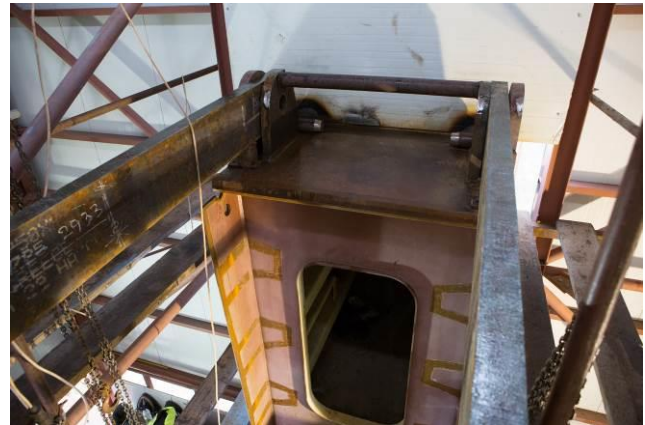
Figure 13. Connection arrangement for fixing the crown gap between the arch parts to weld the key segment (a) drawing (b) implementation.

The length of the crown gap changed during a 24 hours cycle up to 4 cm, because of the high temperature differences, rendering difficult the welding of the key segment. The gap was fixed to a firm distance to allow the welding of the last “tailor made” piece of the arch, using steel plates and pins. Four connections were designed (Figure 13) to sustain a total tensile and compressive force between the constructed parts of the arch equal to 10000 kN, caused by a mean temperature difference of $\pm 15^{\circ}\text{C}$.
