Masonry Arch Bridges with Reinforced Soil Spandrel Walls

ABSTRACT *In the United Kingdom, most masonry arch bridges were built before the beginning of the twentieth century and many are more than 250 years old and of architectural significance. Masonry arch bridges are simple structures with a stone or brick arch supporting outer spandrel walls infilled with soil or granular material. Originally built to carry horse and cart traffic, they have proved to be able to support modern traffic loadings. However, constant traffic can lead to the spread and even the collapse of the spandrel walls due to distortion of the fill. The general maintenance cost of masonry bridges has proved to be lower than most modern structures, and the construction of new masonry arch bridges is encouraged in the United Kingdom. This paper provides two linked case histories relating to (i) the first use of reinforced soil to repair a 250-year-old masonry arch bridge in 1984 and (ii) the introduction of reinforced soil into the basic design of a new masonry arch bridge constructed in 2000.*

Reference: Jones, C.J.F.P. and Doulala-Rigby, C. (2022). Masonry Arch Bridges with Reinforced Soil Spandrel Walls. Inter

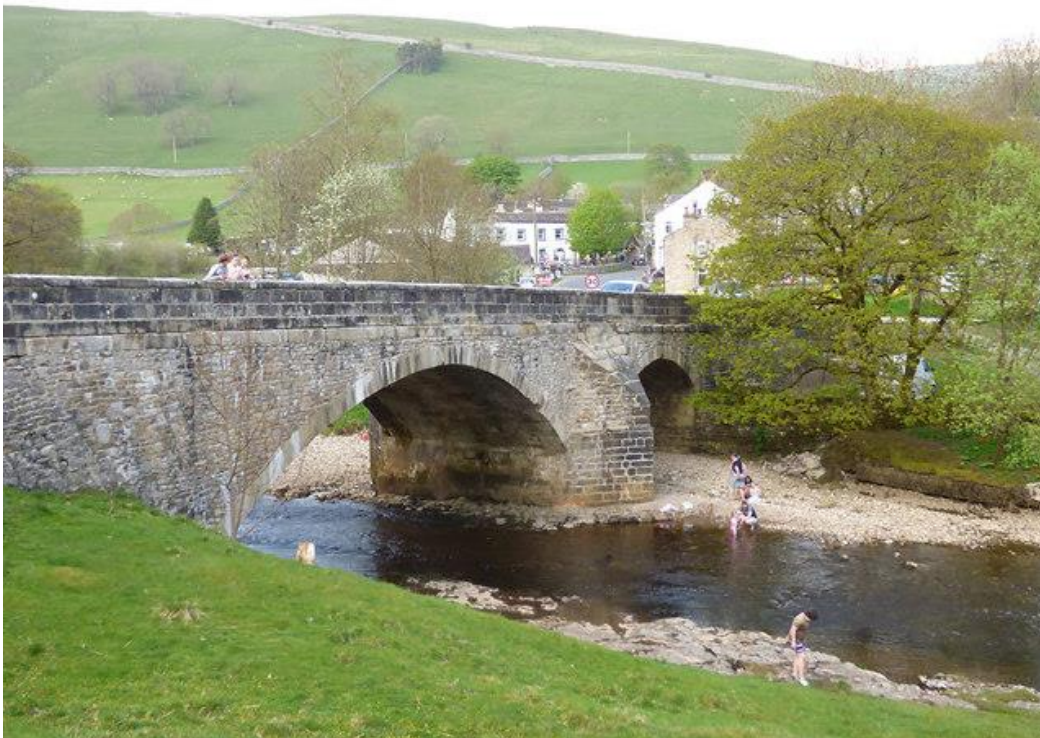
Figure 8. Kettlewell New Bridge, North Yorkshire, UK (Photo © [Stephen Craven \(cc-by-sa/2.0\)](#)).

Kettlewell New Bridge is a “listed” dual span masonry arch bridge over the Wharfe River in North Yorkshire constructed in the 18th century, shown in Figure 8. A listed building, structure, or environment is one that is recognized as being of national importance and part of the United Kingdom’s heritage. Listed structures are legally protected from being demolished, extended, or altered. Kettlewell New Bridge was the first to be repaired using geogrid reinforced soil to stabilize its failing spandrel walls.

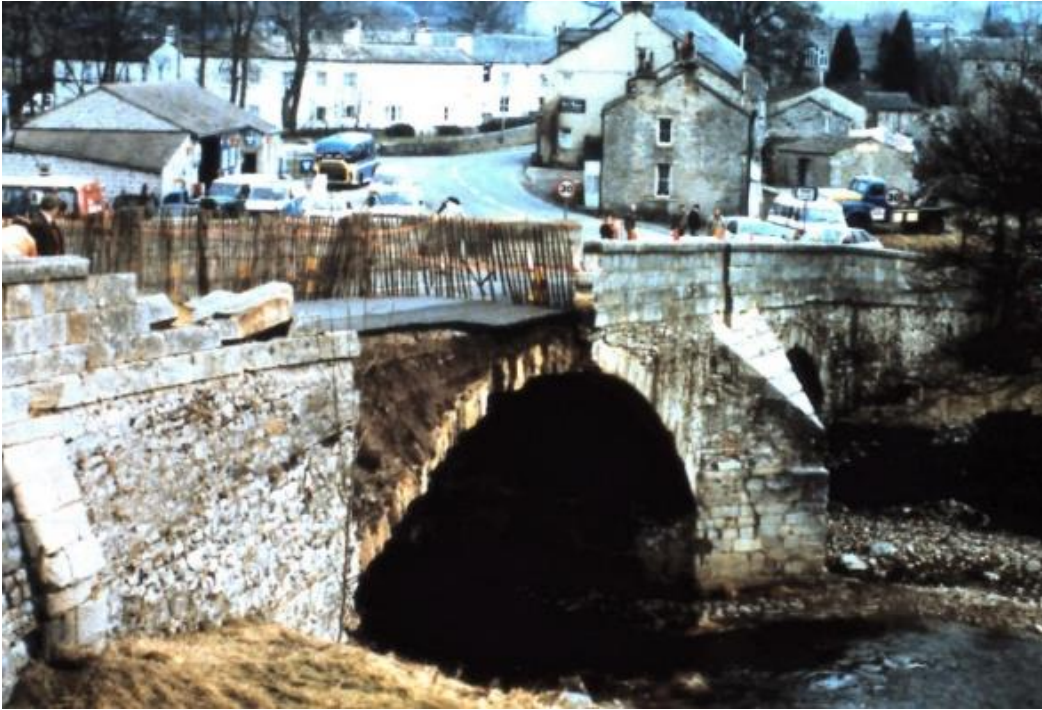
Figure 9. Failure of spandrel wall, Kettlewell New Bridge, 1984.

In 1984, the spandrel wall on one side of the bridge failed due to bulging and lateral sliding, though the infill soil remained intact (see Figure 9). Repair was undertaken with geogrid reinforced fill between the spandrel walls, designed in accordance with United Kingdom Memorandum BE 3/78, using the concertina method of construction of reinforced soil, seen in Figure 10. Lateral loading from the reinforced fill onto the reconstructed spandrel walls was eliminated by forming a small permanent gap between the reinforced fill and the back of the spandrel walls, shown in Figure 7. The Concertina Method of construction accommodates difficult geometries particularly if the face is formed by wrapping geogrid reinforcement over sandbags. The 3D shape of the void above the arch results in the shape of the facing changing and the vertical spacing of the reinforcement varying. This is easily accommodated during construction by hammering the sandbags into the desired shape using a wooden mallet.

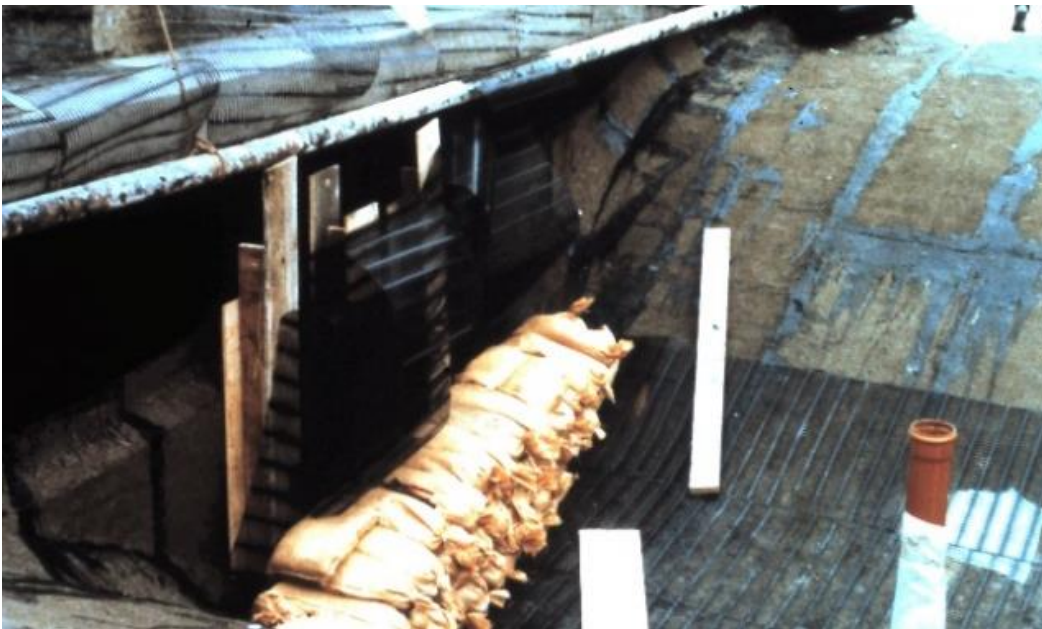
Figure 10. Construction of geogrid reinforced infill to spandrel walls, Kettlewell New Bridge, 1984.

The required vertical spacing of the reinforcement is at a maximum at the springing of the arch; thus, if this section is stable in accordance with the design Memorandum BE 3/78, no other sections need to be checked. Construction in the confined space over the arch between the spandrel walls is possible, as construction is primary by hand using minimum construction equipment. The geogrid used in the repair of Kettlewell Bridge was the newly developed 1-meter-wide high-density polyethylene (HDPE) uniaxially oriented geogrid with a tensile strength of 80 kN/m identified as SR1. The spacing of the reinforcement at the springing of the arch was 400 mm. The original soil fill removed to undertake the repair was reused (if in suitable condition, e.g., unsaturated). As part of the repair, a waterproof membrane was applied to the extrados of the arch with a positive drain provided at the springing.

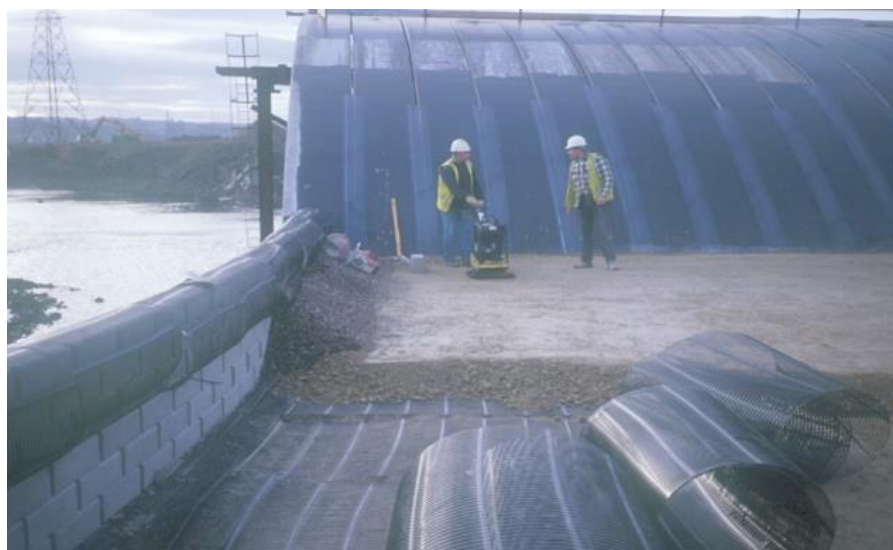
Figure 14. Construction of the soil reinforced masonry spandrel walls.

The facing of the spandrel walls was constructed using unreinforced concrete masonry blocks (400 mm long; 220 mm wide; 150 mm high). The reinforcement used was the Tensar geogrid. Geogrids with tensile strengths of 50, 80, and 120 kN/m were used so that the vertical spacing of the reinforcement could be kept constant at 450 mm (i.e., three blocks high), as shown in Figures 12 and 14. The connection between the reinforcement and the masonry block facing used a propriety system whereby the geogrid is held in place between the blocks using a polymeric comb, seen in Figure 13. The reinforcement was tensioned before the placement of the fill. The fill used to form the spandrel walls and adjacent retaining walls was DoT Type 6I with Type 8H drainage stone, and compaction of the fill was in accordance with DoT BD 70/97 (Highways Agency, 1997). The rate of construction was influenced by the need to accommodate the rise and fall of the Tyne River, which is tidal. The average construction rate was 40 m² of wall face/day.
