# MSE Wall Behavior during Large Truck Impact at High Speed against Barrier on Top of Wall

**Reference:** Briaud J.-L., Bligh R., and Maddah L. (2024). *MSE Wall Behavior during Large Truck Impact at High Speed against Barrier on Top of Wall*. International Journal of Geoengineering Case Histories, Vol. 8, Issue 1, p.1-24. doi: 10.4417/IJGCH-08-01-01

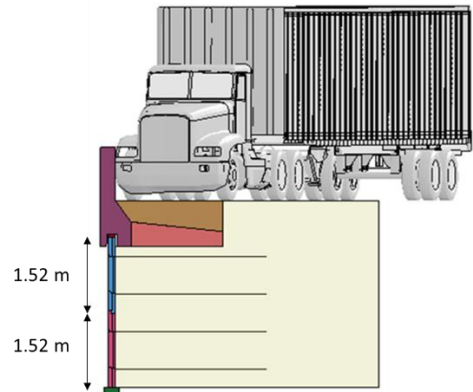
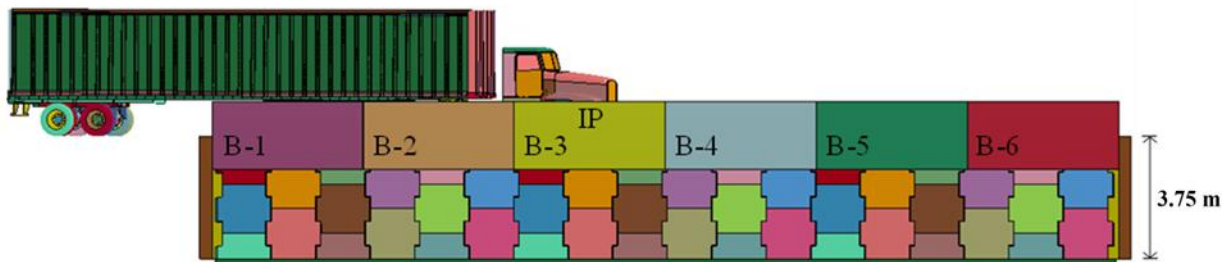
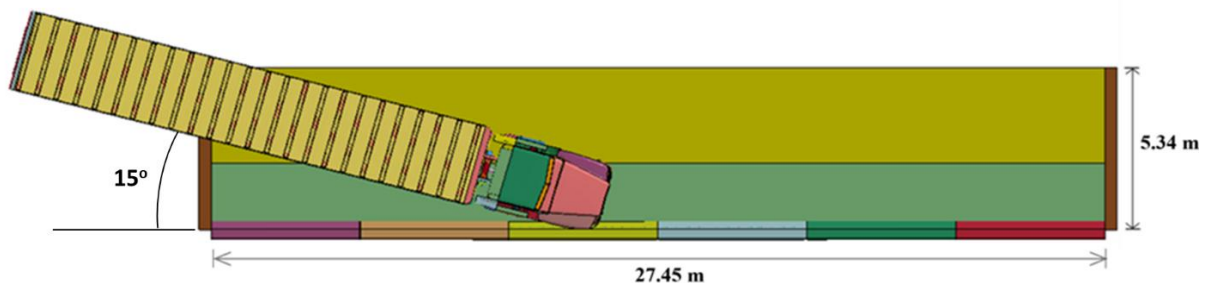
(a) Cross section of barrier-moment slab-MSE wall assembly with truck.

(b) Front view of the barrier-moment slab-MSE wall assembly with truck.

(c) Plan view of the barrier-moment slab-MSE wall assembly with truck.

**Figure 1.** Finite element mesh for simulation of barrier-moment slab-MSE wall assembly with truck: (a) cross section of barrier-moment slab-MSE wall assembly with truck, (b) front view of the barrier-moment slab-MSE wall assembly with truck, and (c) plan view of the barrier-moment slab-MSE wall assembly with truck.

The software used for the simulations was LS-DYNA (Hallquist, 2007). The Finite Element Method (FEM) models included the tractor-trailer truck, the L shape barrier and moment slab, and the MSE wall with soil and reinforcement strips (Figure 1).

The dimensions of the model (Figure 1) were 27.45 m in length, 3.75 m in height, and 5.34 m in width. The barrier height from the pavement surface to the top of the barrier was 1.07 m and the width of the moment slab was varied but finally chosen as 2.13 m, measured from the back of the MSE wall panel to the end of the moment slab. The bottom of the moment slab was 1.02 m deep below the pavement surface, and the length of the reinforcement strips was 3.05 m. Referring to Figure 1, the boundary conditions were as follows: all boundaries were free of any constraints except for the vertical boundary at the back of the wall, at the bottom of the wall and on the side-ends of the wall.

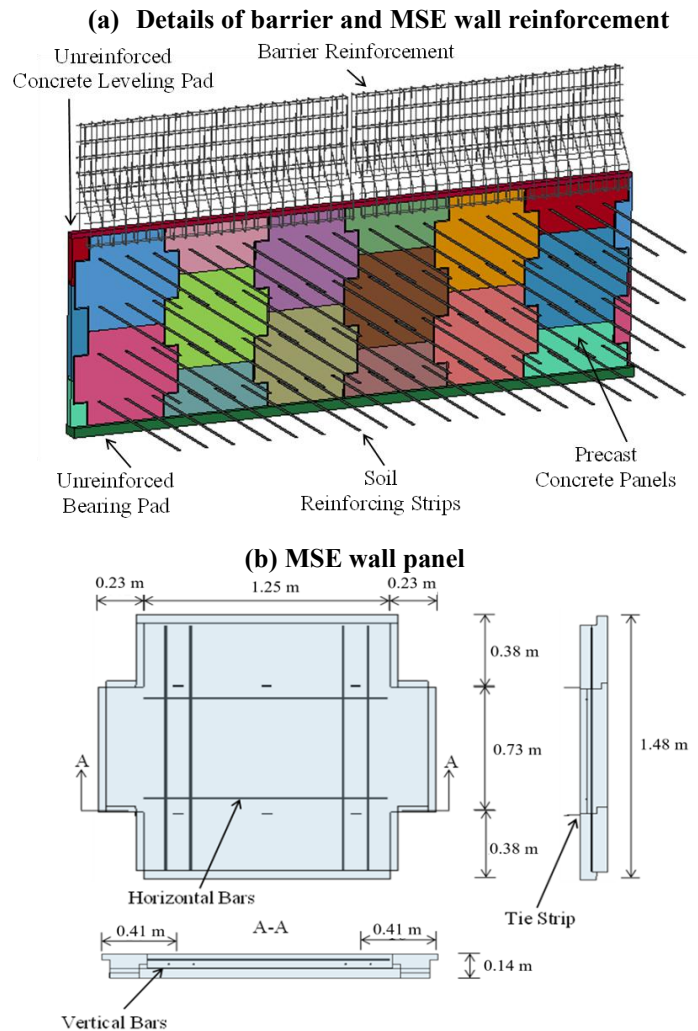
**Figure 2.** Barrier-moment slab and MSE wall model: (a) details of barrier and MSE wall reinforcement, and (b) MSE wall panel.

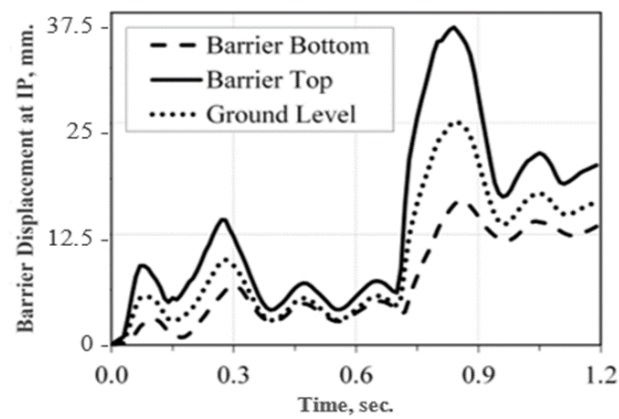
**Figure 4.** Barrier displacement during impact in FEM simulation.

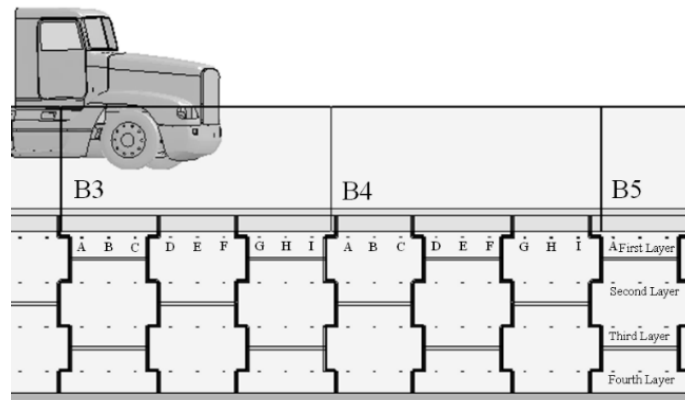
**Figure 5.** Reference designation for the strips in the wall.

The total load in the MSE wall strips is the addition of the static load due to the earth pressure in the wall and the dynamic load due to the TL5 impact. The designation of the strips in the wall is given in Figure 5. For example, B3\_B\_1<sup>st</sup> refers to barrier segment B3, strip B in the first layer of strips. The top or first layer of strips is the one that is most severely influenced by the dynamic impact. The total load in the most heavily loaded individual strip in the first layer of strips during the impact and the dynamic component are shown in Figure 6a. The peak total load is 26.03 kN with a peak dynamic component of 22.02 kN. In the second layer of strips (Figure 6b), the corresponding peak total load and peak dynamic load were 15.4 and 8.5 kN respectively. The calculated maximum pullout resistance of the strips according to AASHTO LRFD (2014) was 10.14 kN for strips in the first layer and 15.57 kN for strips in the second layer. Therefore, according to the numerical simulation, the reinforcing strips of the first layer reached pull-out failure during the impact. The pull-out displacement of the strips is shown in Figure 7 and indicates a maximum displacement of 10 mm. Laboratory tests conducted on strips in a pressurized sand box showed displacements to failure of about 5 mm. This is consistent with the numerical simulations indicating that the reinforcement strips were at failure during the impact. The dynamic and permanent displacement of the wall panels are shown in Figure 8; the permanent displacement of the panels is limited to 7 mm, indicating that the wall could likely be reused without repair.

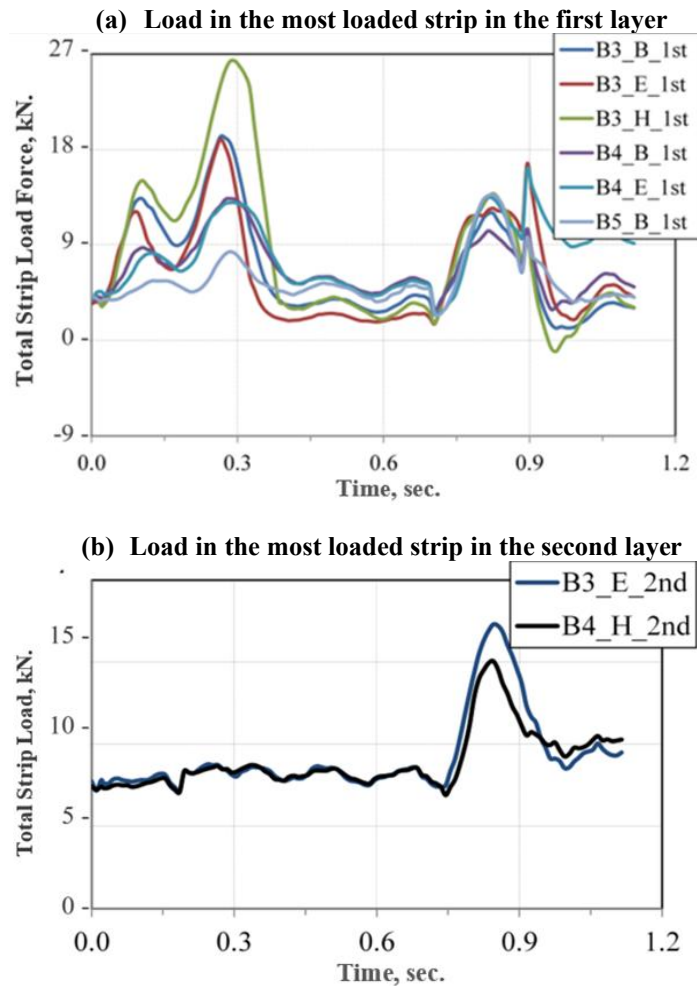
**Figure 6.** Total load in the most loaded strip for the first and second rows of strips in FEM simulation: (a) load in the most loaded strip in the first layer, and (b) load in the most loaded strip in the second layer.

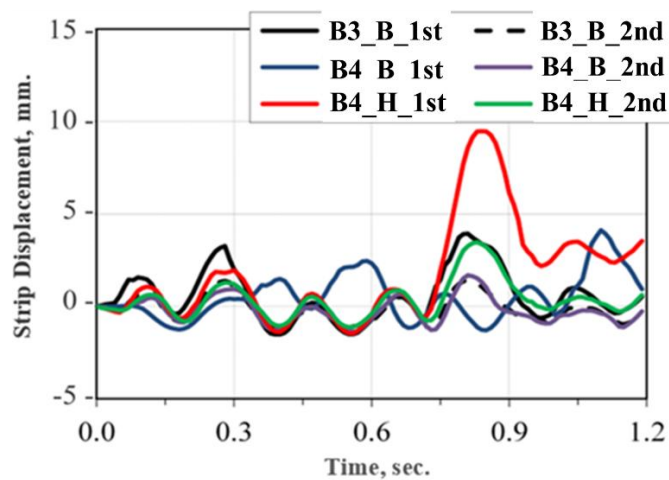
**Figure 7.** Displacement of the reinforcing strips (first level and second level) in FEM simulation.

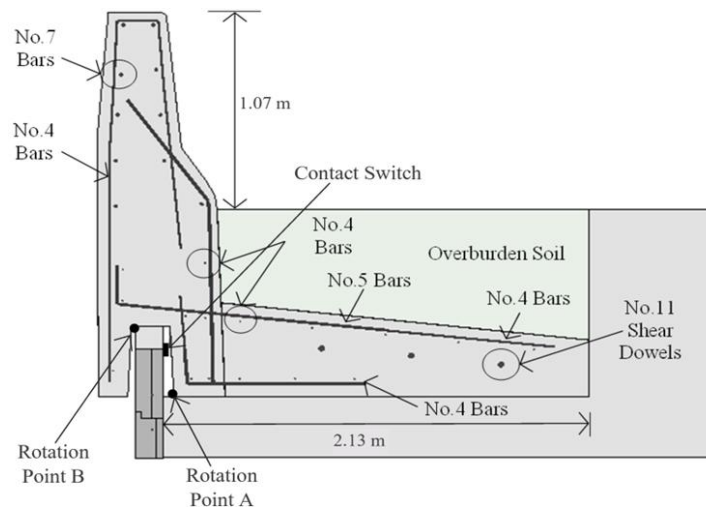
**Figure 9.** The TL5 barrier and moment slab as placed on the MSE wall.

3. The point of rotation of the barrier can be point A or B, as shown in Figure 9. Point A should be selected for overturning design if the top of the wall panel is not in contact with the coping. Point B should be used if there is direct bearing between the bottom of the coping and the top of the wall panel or level-up concrete.

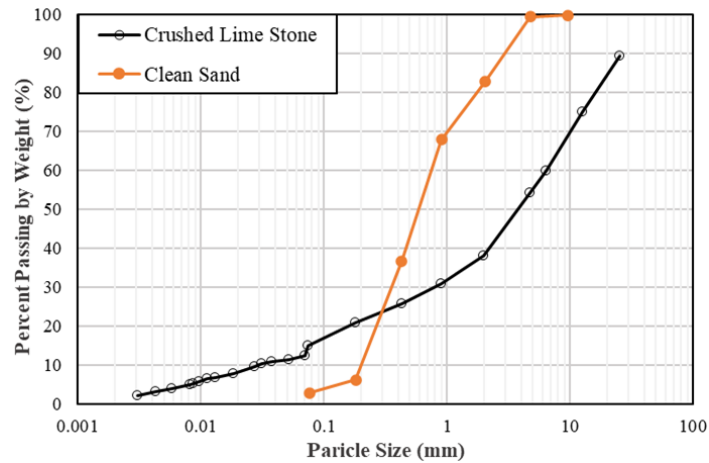
**Figure 10.** Particle size distribution curves for the clean sand and the crushed limestone rock.

The backfill consisted of two soils: the clean sand used to build the wall from the bottom of the excavation to the bottom of the moment slab (1.98 m), and the crushed limestone from the bottom of the moment slab to the pavement surface (1.02 m). The clean sand was a poorly graded sand (SP) with a  $D_{50}$  of 0.51 mm, a coefficient of uniformity of 3.85, a coefficient of curvature of 0.84, and 3.1% passing sieve No. 200 (Figure 10a). The modulus of the sand was 14.8 MPa as measured with the BCD (Briaud et al., 2006), and the direct shear test friction angle was 34 degrees. The crushed limestone rock (also called road base) was a silty gravel with a  $D_{50}$  of 4 mm, a coefficient of uniformity of 216.7, a coefficient of curvature of 3.28, and 15.0 % passing sieve No. 200 (Figure 10b). The modulus of the crushed limestone was 55.2 MPa as measured with the BCD, and a large triaxial cell test gave a friction angle of 45 degrees. The sand was compacted in 150 mm thick lifts to a dry density of 17.4 kN/m<sup>3</sup> (95% of maximum dry density) and 3.03% water content, while the crushed limestone was compacted in lifts of 250 mm to a dry density of 20.1 kN/m<sup>3</sup> (95% of maximum dry density) and 5.81% water content.

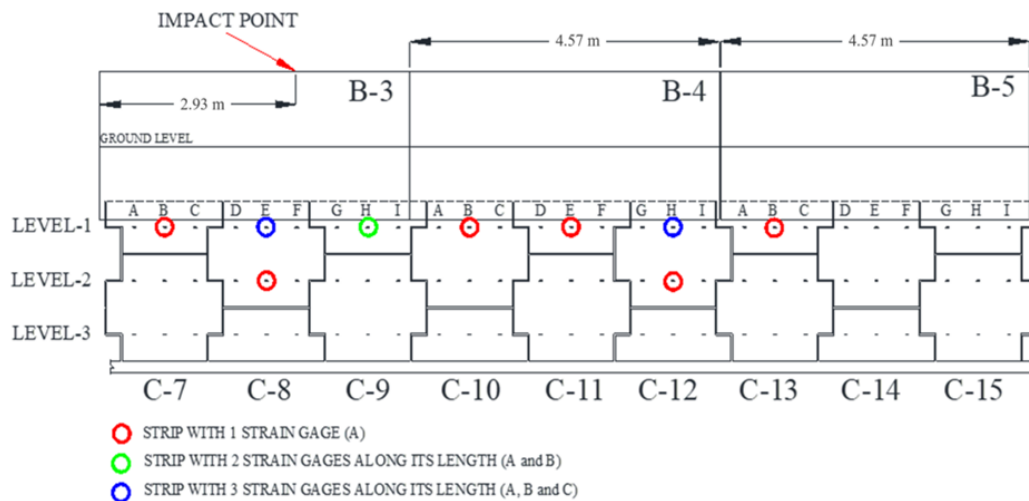
**Figure 11.** Location of the instrumented reinforcing strips.

The location of the MSE wall reinforcing strips that were instrumented is shown in Figure 11. The total load in a strip in this project is defined as the addition of the static load due to the internal stability of the wall under gravity active pressure and the dynamic load induced by the truck impact. The load in the strips was measured 0.178 m behind the strip connection to the panel, and the dynamic load vs. time is shown in Figure 13. The maximum dynamic component of the loads in the strips is listed in Table 1 and the total load in Table 2. The dynamic load in the strips was maximum near the strip-to-panel connection point. As can be seen, the measured static loads are close to those calculated by AASHTO. The sum of the dynamic load and the static load is defined as the total load in the first layer of strips; the total load reaches the calculated ultimate resistance of the strip closest to the impact.

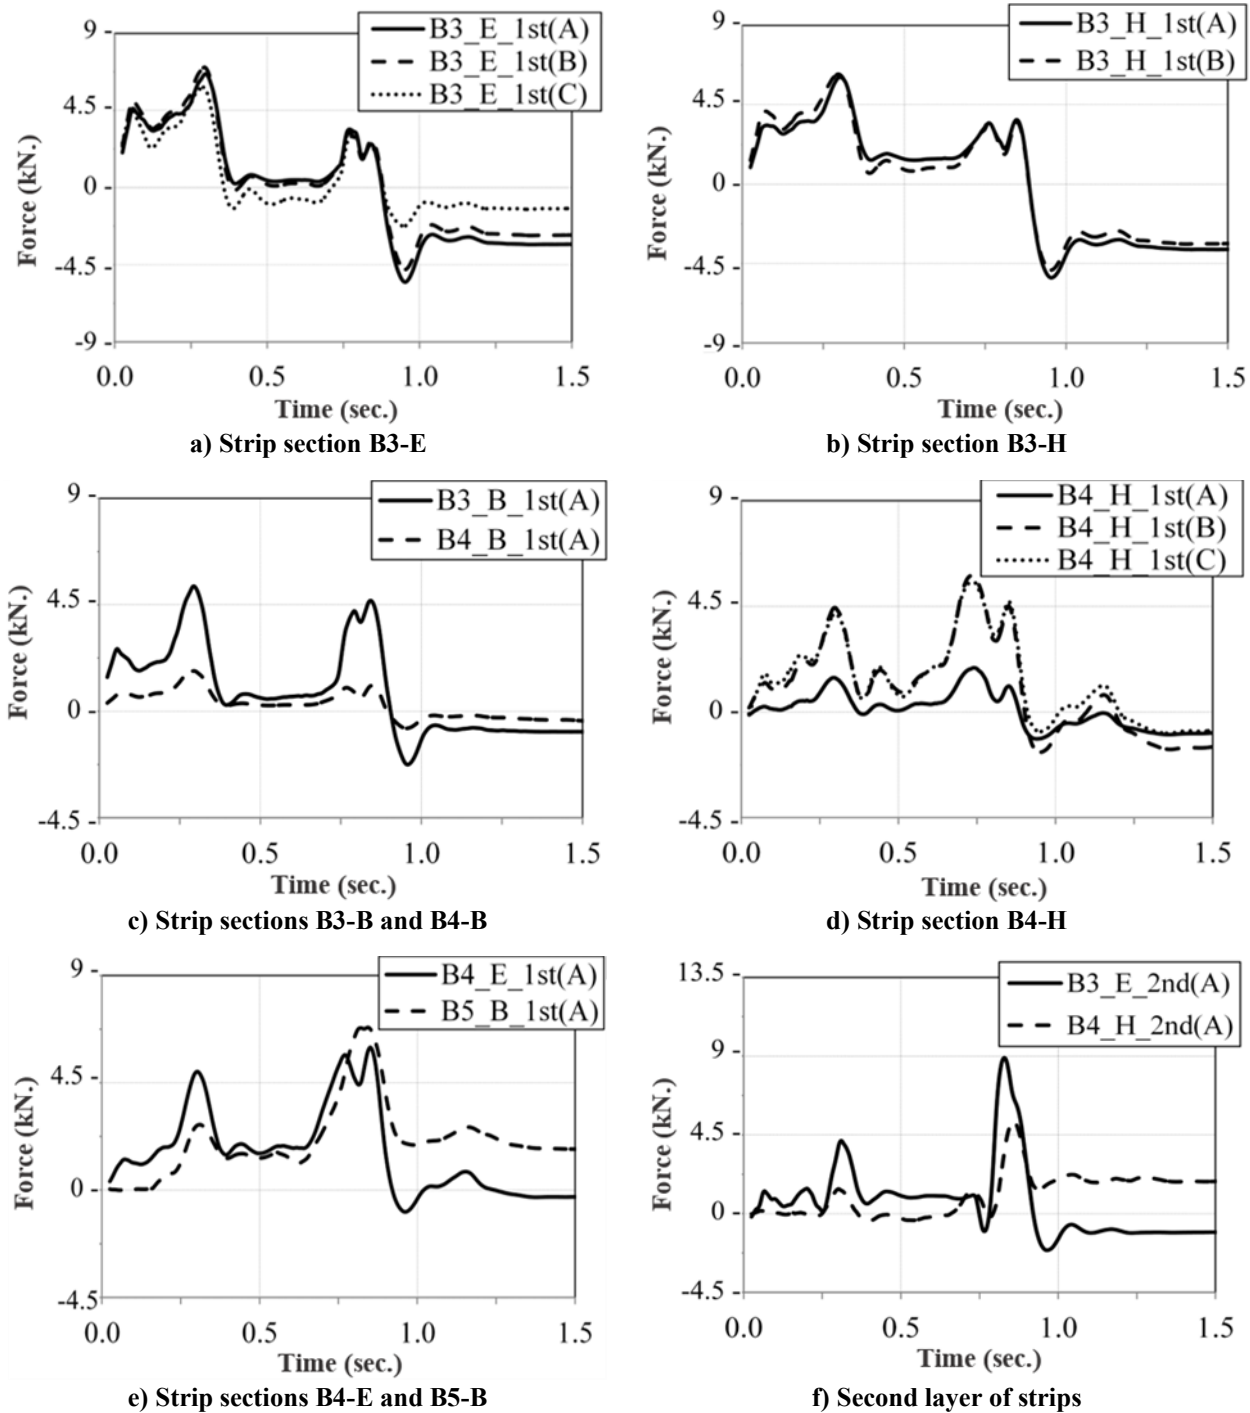
**Figure 13.** Dynamic load in the wall reinforcing strips during the impact (50 msec average): (a) strip section B3-E, (b) strip section B3-H, (c) strip sections B3-B and B4-B, (d) strip section B4-H, (e) strip sections B4-E and B5-B, and (f) second layer of strips.

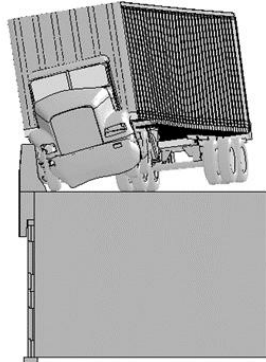
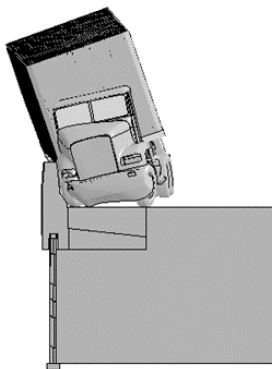
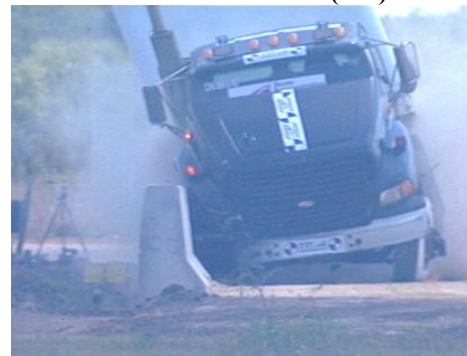
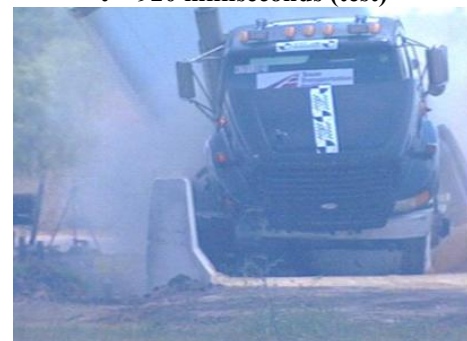
**Figure 14.** Comparison between simulation and test of sequential views of the impact.

Qualitatively, the sequential views of the impact from the simulation and the test compare well, as seen in Figure 14. Quantitatively, the acceleration results were closer for the rear axle of the trailer, which corresponds to the highest load in the impact than for the rear axle of the tractor. Indeed, for the trailer, the longitudinal and lateral accelerations were -2.7 g's and -11.6 g's for the model, and -3.4 g's and -10.8 g's for the test; for the tractor, they were -2.1 g's and -5.3 g's for the longitudinal

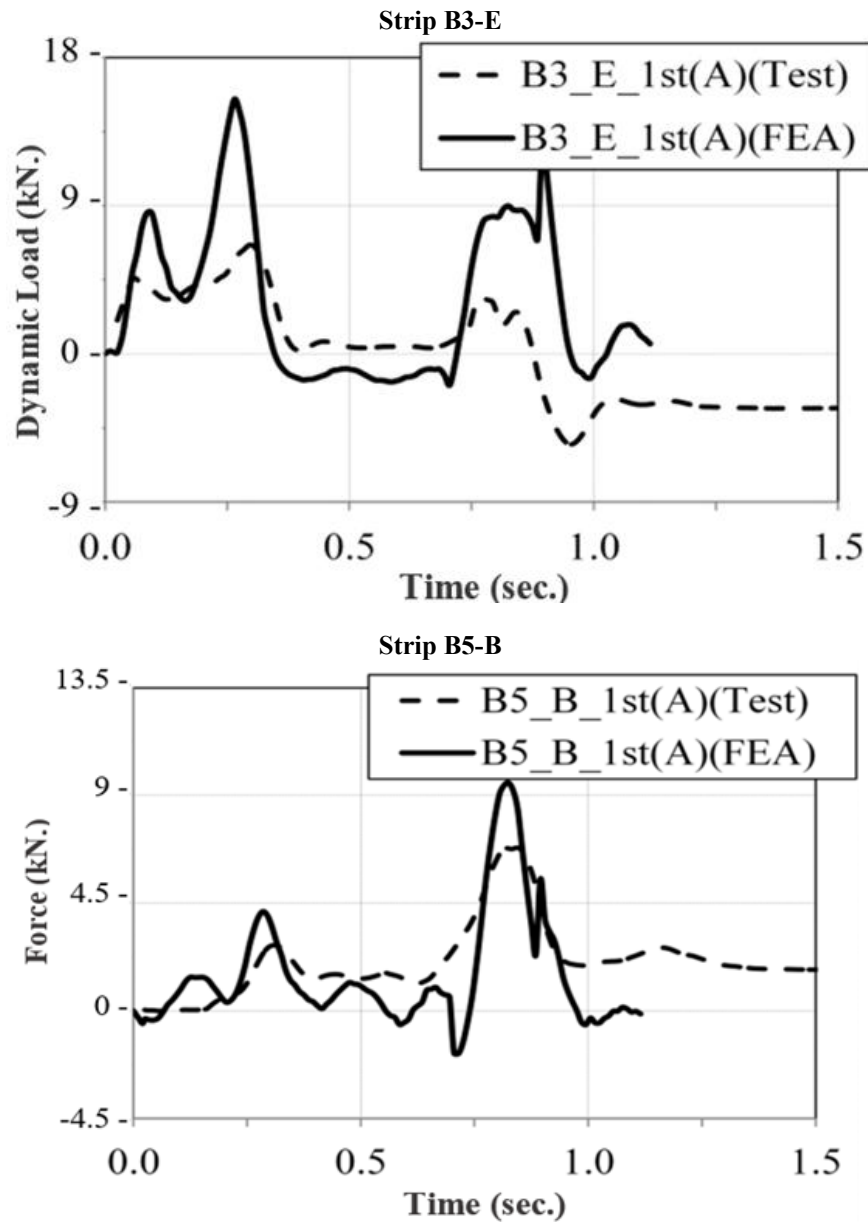
**Figure 15.** Comparison of the dynamic component of the strips' loads in the uppermost layer of soil reinforcement.

and lateral acceleration in the model, and -1.4 g's and -4.4 g's for the test. These acceleration values are 50 msec averages. The simulation predicted reasonably well the permanent displacement of the barrier, as shown in Table 3. The dynamic displacements of the wall panels during the test could not be measured due to problems in the instrumentation. The measured lateral permanent deflections of the wall panels after the test ranged from 0.25 mm to 13.72 mm. The dynamic and permanent deflection determined from the simulation ranged from 0.25 mm to 14.73 mm and from 0.25 mm to 7.11 mm, respectively. The simulation under-predicted the permanent displacement in some wall panels but predicted others reasonably well. In addition, the simulation predicted high bending stresses of the panels located underneath the impact point and, after the test, hairline cracks were observed at those locations. The simulation overpredicted the tension load in the top strips near the point of impact but did better at other locations (Figure 15), particularly in the second row of strips.

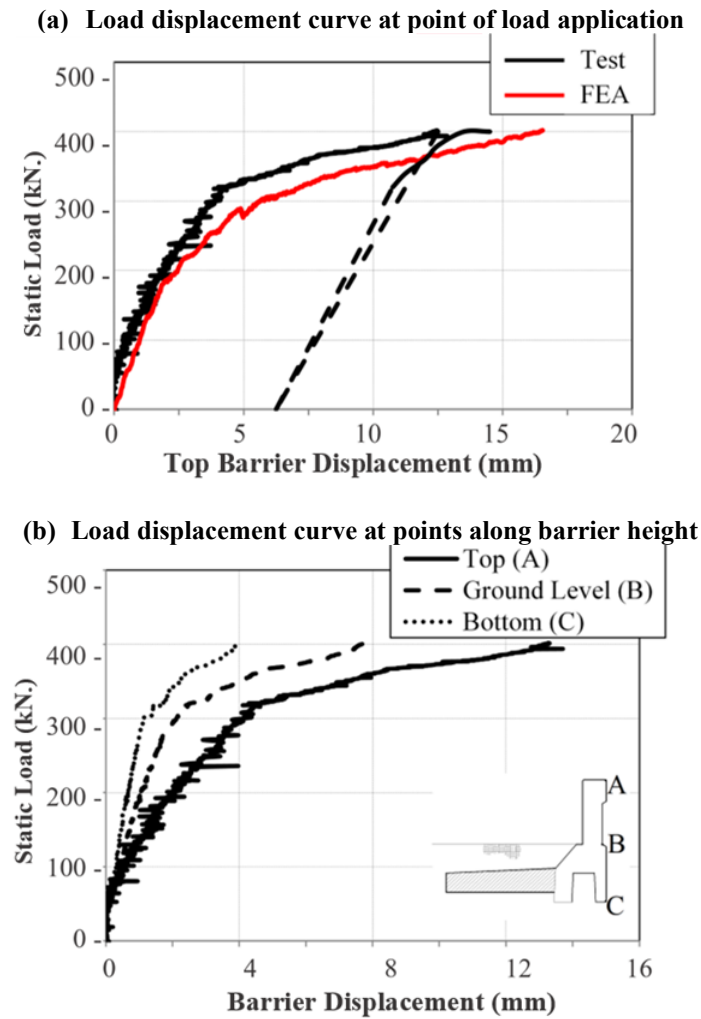
**Figure 17.** Horizontal load vs. horizontal displacement of the barrier: measurements and simulation: (a) load displacement curve at point of load application, and (b) load displacement curve at points along barrier height.

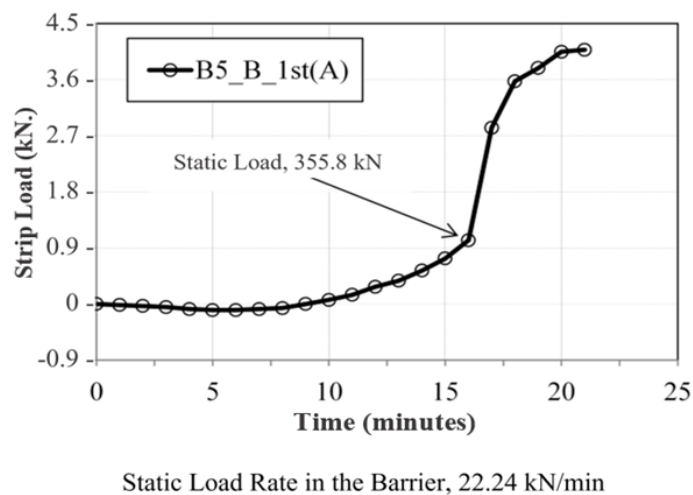
**Figure 18.** Load in top strip below barrier loading point.

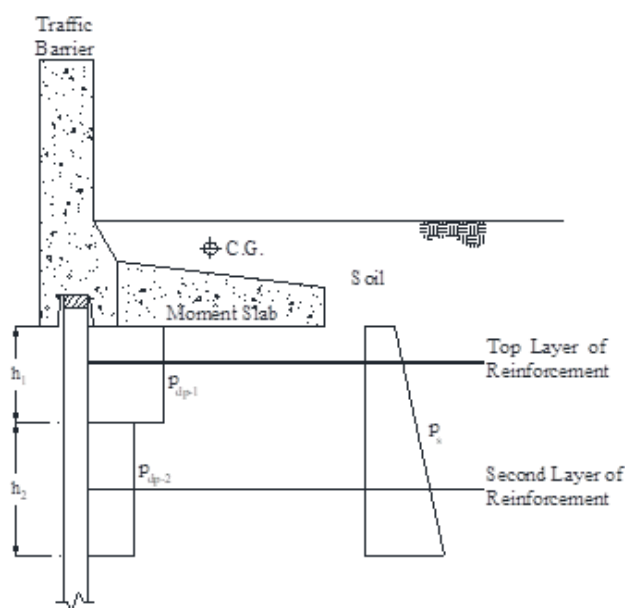
**Figure 19.** Pressure diagram for static and dynamic components to design MSE wall strips for TL5 impact loading.

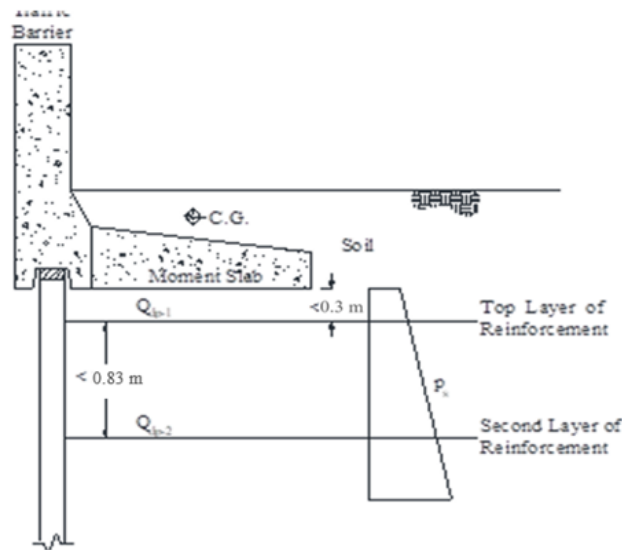
**Figure 20.** Line load diagram for static and dynamic components to design MSE wall strips for TL5 impact loading.
