MSE Wall Behavior during Large Truck Impact at High Speed against Barrier on Top of Wall

KEYWORDS: MSE wall, pullout load, crash test, barrier, TL5, numerical simulation, measured behavior, full-scale test

Reference: Briaud J.-L., Bligh R., and Maddah L. (2024). *MSE Wall Behavior during Large Truck Impact at High Speed against Barrier on Top of Wall*. International Journal of Geoengineering Case Histories, Vol. 8, Issue 1, p.1-24. doi: 10.4417/IJGCH-08-01-01

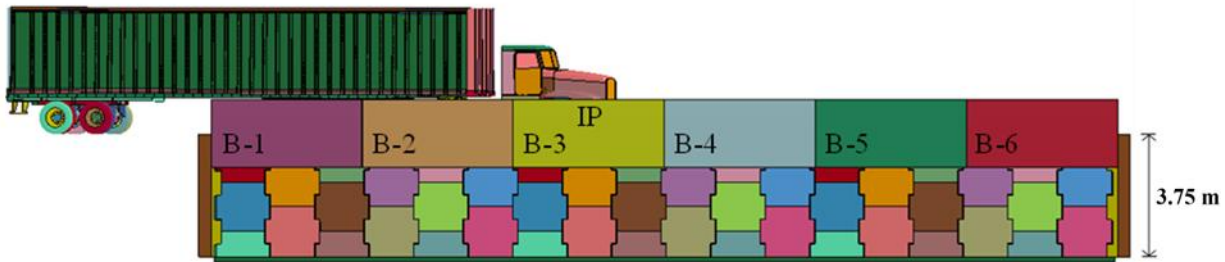
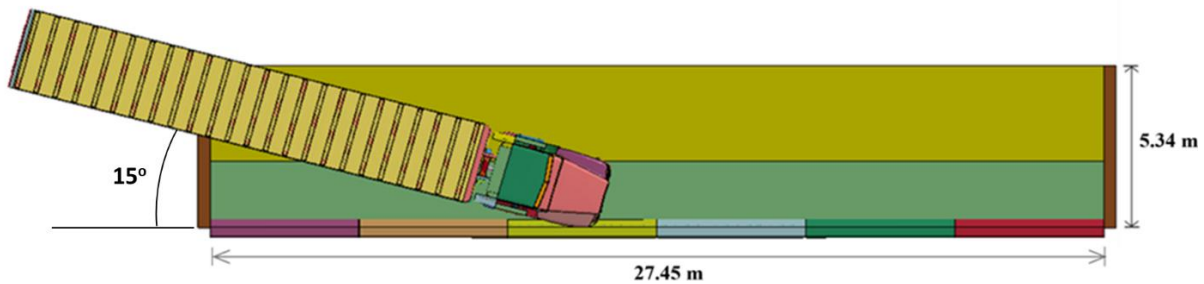
(a) Cross section of barrier-moment slab-MSE wall assembly with truck.

(b) Front view of the barrier-moment slab-MSE wall assembly with truck.

(c) Plan view of the barrier-moment slab-MSE wall assembly with truck.

Figure 1. Finite element mesh for simulation of barrier-moment slab-MSE wall assembly with truck: (a) cross section of barrier-moment slab-MSE wall assembly with truck, (b) front view of the barrier-moment slab-MSE wall assembly with truck, and (c) plan view of the barrier-moment slab-MSE wall assembly with truck.

The software used for the simulations was LS-DYNA (Hallquist, 2007). The Finite Element Method (FEM) models included the tractor-trailer truck, the L shape barrier and moment slab, and the MSE wall with soil and reinforcement strips (Figure 1).

The dimensions of the model (Figure 1) were 27.45 m in length, 3.75 m in height, and 5.34 m in width. The barrier height from the pavement surface to the top of the barrier was 1.07 m and the width of the moment slab was varied but finally chosen as 2.13 m, measured from the back of the MSE wall panel to the end of the moment slab. The bottom of the moment slab was 1.02 m deep below the pavement surface, and the length of the reinforcement strips was 3.05 m. Referring to Figure 1, the boundary conditions were as follows: all boundaries were free of any constraints except for the vertical boundary at the back of the wall, at the bottom of the wall and on the side-ends of the wall.

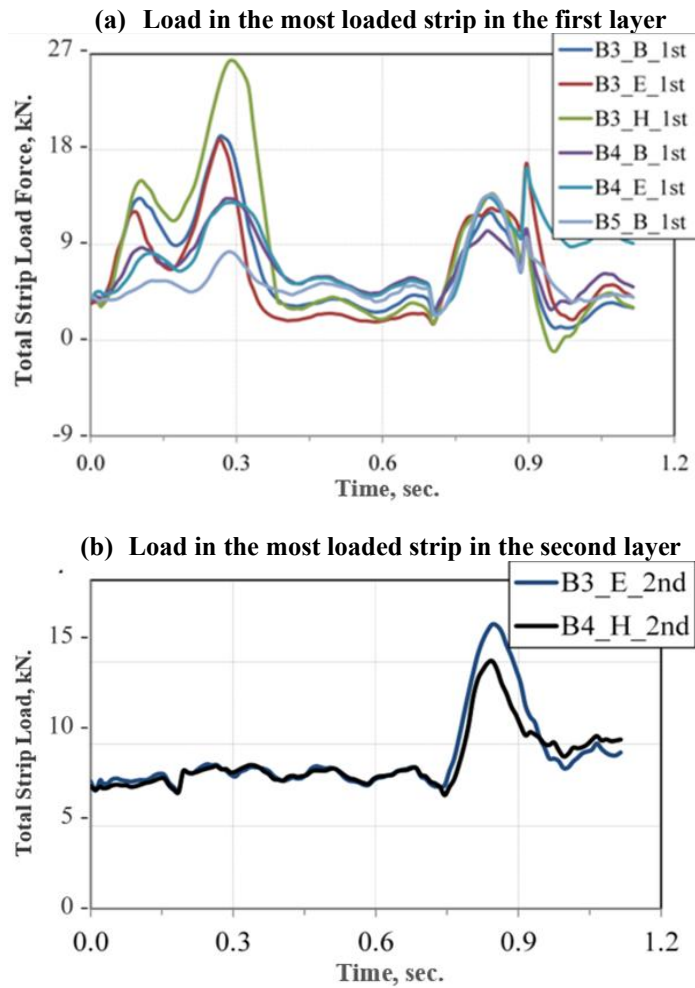
Figure 6. Total load in the most loaded strip for the first and second rows of strips in FEM simulation: (a) load in the most loaded strip in the first layer, and (b) load in the most loaded strip in the second layer.

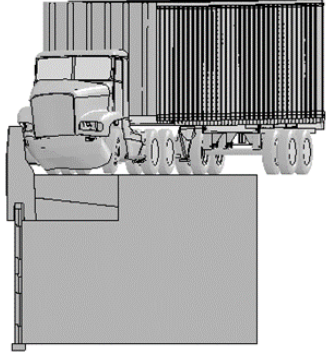
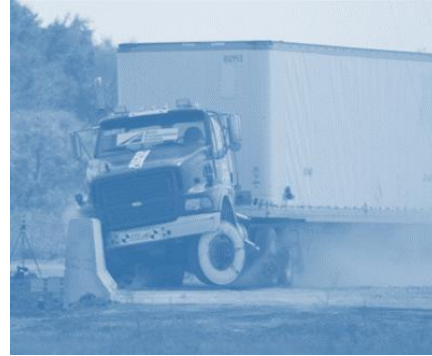
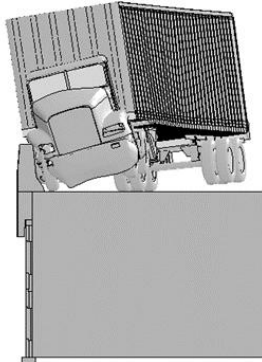
Figure 14. Comparison between simulation and test of sequential views of the impact.

Qualitatively, the sequential views of the impact from the simulation and the test compare well, as seen in Figure 14. Quantitatively, the acceleration results were closer for the rear axle of the trailer, which corresponds to the highest load in the impact than for the rear axle of the tractor. Indeed, for the trailer, the longitudinal and lateral accelerations were -2.7 g's and -11.6 g's for the model, and -3.4 g's and -10.8 g's for the test; for the tractor, they were -2.1 g's and -5.3 g's for the longitudinal

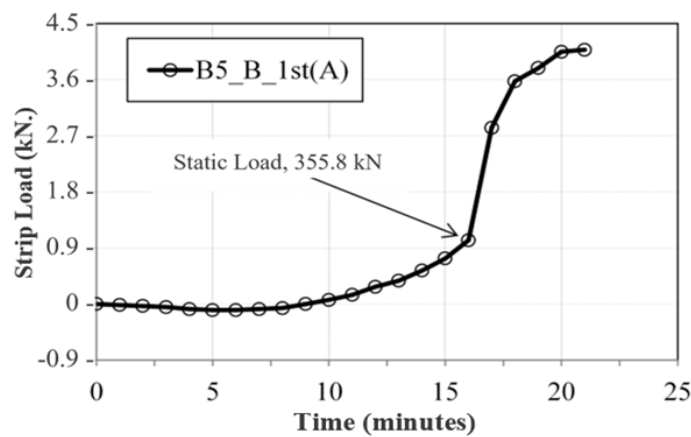
Static Load Rate in the Barrier, 22.24 kN/min

Figure 18. Load in top strip below barrier loading point.
