# MSE Wall Behavior during Large Truck Impact at High Speed against Barrier on Top of Wall

**Reference:** Briaud J.-L., Bligh R., and Maddah L. (2024). *MSE Wall Behavior during Large Truck Impact at High Speed against Barrier on Top of Wall*. International Journal of Geoengineering Case Histories, Vol. 8, Issue 1, p.1-24. doi: 10.4417/IJGCH-08-01-01

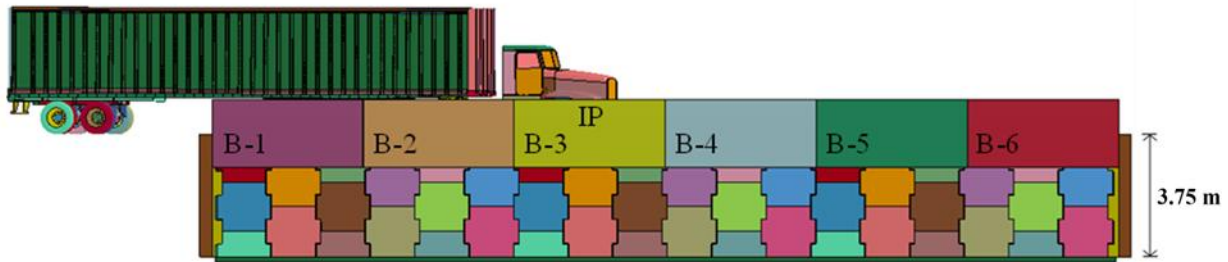
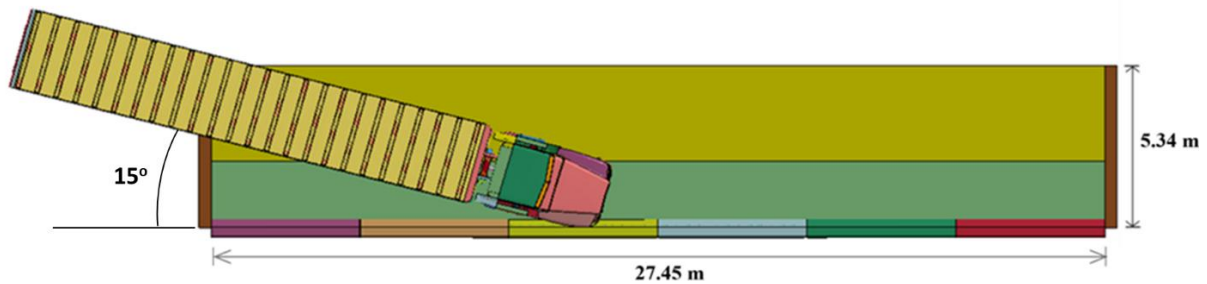
(a) Cross section of barrier-moment slab-MSE wall assembly with truck.

(b) Front view of the barrier-moment slab-MSE wall assembly with truck.

(c) Plan view of the barrier-moment slab-MSE wall assembly with truck.

**Figure 1.** Finite element mesh for simulation of barrier-moment slab-MSE wall assembly with truck: (a) cross section of barrier-moment slab-MSE wall assembly with truck, (b) front view of the barrier-moment slab-MSE wall assembly with truck, and (c) plan view of the barrier-moment slab-MSE wall assembly with truck.

The software used for the simulations was LS-DYNA (Hallquist, 2007). The Finite Element Method (FEM) models included the tractor-trailer truck, the L shape barrier and moment slab, and the MSE wall with soil and reinforcement strips (Figure 1).

The dimensions of the model (Figure 1) were 27.45 m in length, 3.75 m in height, and 5.34 m in width. The barrier height from the pavement surface to the top of the barrier was 1.07 m and the width of the moment slab was varied but finally chosen as 2.13 m, measured from the back of the MSE wall panel to the end of the moment slab. The bottom of the moment slab was 1.02 m deep below the pavement surface, and the length of the reinforcement strips was 3.05 m. Referring to Figure 1, the boundary conditions were as follows: all boundaries were free of any constraints except for the vertical boundary at the back of the wall, at the bottom of the wall and on the side-ends of the wall.
