# MSE Wall Behavior during Large Truck Impact at High Speed against Barrier on Top of Wall

**Reference:** Briaud J.-L., Bligh R., and Maddah L. (2024). *MSE Wall Behavior during Large Truck Impact at High Speed against Barrier on Top of Wall*. International Journal of Geoengineering Case Histories, Vol. 8, Issue 1, p.1-24. doi: 10.4417/IJGCH-08-01-01

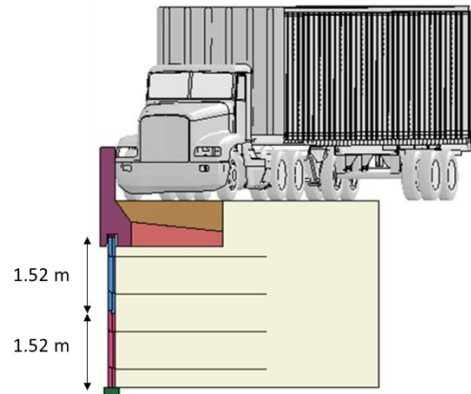
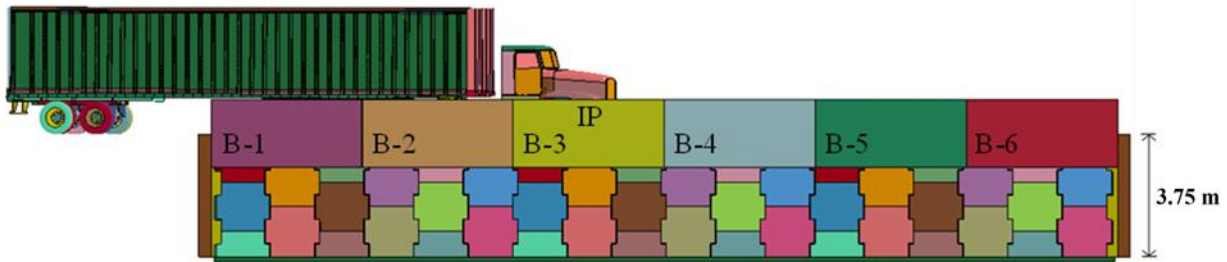
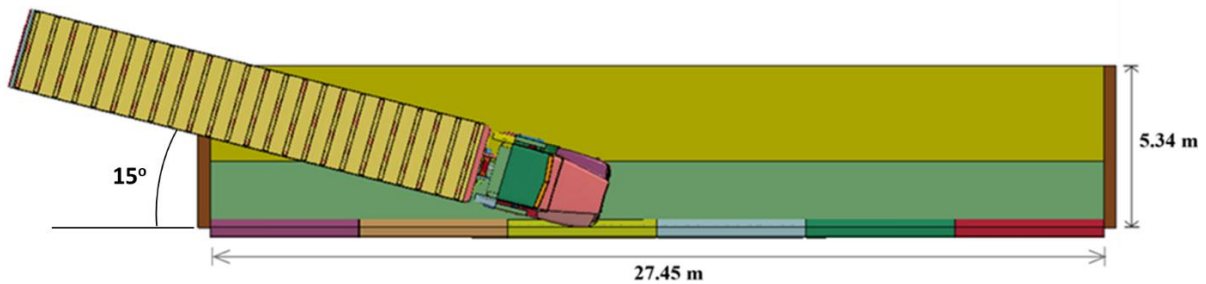
(a) Cross section of barrier-moment slab-MSE wall assembly with truck.

(b) Front view of the barrier-moment slab-MSE wall assembly with truck.

(c) Plan view of the barrier-moment slab-MSE wall assembly with truck.

**Figure 1.** Finite element mesh for simulation of barrier-moment slab-MSE wall assembly with truck: (a) cross section of barrier-moment slab-MSE wall assembly with truck, (b) front view of the barrier-moment slab-MSE wall assembly with truck, and (c) plan view of the barrier-moment slab-MSE wall assembly with truck.

The software used for the simulations was LS-DYNA (Hallquist, 2007). The Finite Element Method (FEM) models included the tractor-trailer truck, the L shape barrier and moment slab, and the MSE wall with soil and reinforcement strips (Figure 1).

The dimensions of the model (Figure 1) were 27.45 m in length, 3.75 m in height, and 5.34 m in width. The barrier height from the pavement surface to the top of the barrier was 1.07 m and the width of the moment slab was varied but finally chosen as 2.13 m, measured from the back of the MSE wall panel to the end of the moment slab. The bottom of the moment slab was 1.02 m deep below the pavement surface, and the length of the reinforcement strips was 3.05 m. Referring to Figure 1, the boundary conditions were as follows: all boundaries were free of any constraints except for the vertical boundary at the back of the wall, at the bottom of the wall and on the side-ends of the wall.

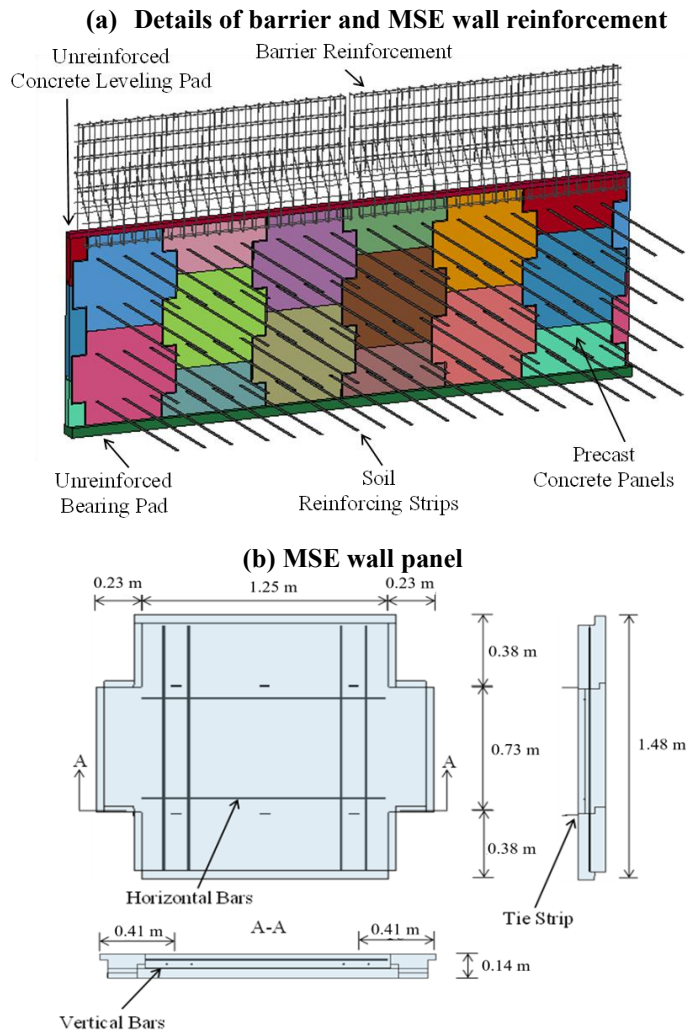
**Figure 2.** Barrier-moment slab and MSE wall model: (a) details of barrier and MSE wall reinforcement, and (b) MSE wall panel.

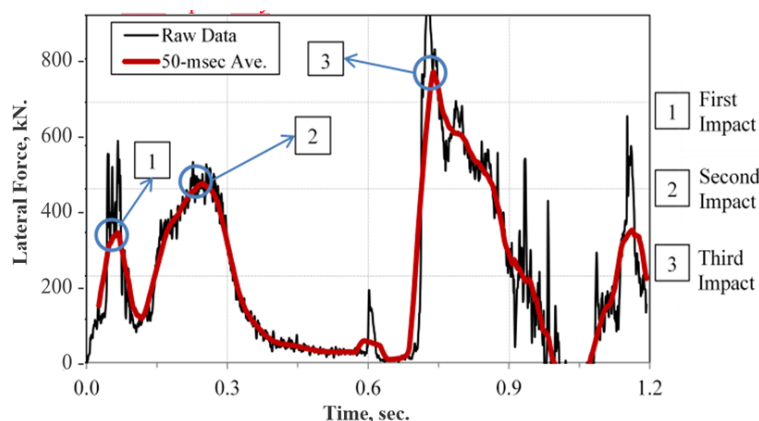
**Figure 3.** Horizontal impact force as a function of time in FEM simulation.

The impact horizontal force on the barrier as a function of time is shown in Figure 3. Two lines can be seen: one shows rapid variations in the load which is the actual measured response, and the other shows a smoother variation. The smoother line corresponds to the 50-millisecond average of the signal, which is common practice in roadside safety data analysis. The 50-ms signal identifies three distinct impacts associated with the front axle of the tractor at a peak dynamic force of 332 kN, the rear axle of the tractor (458.8 kN), and the rear axle of the trailer also known as the back slap (744.9 kN). Figure 4 shows the displacement at the top and at the bottom of the barrier. The main part of the impact lasted one second.

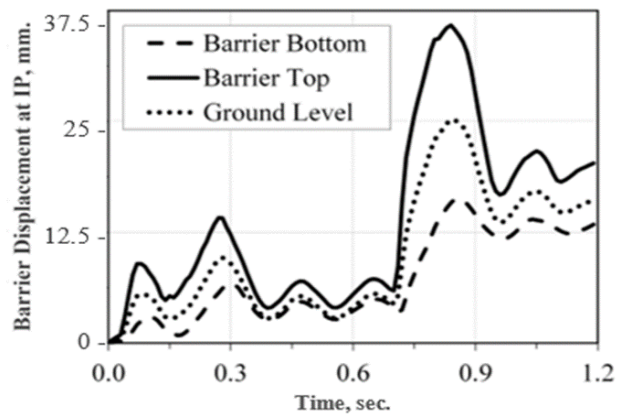
**Figure 4.** Barrier displacement during impact in FEM simulation.

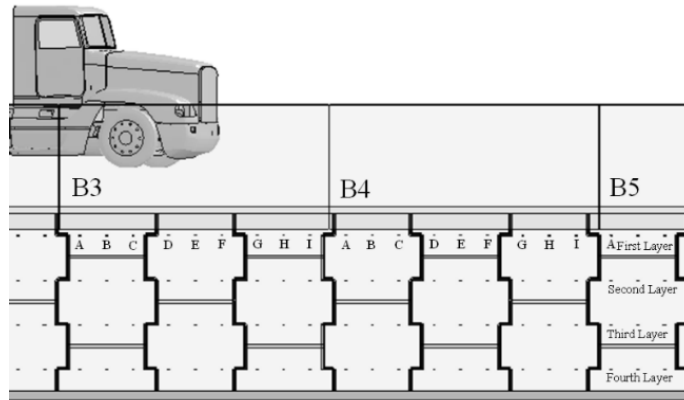
**Figure 5.** Reference designation for the strips in the wall.

The total load in the MSE wall strips is the addition of the static load due to the earth pressure in the wall and the dynamic load due to the TL5 impact. The designation of the strips in the wall is given in Figure 5. For example, B3\_B\_1<sup>st</sup> refers to barrier segment B3, strip B in the first layer of strips. The top or first layer of strips is the one that is most severely influenced by the dynamic impact. The total load in the most heavily loaded individual strip in the first layer of strips during the impact and the dynamic component are shown in Figure 6a. The peak total load is 26.03 kN with a peak dynamic component of 22.02 kN. In the second layer of strips (Figure 6b), the corresponding peak total load and peak dynamic load were 15.4 and 8.5 kN respectively. The calculated maximum pullout resistance of the strips according to AASHTO LRFD (2014) was 10.14 kN for strips in the first layer and 15.57 kN for strips in the second layer. Therefore, according to the numerical simulation, the reinforcing strips of the first layer reached pull-out failure during the impact. The pull-out displacement of the strips is shown in Figure 7 and indicates a maximum displacement of 10 mm. Laboratory tests conducted on strips in a pressurized sand box showed displacements to failure of about 5 mm. This is consistent with the numerical simulations indicating that the reinforcement strips were at failure during the impact. The dynamic and permanent displacement of the wall panels are shown in Figure 8; the permanent displacement of the panels is limited to 7 mm, indicating that the wall could likely be reused without repair.

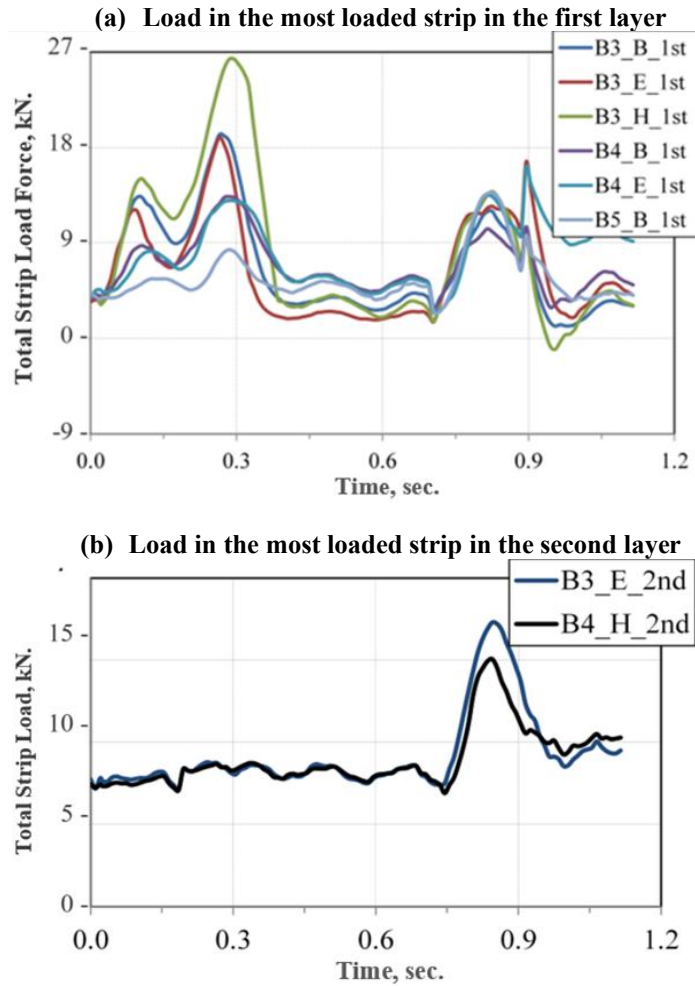
**Figure 6.** Total load in the most loaded strip for the first and second rows of strips in FEM simulation: (a) load in the most loaded strip in the first layer, and (b) load in the most loaded strip in the second layer.

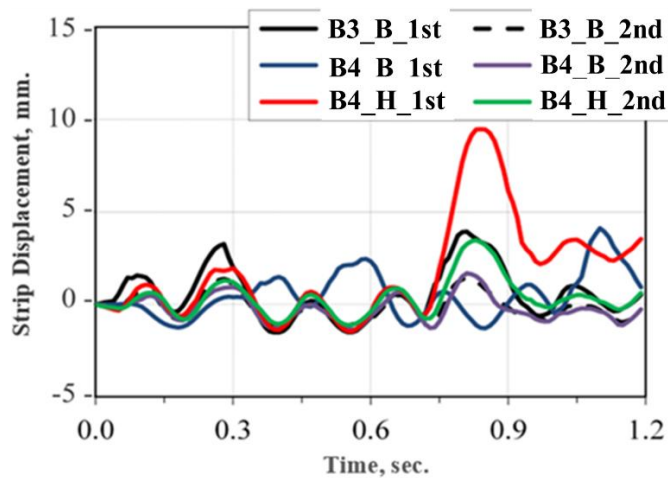
**Figure 7.** Displacement of the reinforcing strips (first level and second level) in FEM simulation.

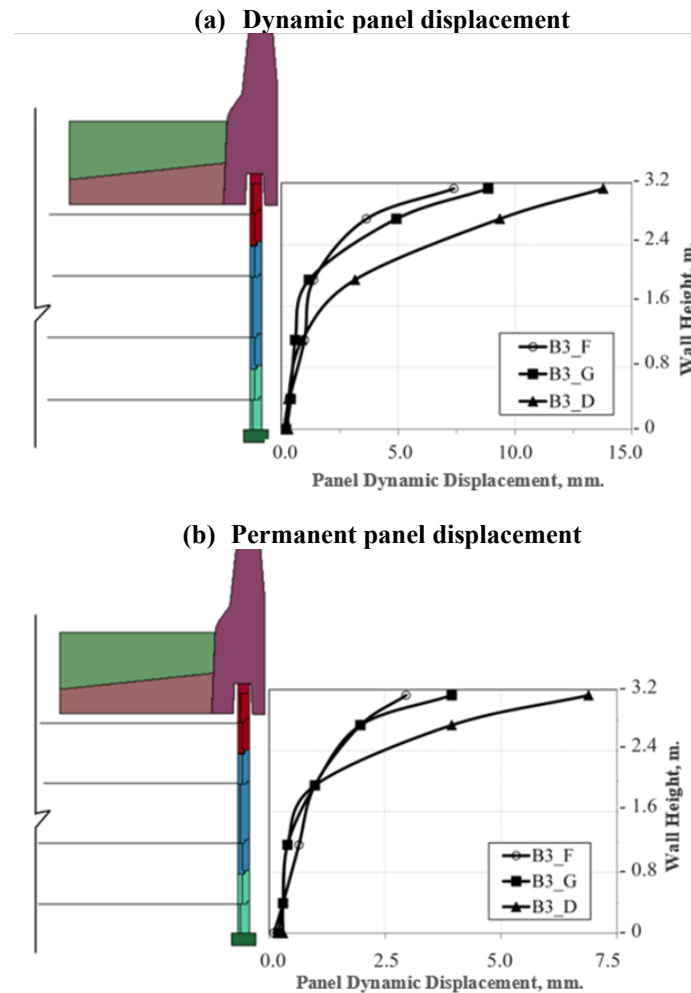
**Figure 8.** Displacement of the MSE wall panel in FEM simulation: (a) dynamic panel displacement, and (b) permanent panel displacement.

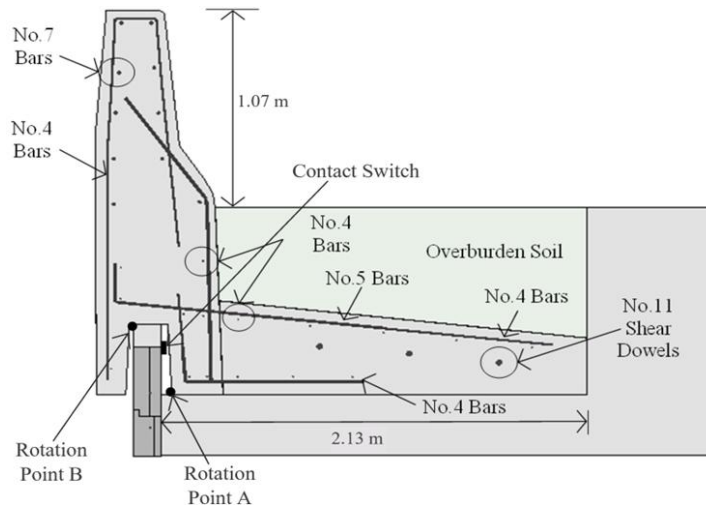
**Figure 9.** The TL5 barrier and moment slab as placed on the MSE wall.

3. The point of rotation of the barrier can be point A or B, as shown in Figure 9. Point A should be selected for overturning design if the top of the wall panel is not in contact with the coping. Point B should be used if there is direct bearing between the bottom of the coping and the top of the wall panel or level-up concrete.

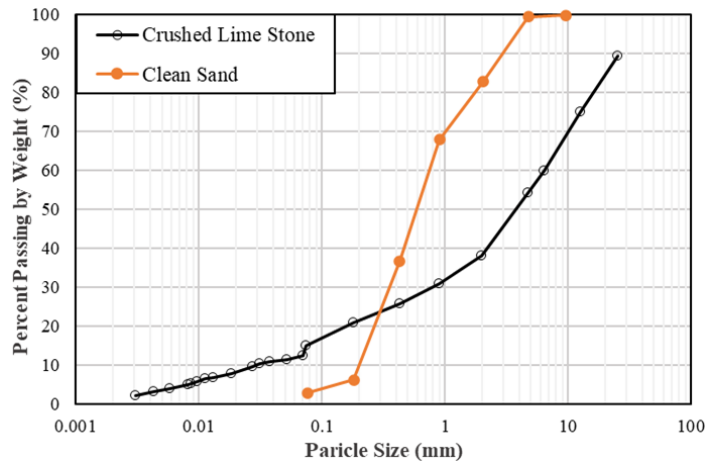
**Figure 10.** Particle size distribution curves for the clean sand and the crushed limestone rock.

The backfill consisted of two soils: the clean sand used to build the wall from the bottom of the excavation to the bottom of the moment slab (1.98 m), and the crushed limestone from the bottom of the moment slab to the pavement surface (1.02 m). The clean sand was a poorly graded sand (SP) with a  $D_{50}$  of 0.51 mm, a coefficient of uniformity of 3.85, a coefficient of curvature of 0.84, and 3.1% passing sieve No. 200 (Figure 10a). The modulus of the sand was 14.8 MPa as measured with the BCD (Briaud et al., 2006), and the direct shear test friction angle was 34 degrees. The crushed limestone rock (also called road base) was a silty gravel with a  $D_{50}$  of 4 mm, a coefficient of uniformity of 216.7, a coefficient of curvature of 3.28, and 15.0 % passing sieve No. 200 (Figure 10b). The modulus of the crushed limestone was 55.2 MPa as measured with the BCD, and a large triaxial cell test gave a friction angle of 45 degrees. The sand was compacted in 150 mm thick lifts to a dry density of  $17.4 \text{ kN/m}^3$  (95% of maximum dry density) and 3.03% water content, while the crushed limestone was compacted in lifts of 250 mm to a dry density of  $20.1 \text{ kN/m}^3$  (95% of maximum dry density) and 5.81% water content.

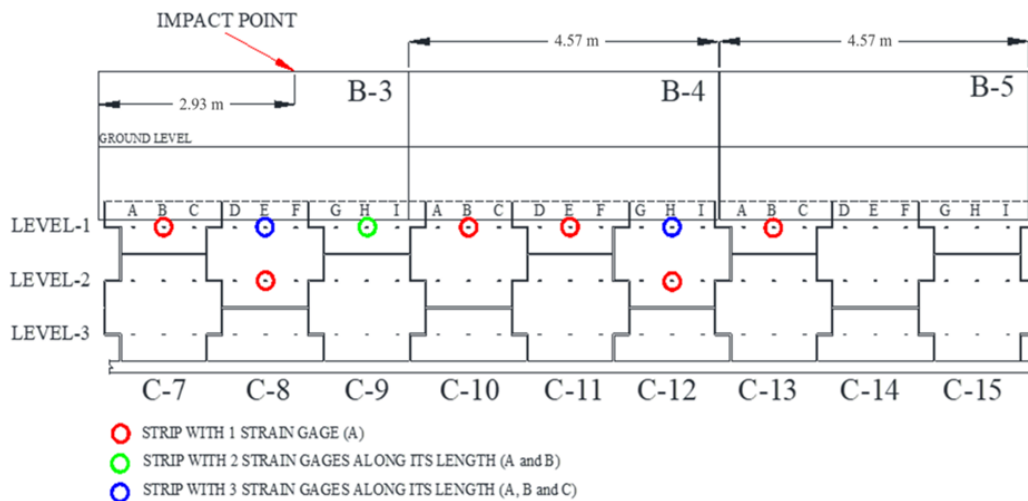
**Figure 11.** Location of the instrumented reinforcing strips.

The location of the MSE wall reinforcing strips that were instrumented is shown in Figure 11. The total load in a strip in this project is defined as the addition of the static load due to the internal stability of the wall under gravity active pressure and the dynamic load induced by the truck impact. The load in the strips was measured 0.178 m behind the strip connection to the panel, and the dynamic load vs. time is shown in Figure 13. The maximum dynamic component of the loads in the strips is listed in Table 1 and the total load in Table 2. The dynamic load in the strips was maximum near the strip-to-panel connection point. As can be seen, the measured static loads are close to those calculated by AASHTO. The sum of the dynamic load and the static load is defined as the total load in the first layer of strips; the total load reaches the calculated ultimate resistance of the strip closest to the impact.

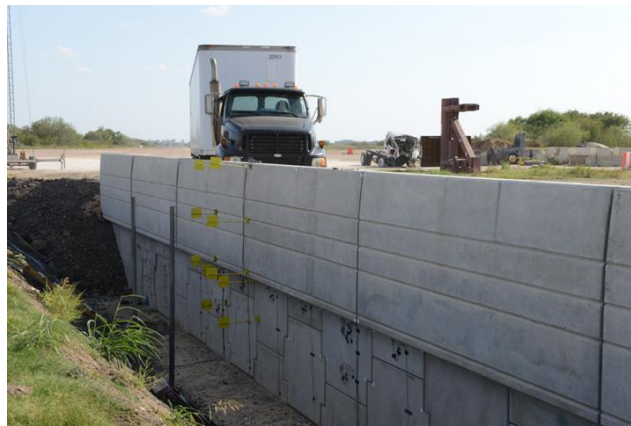
*Figure 12. Test set up just before impact test.*

The TL5 test, also called MASH test 5-12, was conducted on 26 September 2012 under a clear sky and a temperature of 31.7°C (Figure 12). The tractor was a 2000 Sterling TF with a 1997 Stri 14.63 m long trailer. The tractor-trailer assembly weighed 352 kN and hit the barrier at 79.5 kph and at a 15° angle. The vehicle was directed into the test installation under power using a cable guidance system and was released to be free-wheeling and unrestrained just prior to impact. The tractor impacted the barrier 11.28 m from the upstream end of the barrier. At 0.070 sec after impact, the tire of the front axle of the tractor contacted the barrier and the tractor started to redirect. At 0.190 sec, the tire of the rear tandem of the tractor contacted the barrier, and at 0.757 sec the rear axle of the trailer contacted the barrier and created the highest dynamic horizontal load. The tractor-trailer rode off the end of the barrier and came to rest 53.8 m downstream of impact. The brakes on the vehicle were not applied.

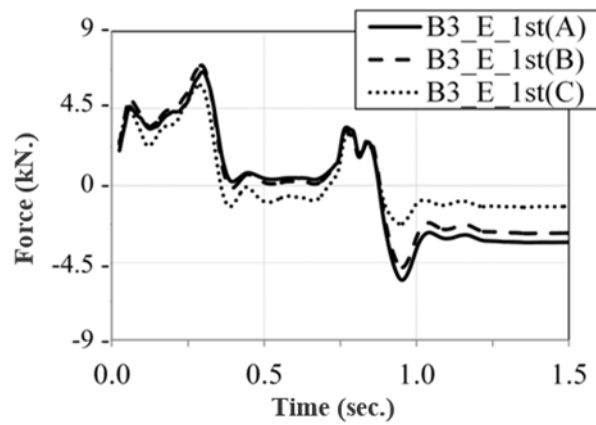
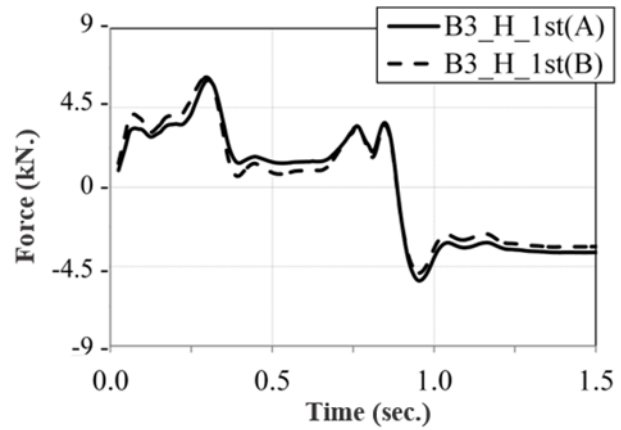
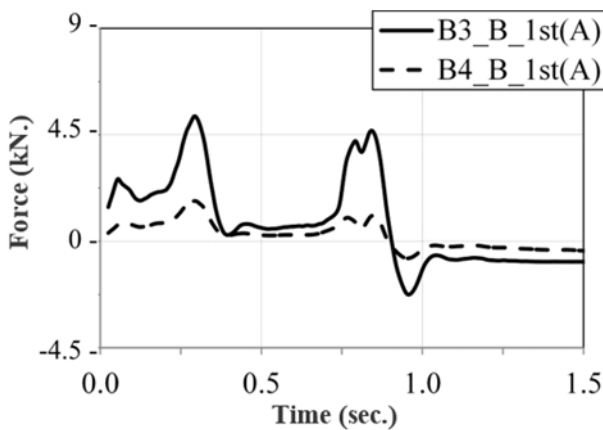
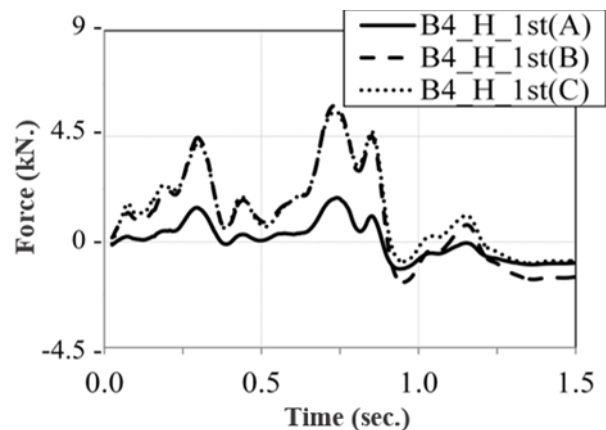
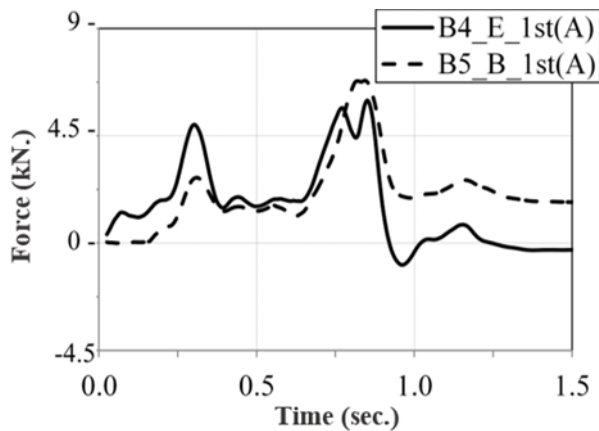
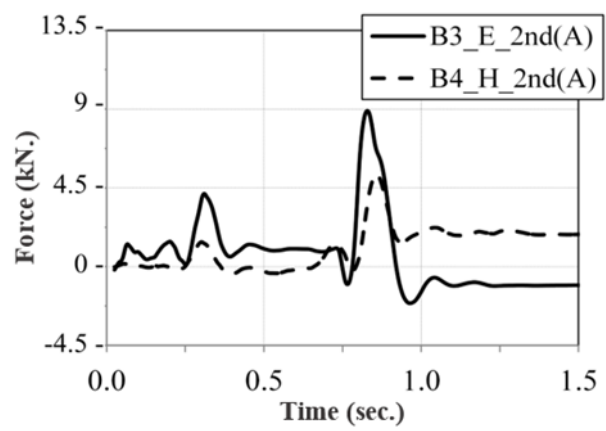
**Figure 13.** Dynamic load in the wall reinforcing strips during the impact (50 msec average): (a) strip section B3-E, (b) strip section B3-H, (c) strip sections B3-B and B4-B, (d) strip section B4-H, (e) strip sections B4-E and B5-B, and (f) second layer of strips.

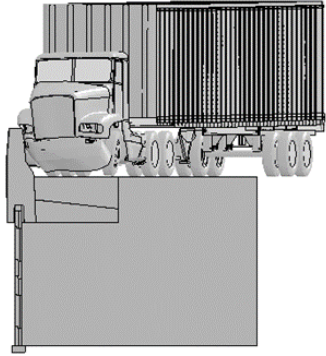
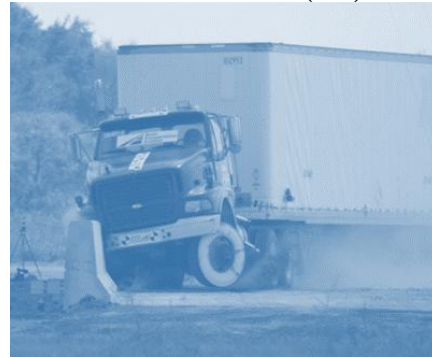
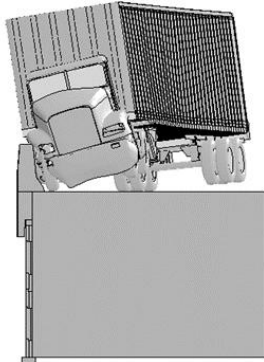
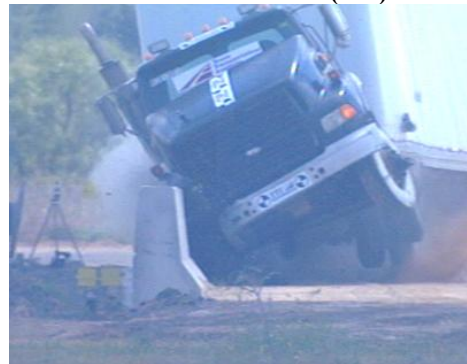
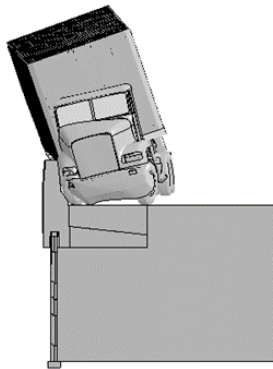
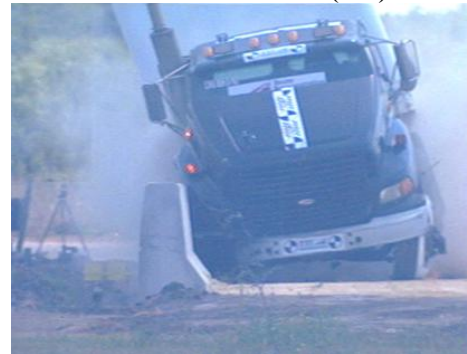
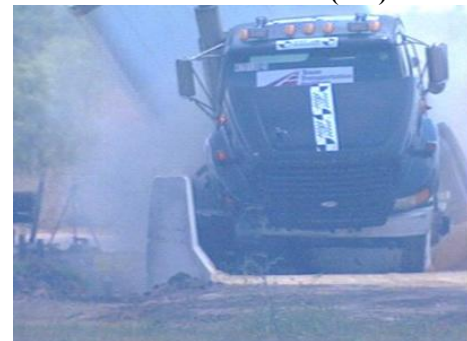
**Figure 14.** Comparison between simulation and test of sequential views of the impact.

Qualitatively, the sequential views of the impact from the simulation and the test compare well, as seen in Figure 14. Quantitatively, the acceleration results were closer for the rear axle of the trailer, which corresponds to the highest load in the impact than for the rear axle of the tractor. Indeed, for the trailer, the longitudinal and lateral accelerations were -2.7 g's and -11.6 g's for the model, and -3.4 g's and -10.8 g's for the test; for the tractor, they were -2.1 g's and -5.3 g's for the longitudinal

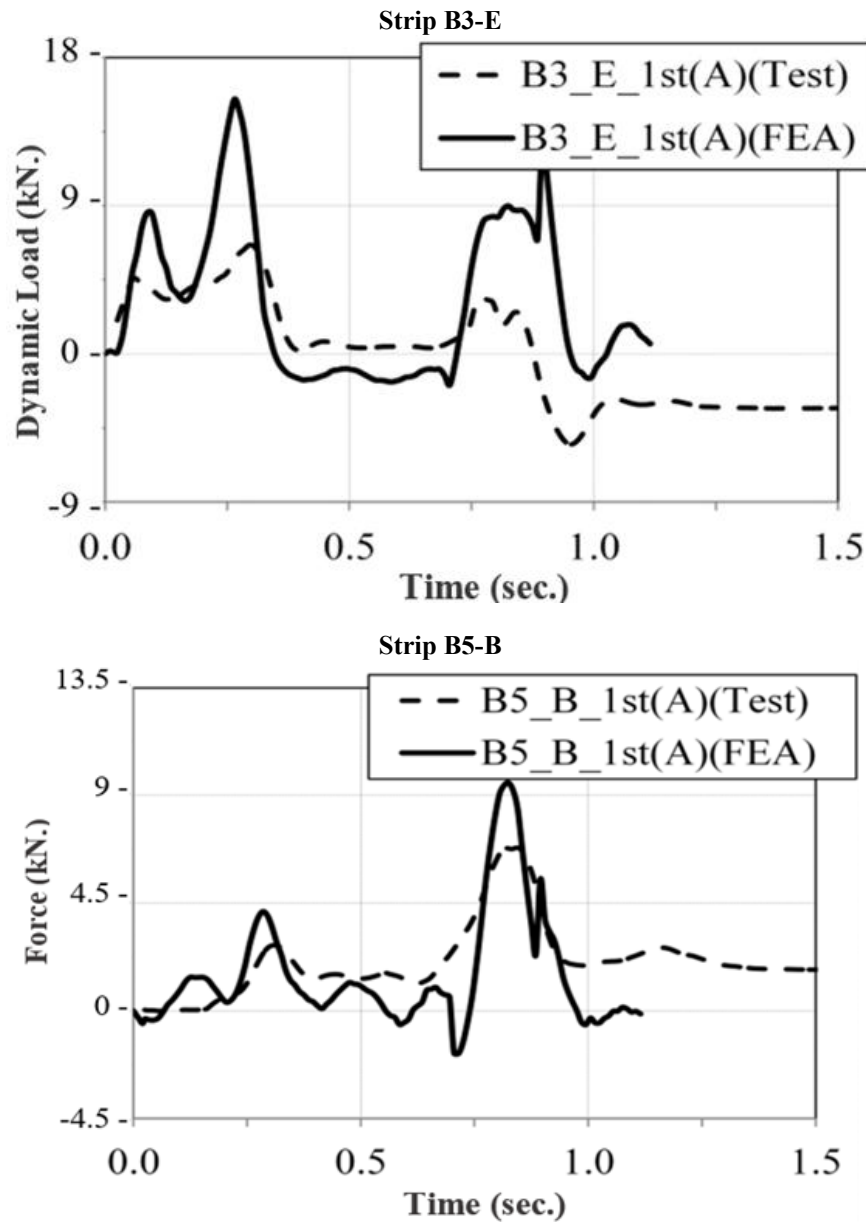
*Figure 15. Comparison of the dynamic component of the strips' loads in the uppermost layer of soil reinforcement.*

and lateral acceleration in the model, and  $-1.4\text{ g}'\text{s}$  and  $-4.4\text{ g}'\text{s}$  for the test. These acceleration values are 50 msec averages. The simulation predicted reasonably well the permanent displacement of the barrier, as shown in Table 3. The dynamic displacements of the wall panels during the test could not be measured due to problems in the instrumentation. The measured lateral permanent deflections of the wall panels after the test ranged from 0.25 mm to 13.72 mm. The dynamic and permanent deflection determined from the simulation ranged from 0.25 mm to 14.73 mm and from 0.25 mm to 7.11 mm, respectively. The simulation under-predicted the permanent displacement in some wall panels but predicted others reasonably well. In addition, the simulation predicted high bending stresses of the panels located underneath the impact point and, after the test, hairline cracks were observed at those locations. The simulation overpredicted the tension load in the top strips near the point of impact but did better at other locations (Figure 15), particularly in the second row of strips.

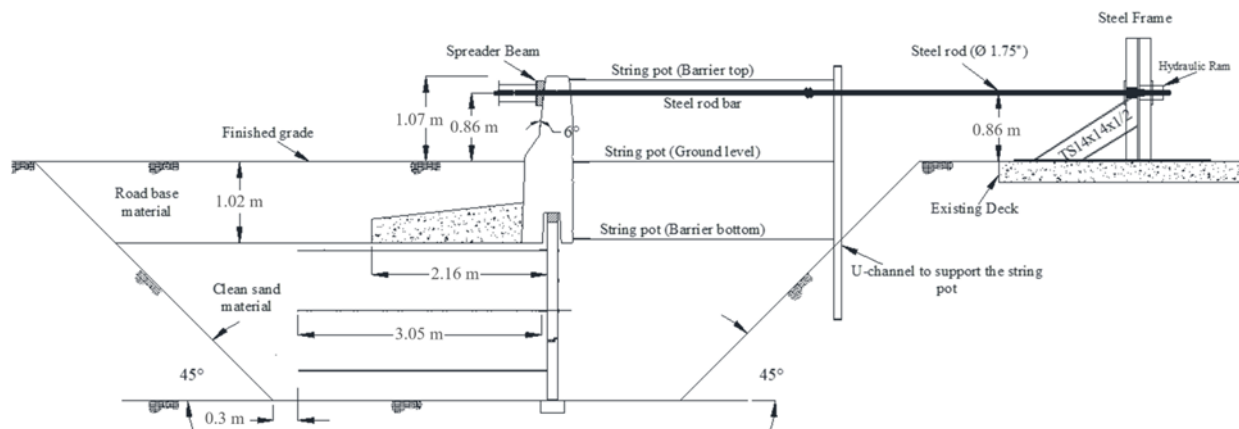
**Figure 16.** Set up for the horizontal static load test on the barrier.

After the full-scale impact test, a horizontal static load test was performed on the barrier moment slab system on top of the MSE wall (Figure 16). The objective was to assess the ultimate horizontal load of the system as an equivalent static load to the maximum horizontal dynamic load in the impact test. The section of barrier selected was one that had received minor loading from the impact of the truck (B5). The horizontal load was applied at a height of 0.864 m through a 3.05 m long spreader bar to engage a 9.15 m length of barrier and a 9.15 m length of moment slab in the load test. The load was applied in 22.25 kN increments lasting one minute each. The horizontal displacement of the top and the bottom of the barrier were recorded, as well as the horizontal displacement of the coping. The horizontal load-horizontal displacement curve for the load test is shown on Figure 17(a) along with the numerical simulation results. Figure 17(b) shows the displacements at different heights of the barrier. During the static load test, the load in the strip right below the loading point (B5\_B\_1<sup>st</sup>(A)) was recorded (Figure 18). The figure indicates that the load started to increase rapidly in the strip when the static load on the barrier exceeded 356 kN, which is assumed to be the point at which sliding of the barrier was prominently engaged. Because the barrier moment slab redirected the truck properly and without major repair needed, the static load considered to be equivalent to the maximum dynamic load on the barrier was the maximum load applied to the barrier in the horizontal static load test before the nonlinear behavior started, or 356 kN.

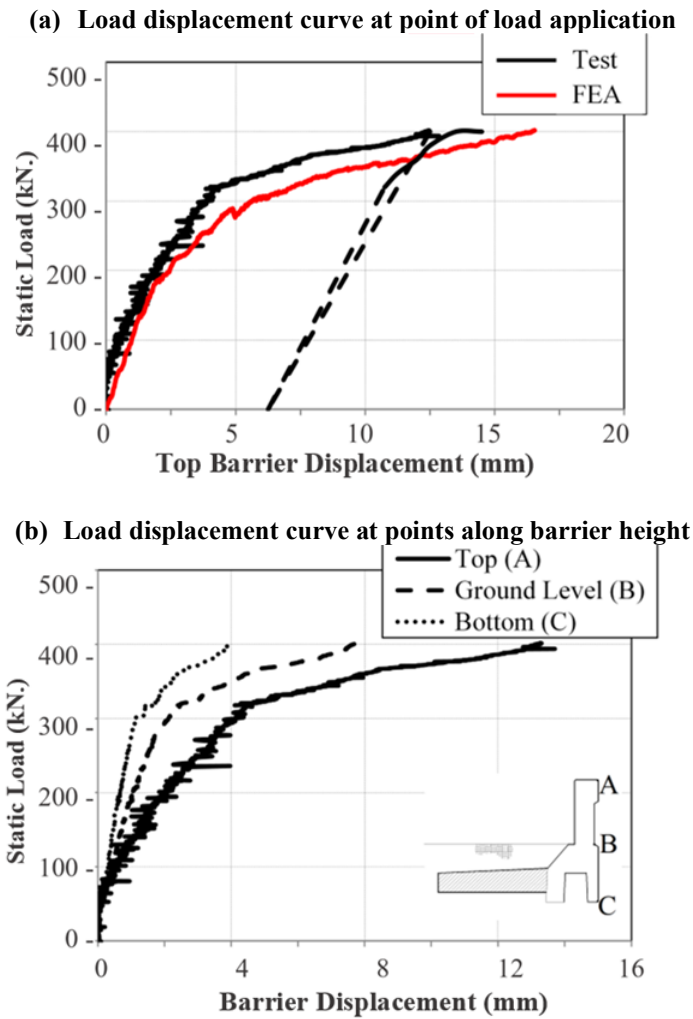
**Figure 17.** Horizontal load vs. horizontal displacement of the barrier: measurements and simulation: (a) load displacement curve at point of load application, and (b) load displacement curve at points along barrier height.

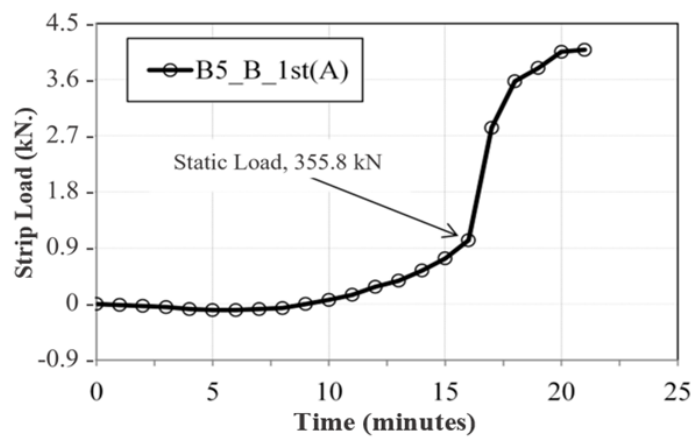
**Figure 18.** Load in top strip below barrier loading point.

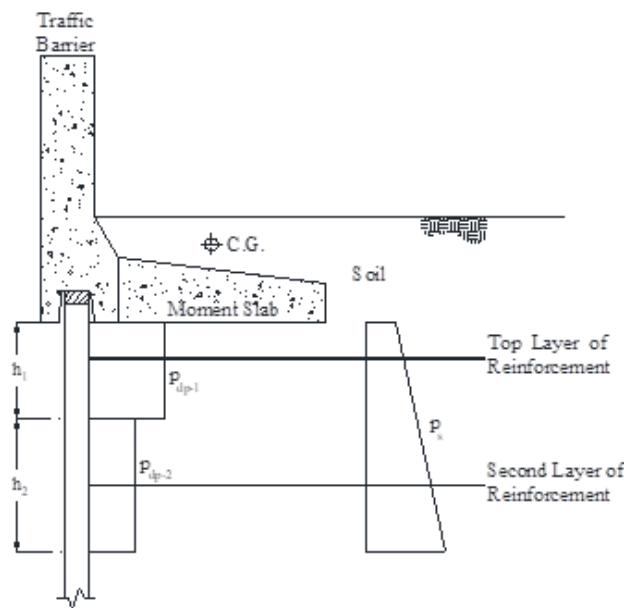
*Figure 19. Pressure diagram for static and dynamic components to design MSE wall strips for TL5 impact loading.*

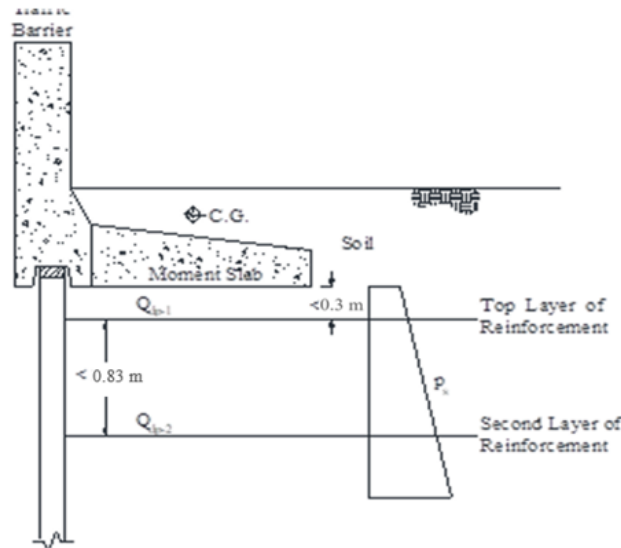
**Figure 20.** Line load diagram for static and dynamic components to design MSE wall strips for TL5 impact loading.
