# Groundwater Management Strategies for Ensuring Tunnel Safety at the Hospital Kuala Lumpur Station

**ABSTRACT:** *This paper presents a detailed case history of groundwater management implemented to ensure the safety of temporary twin TBM bored tunnels within the excavation and construction of an underground metro station in an urban environment. The metro station, constructed using the top-down construction method with tunnels bored prior to the deep excavation, is located within the Kenny Hill Formation in Kuala Lumpur, Malaysia, interfacing with the weathered quartz intrusions. The weathered material of the quartz intrusions consists of significant amounts of medium and fine sand, which are considered to be erodible. The presence of groundwater and highly permeable materials posed risks of tunnel flotation and challenges to preserving the stability and safety of the deep excavation. This study focuses on the methods and techniques employed to temporarily manage groundwater levels within the excavation to minimize the subsequent impact on the tunnel integrity. Through comprehensive monitoring and data analysis, the effectiveness of the groundwater management strategy is evaluat

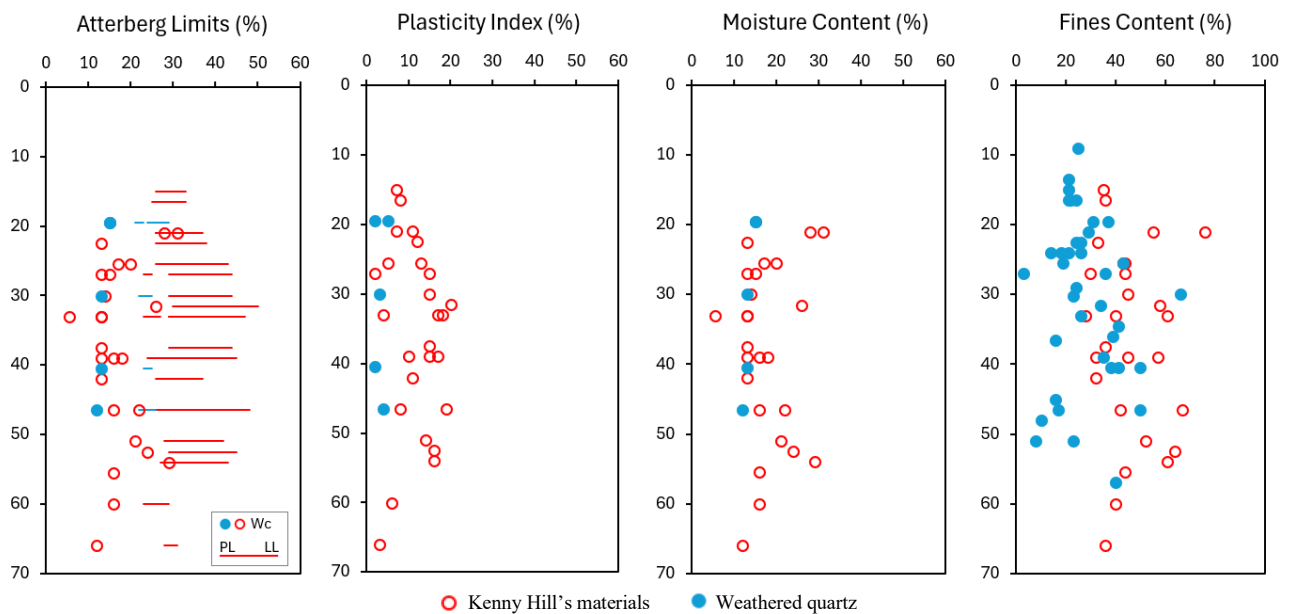
Figure 8 presents the range of index properties of the Kenny Hill's materials and weathered quartz collected from the site. Overall, the results indicate that the Kenny Hill materials exhibit higher plasticity and moisture content compared to the weathered quartz. The liquid limit and plasticity index of the Kenny Hill samples generally fall within the range of low to medium plastic clays, whereas the weathered quartz samples show very low plasticity, consistent with their coarse and silty composition. The fines content for the weathered quartz is comparatively lower and more variable, reflecting its heterogeneity and higher permeability. These contrasts highlight the distinct geotechnical behaviour between the two geological units, particularly in terms of compressibility and groundwater response.

**Figure 8.** Soil index properties – Kenny Hill's materials vs. weathered quartz.

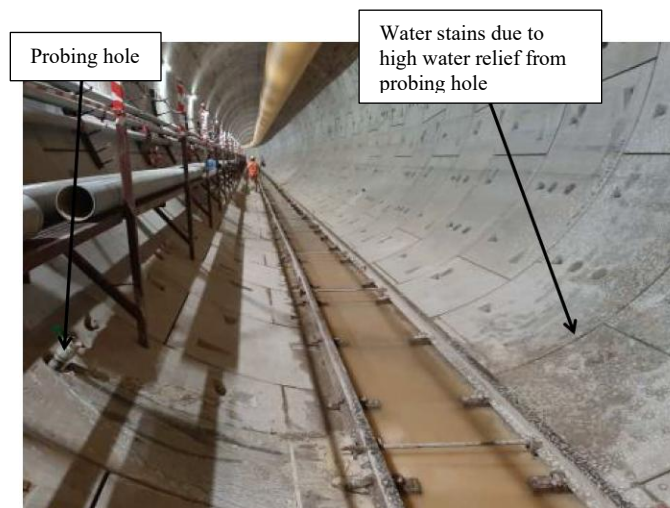
The buoyancy forces have to be resisted by dead weight of the tunnel lining, the soil cover and the shear resistance of the soil above it (Figure 10). In deep excavations, the groundwater forces may exceed the buoyancy forces, due to the presence of groundwater seepage, if the retaining wall is not socketed into an impermeable strata, i.e. an aquitard. Depending on the permeability of the soil, the efficiency of the some solutions to overcome flotation may be affected. For example, for less permeable ground, where the water inflow is negligible or manageable, the water pressure may be relieved by coring-through the segments given that the segments within the excavation are temporary. However, for permeable ground conditions with risk of eroding material, this may inhibit the tunnelling operations and safety. As excavation progressed at this site, water seepage observed on the northern side was greater than typically experienced in the Kenny Hill Formation due to the more permeable weathered quartz discussed in the previous section. Verification was carried out at a few tunnel rings by turning on the valve of grouting ports while excavation was still at a higher level. For some tunnel rings located in the envisaged quartz intrusion area, when the valve was released, water carrying fines flowed into the lining (Figure 11). In contrast, tunnel rings on the southern side, within the Kenny Hill Formation, remained relatively dry.

*Figure 11. Observation of high water seepage through temporary tunnel probing.*

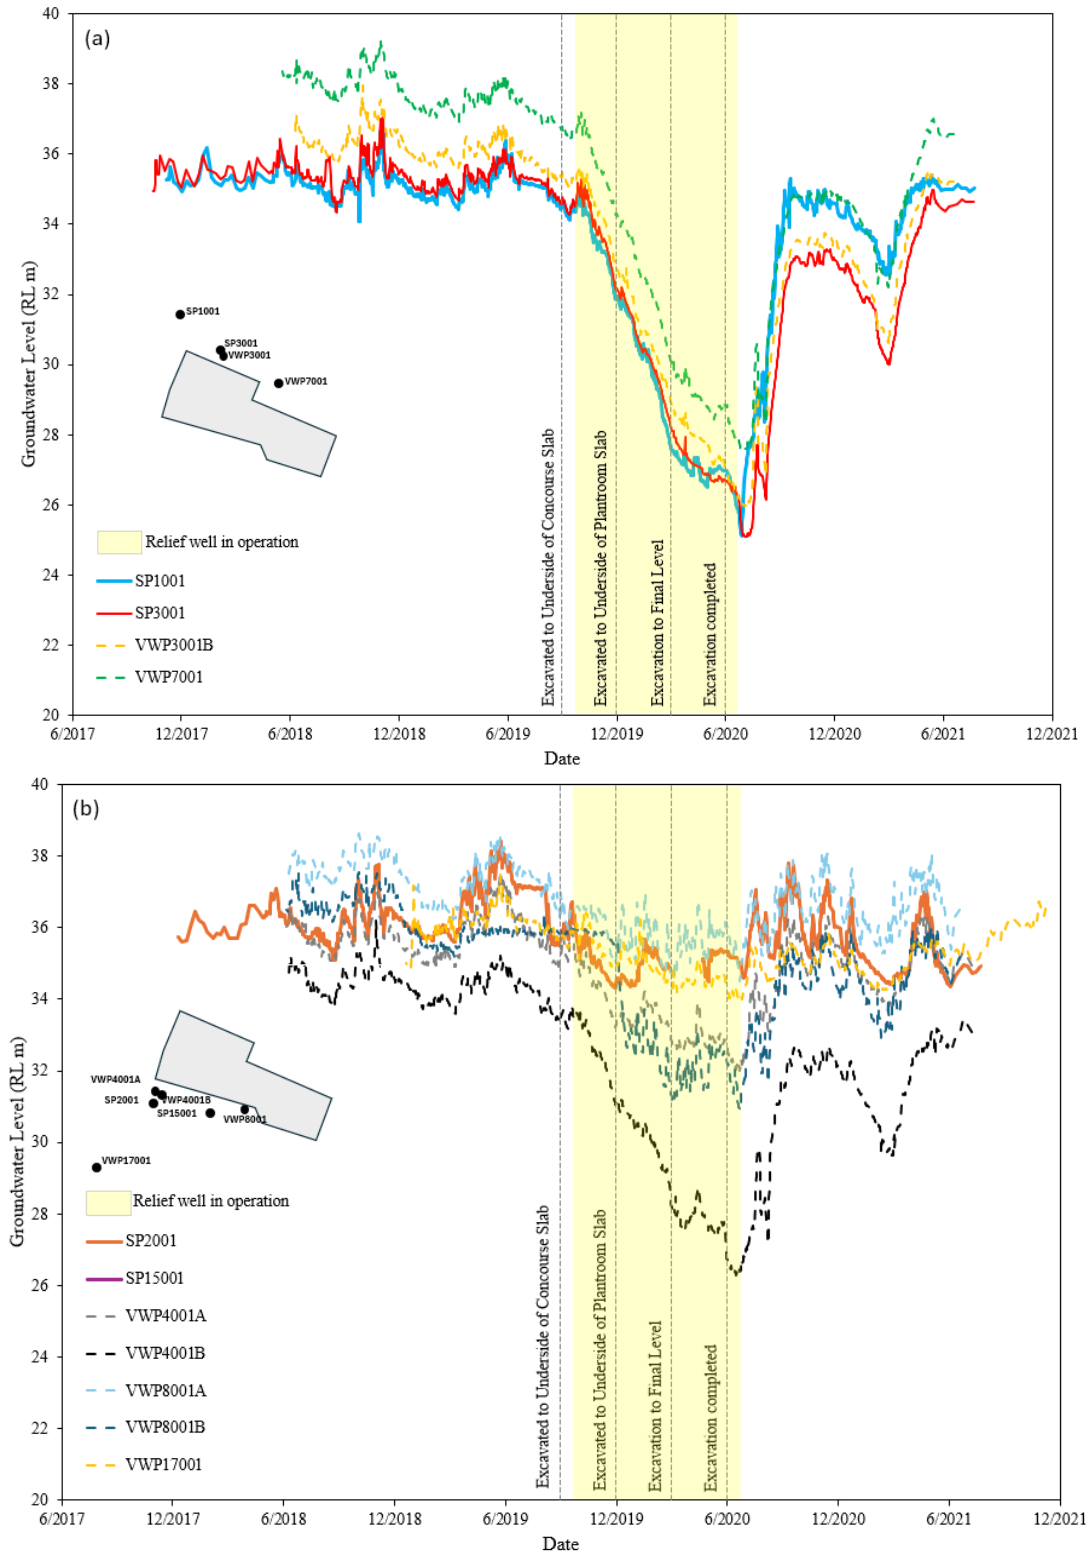
The recorded groundwater levels throughout the entire construction period, including the groundwater control activities, are presented in Figures 15(a) and 15(b) for the northern and southern sections, respectively. The groundwater level profile clearly shows significant drawdown, particularly in the northern section, where a lowering of about 10 m was observed. However, the groundwater rapidly recovered once the base slab was cast, following the completion of excavation to the final level, during which the removal of the tunnel lining was carried out concurrently. In contrast, the groundwater response in the southern section was more gradual and relatively insignificant, except at VWP4001B. This contrast highlights the influence of local soil conditions on hydrogeological behaviour, where the northern section comprising predominantly weathered quartz with relatively higher permeability exhibited a more rapid drawdown, whereas the southern section, underlain by more clayey Kenny Hill materials, showed a slower and less pronounced groundwater response.

**Figure 15.** Monitored groundwater levels throughout the construction (a) northern section (predominantly weathered quartz), and (b) southern section (predominantly Kenny Hill materials).

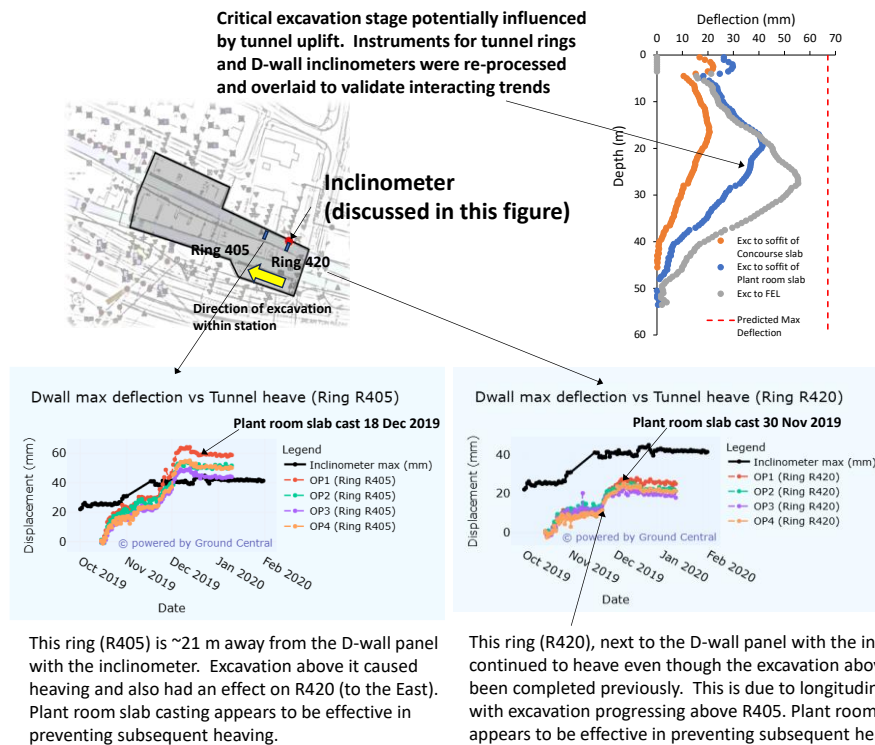
The measured diaphragm wall deflection using inclinometers from the concourse to final excavation level is presented in Figure 19. The increase in diaphragm wall deflection during the excavation from the Concourse Level to the Plant Room Level is of almost similar magnitude compared to the convergence measured in the tunnel rings (Figure 18). This observation indicates a consistent relationship between the wall deflection and the tunnel convergence, suggesting that both phenomena are influenced by similar factors during excavation. A monitoring plan was in place to ensure that the diaphragm walls are monitored against the design predictions, i.e. Alert, Action and Alarm. The Alarm value was set as the predicted value for the retaining walls of deep excavations (being 67 mm in this case). Based on Figure 19, the measured deflection at the final excavation level was 55 mm, being less than the Alarm value of 67 mm. Typically, for deep excavation projects, where monitoring triggers are breached, in-place contingency measures would generally be to revise the predictions and propose mitigation action plans if there is insufficient reserve capacities in the retaining systems, such as introducing intermediate strutting. In this case, such measures were not required, as the deformations were within acceptable limits.

It is likely that the diaphragm wall moved during the TBM bore through and had been demonstrated in Boon et al. (2016) for another site. However, for the Hospital Kuala Lumpur Station, the excavation to the underside of the Roof Slab is 5-6 m below ground (Figure 9). While baseline monitoring was taken prior to excavation to the roof slab, the inclinometer sleeves through the diaphragm walls could only be resumed once backfill was completed above the roof slab to provide staging to access the inclinometers. Due to the lack of staging to access the inclinometers during TBM boring, only the total cumulative movement is available, comprising the TBM bore-through and excavation to the concourse level, after the roof slab level is backfilled (orange line in the inclinometer profile in Figure 19).

**Figure 19.** Monitored diaphragm wall deflections and overlaying against tunnel upward heave at two tunnel rings to validate (i) potential mechanisms in Figure 10 and (ii) the effectiveness of progressive slab casting above the tunnels. Longitudinal effects are evident in the tunnel rings (see Figure 18) and can be influenced by excavation activities before and after the ring position.

As the activation of relief wells occurred concurrently with the excavation commencement from the Concourse Level to the underside of the Plant Room level, the wall movement arising from the activation of relief wells alone were masked by the concurrent activities but thought to be beneficial.
