Geotechnical and Structural Challenges over an Active Landslide

ABSTRACT: The construction of the steel arched Tsakona Bridge, designed to overpass an active landslide, required several temporary projects. Auxiliary steel towers were used for the erection and welding of the arch segments. Most of them had to be founded in the body of the sliding mass. An automated instrumentation and monitoring system was installed on site providing early warning to the engineers in charge in case large displacements were measured. The real-time recording data provided valuable information about the landslide movements. These monitoring results defined the geotechnical and structural design criteria for the deep foundation of the temporary towers. Several 2D and 3D geotechnical and structural models were created to evaluate the sliding effect on the foundation components, finalize their dimensioning and calculate the required reinforcement. The procedure followed for the design of the temporary deep foundation is described based on the criteria devised using the monitoring system, emphasizing on the continuous feedback between the geotechnical and structural design teams. Several key structural de

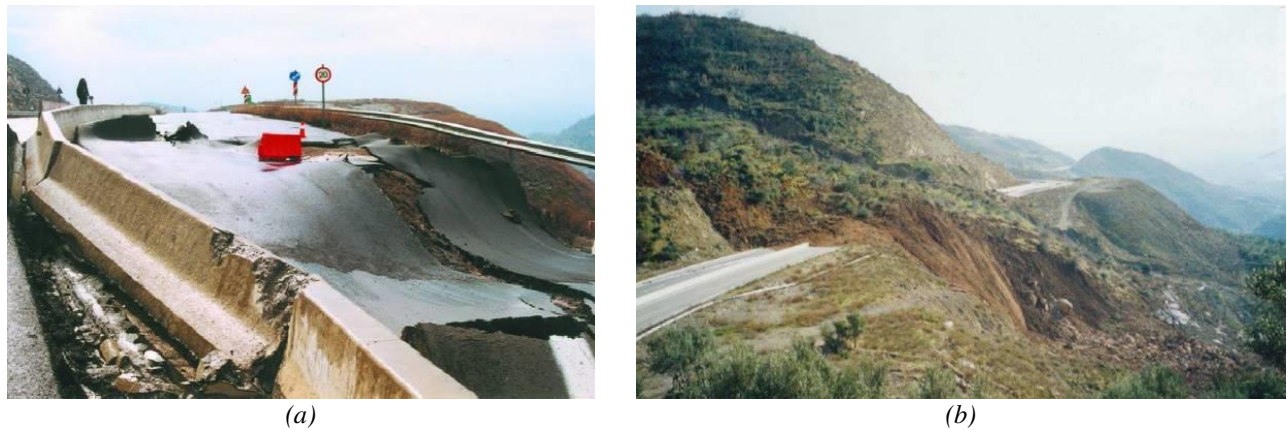
Figure 1. The Tsakona landslide (February 2003) (EMEK S.A (2015)) (a) large settlements on the road pavement (b) massive soil movement (Fikiris et al. (2001)).

The highway to the city of Kalamata in southern Peloponnese crossed through an old landslide, which was reactivated in January 2003 after a period of heavy rainfalls, leading to a major catastrophic slide. The triggered landslide is one of the largest that have occurred in Greece, the consequences of which are shown in Figure 1. Horizontal and vertical displacements of the sliding mass up to 100 m and 40 m, respectively, were measured, causing a soil mass movement of about 6,000,000 m³ of flysch colluvia and manmade deposits, extended in a large area of 400 m upslope and 700 m downslope of the highway (Belokas 2013, Belokas and Dounias 2016). Among several options studied for the rehabilitation of the National Highway, bridging over the landslide was selected as the most cost-efficient and technically feasible solution (Fikiris et al. 2011). The steel arched Tsakona Bridge, sketched in Figure 2, was decided to be constructed over the sliding mass, which moved downslope at an average rate of about 1.5-2.0 mm/month. This rate was increasing significantly during the periods of intense rainfalls, exceeding for short periods of time the value of 30 mm/month (projected rate of movement).

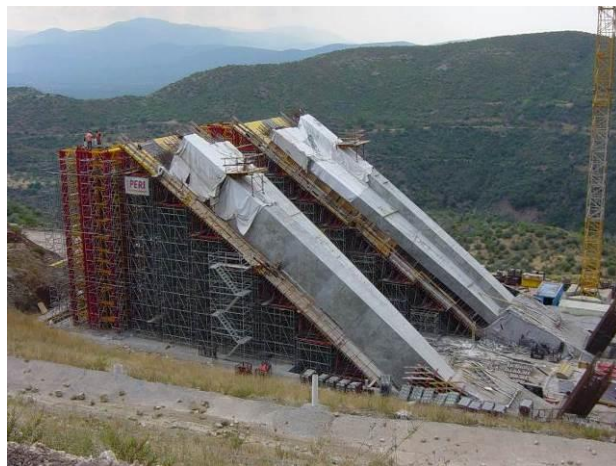
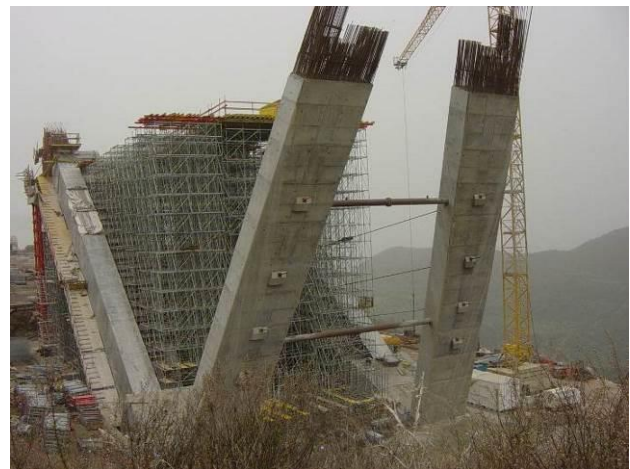
Figure 9. Construction of the (a) curved struts and (b) straight struts of the bridge pier.

The main body of the V-shaped pier consisted of two pairs of supporting struts. The southern struts were curved, following the parabolic geometry of the arch. The northern ones were designed as straight elements on the same inclined plane, converging towards each other. For the construction of the curved struts, scaffolding towers were used, anchored on slabs on the ground. For the straight struts a self-climbing formwork system was mobilized. Temporary horizontal bracings along the transverse direction kept the straight struts in place. At the same time, temporary tendons were utilized to suspend these struts from the completed curved ones, providing the necessary stability to the unfinished V-shaped pier (Figure 9). Before the construction of the curved struts, the two MT towers were installed to support their top ends. They were designed to provide bearing capacity of 12000 kN and 16500 kN each, under static and seismic load combination, respectively. Their foundation consisted of pile-groups penetrating the stable bedrock, connected with pile caps. Ground anchors were also foreseen, as mitigation measure to be activated in case large movements were observed during construction (Figure 10). A special arrangement was provided on the top of the MT towers to compensate any contingency movement within the loose soil above the bedrock as well as the elastic deformations of the auxiliary towers and the deformation due to temperature fluctuations. This arrangement included two (2) elastomeric bearings and four (4) lifting jacks for each tower. Continuous accurate surveying of the level of the bearings and vertical adjustments through the jacks were ensuring the fixed vertical position of the support during construction, until the complete functionality of the arch was achieved.

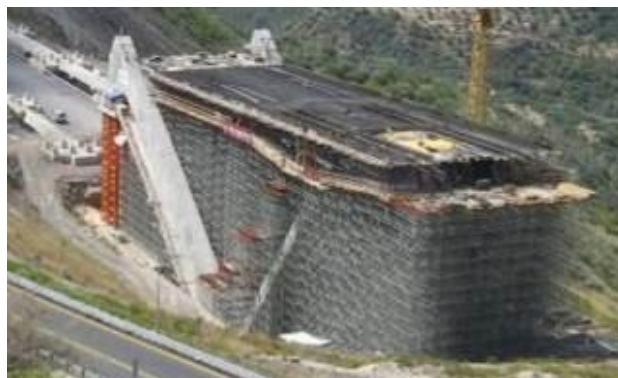
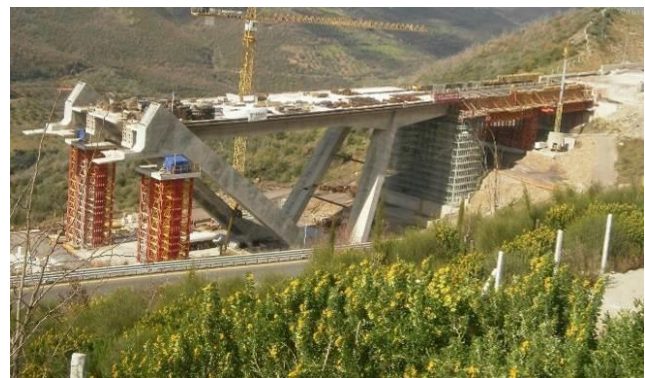
Figure 11. Construction of (a) the 55 m and (b) the 75 m access parts of the bridge prestressed concrete deck.

The 130 m prestressed concrete part of the bridge consisted of two parts, one 55 m long closing the V shape of the bridge pier and the other 75 m long between the straight struts of the pier and the northern abutment, as shown in Figure 11. The first part was poured on scaffolding anchored on the struts of the pier and ground slabs, while for the second one heavy duty bridge-type scaffolding was used, founded with piles on adverse surface morphology conditions, but on a stable ground (Figure 11). The construction of the bridge was completed with the steel arch part. The arch system with a span of 260 m and a rise of 45 m, consisted of two vertical steel arches, one for each branch of the Highway, connected with K-type bracings, all pre-fabricated. Segments of 12 m long were assembled and welded on the ground slabs or the bridge corridors, creating larger pieces of 36 m, which were in turn lifted to position with the heavy lifting system mounted on the temporary steel towers and welded at height. Shelter booths were seated at the top of the towers providing protection from the wind and the rain for the welding procedure of the arch segments (Figure 12a). The bridge was completed with the erection of the composite deck (Figure 12b), which was fully suspended from the arches with the use of hangers (Stathopoulos et al. 2014a, 2014b).

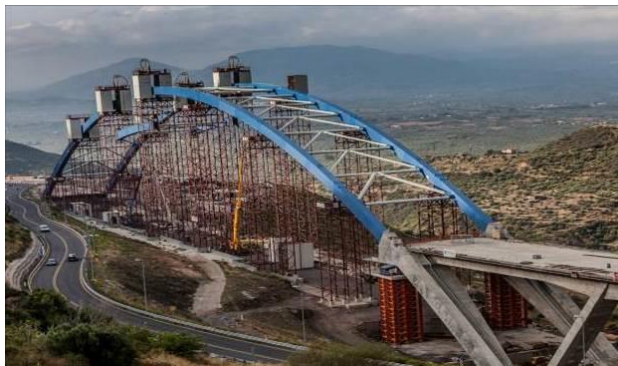
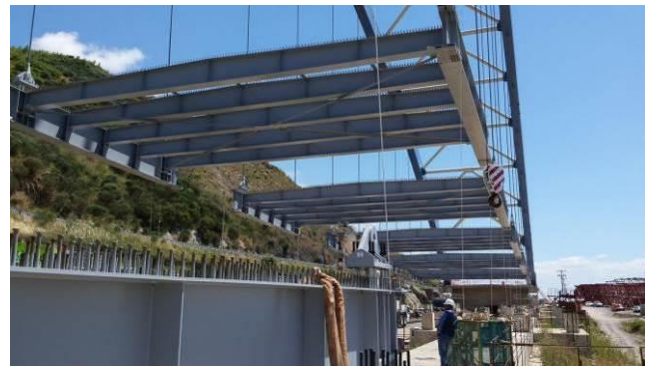
Figure 12. Assembling, erection and welding of (a) the arch segments using the auxiliary steel towers and (b) the composite deck segments.

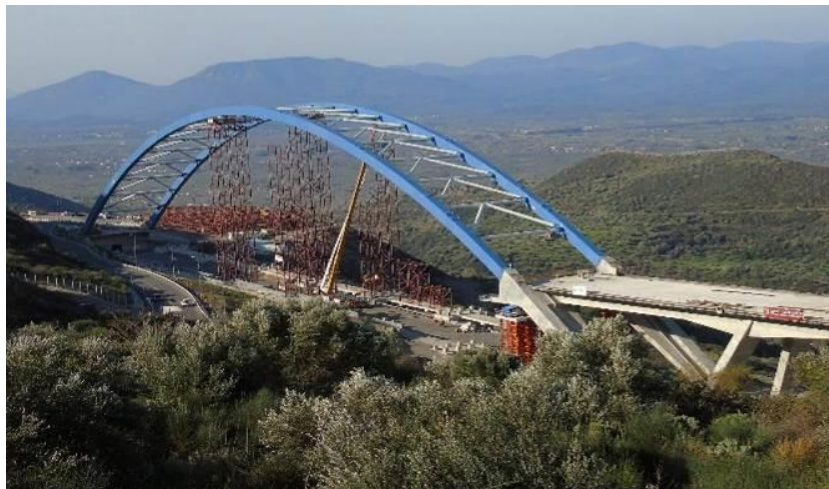
Figure 14. Removal of the temporary towers.

Other crucial issues were related with gradual removal of the arch supporting towers (Figure 14), as well as the total release of the bridge and the removal of the last supporting structure, the MT towers.

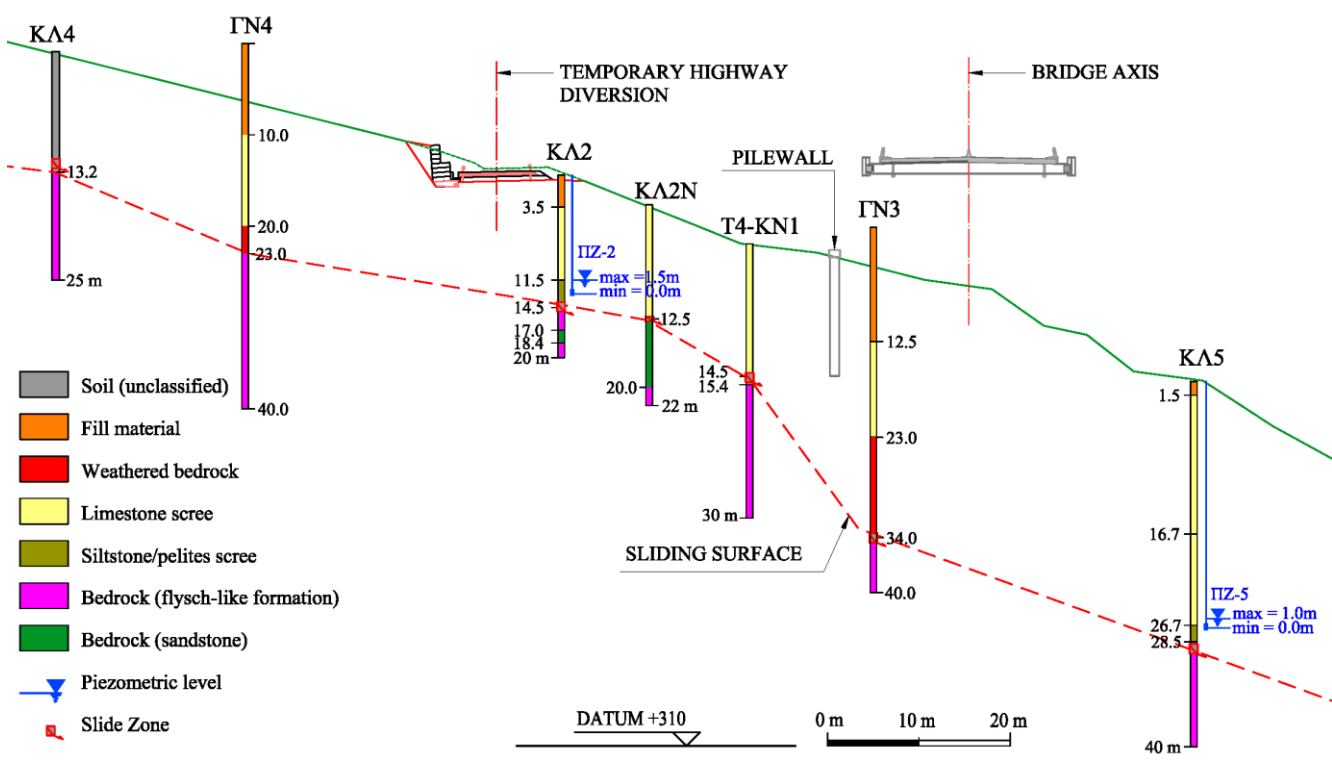
Figure 16. Section in between Piers I12 and I13 showing the position of the geotechnical instruments with respect to the bedrock surface.

In order to explore and deal with an active landslide, which presented very small margins of safety against failure, a network of geotechnical instruments that recorded the movements of the sliding mass and water levels was installed in the 2001-2012 period, comprising optical targets, inclinometers and piezometers. In January 2013, in view of the forthcoming high-risk construction works, a complementary fully automated instrumentation scheme was designed and implemented that continuously recorded, monitored and updated a database (Seferoglou and Chrysohoidis 2016). The instruments were located at key depths within the sliding mass and at positions near structural elements. The new instrumentation system consisted of four (4) in-place inclinometer chains in boreholes KA2, KA3, KA4 and KA5 (later relocated to KA2N, KA3N and KA5N), three (3) electrical piezometers (ΠΖ-2, ΠΖ-3 και ΠΖ-5) close to the boreholes KA2, KA3 and KA5 and a rain gauge (pluviometer). These instruments, along with the conventional ones, provided all the necessary information about the movement of the sliding mass and its impact on the structures. The arrangement of all instruments in plan-view is illustrated in Figure 15, while a characteristic section between piers Π2 and Π3 is shown in Figure 16, pointing out the position of the geotechnical instruments with respect to the bedrock surface.

shown in Figures 6 through 8 and 16. The scope of this procedure aimed at defining the geotechnical parameters that would feed the final structural design of each pier. These parameters were the coefficients of the earth pressure produced by landslide slippage and the constants of the equivalent elastic supports that would be applied as springs at the bottom of each pile of the structural models, simulating the soil-structure interaction. The constant of equivalent vertical spring of each pile of the piers was expressed as $K=P/v_z$, where $P=1000$ kN was a single load applied on the top of the corresponding pile and v_z was the calculating settlement. For the piles of the left branch a mean value derived from the analyses of all piers and a spring constant of 140,000 kN/m was adopted, while for the right branch the calculated values varied within a range of 120,000 kN/m – 1,000,000 kN/m. These results were in accordance with the ones derived from loading tests of non-functional piles. Regarding the earth pressure evolved at the upslope piles of the right branch piers $\Pi 2\Delta$ - $\Pi 4\Delta$, presenting the maximum free height and being founded in the sliding body, the horizontal and vertical stresses were calculated under static loads, resulting in equivalent pressure coefficient equal to $K_0=0.50$. The same value was obtained for the imposed movement, since the floating piles moved along with the sliding mass, as also demonstrated by the 3D geotechnical analyses and confirmed by the monitoring data.

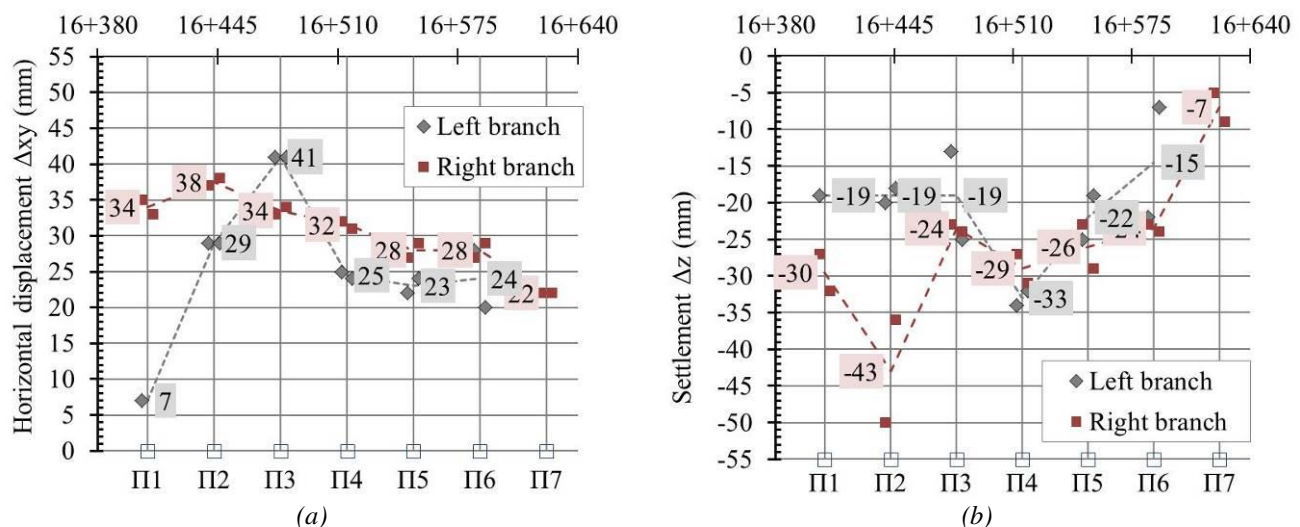
Figure 19. Recorded differential (a) horizontal and (b) vertical displacement between piers (time period 3/13 – 3/14).

- Differential horizontal and vertical displacements were observed between the piers of the two branches of the highway and between the piers of the same branch, as plotted in Figure 19. The maximum differential horizontal displacement was noted between piers Π1A and Π1Δ reaching 2.7 cm, while the maximum vertical displacement was measured between piers Π2A and Π2Δ, being equal to 2.4 cm.

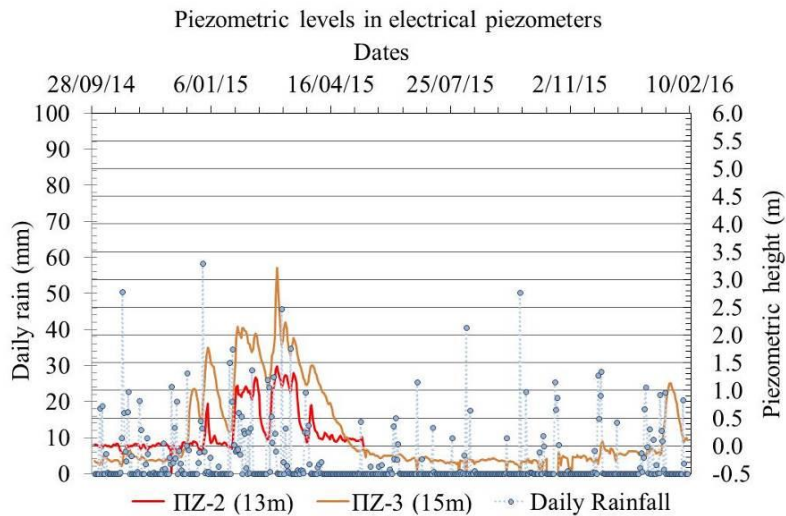
Figure 21. Diagram showing correspondence of piezometric levels to rainfall.

- The rate of the sliding movement varied seasonally depending on rainfall, as shown in Figure 20. The rate picks are concentrated in the months of February and March, reflecting major rainfall incidents as well as the accumulation of rainfall along the whole rainy season (November-March). The influence of heavy rainfalls in the piezometric levels can be seen in Figure 21.

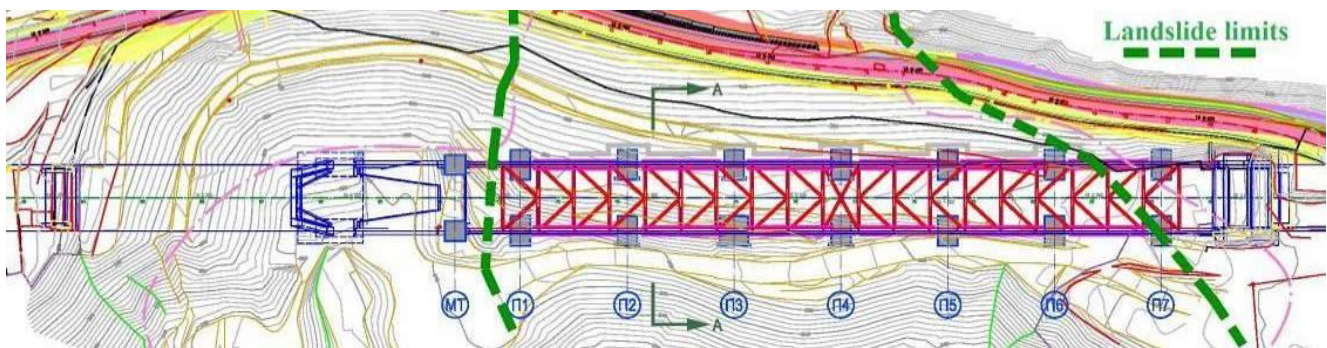
Figure 24. Location in plan view of the characteristic transverse view A-A.

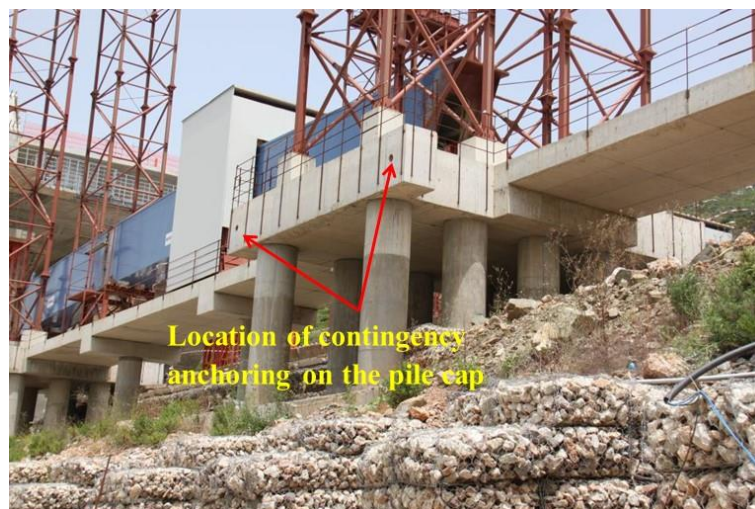
Figure 34. Contingency plan for anchoring of the pile caps.
